Report No. 1
Quarterly

EBIC/TEM INVESTIGATIONS OF PROCESS-INDUCED DEFECTS IN EFG SILICON RIBBON

December 1981

Brian Cunningham and D.G.Ast

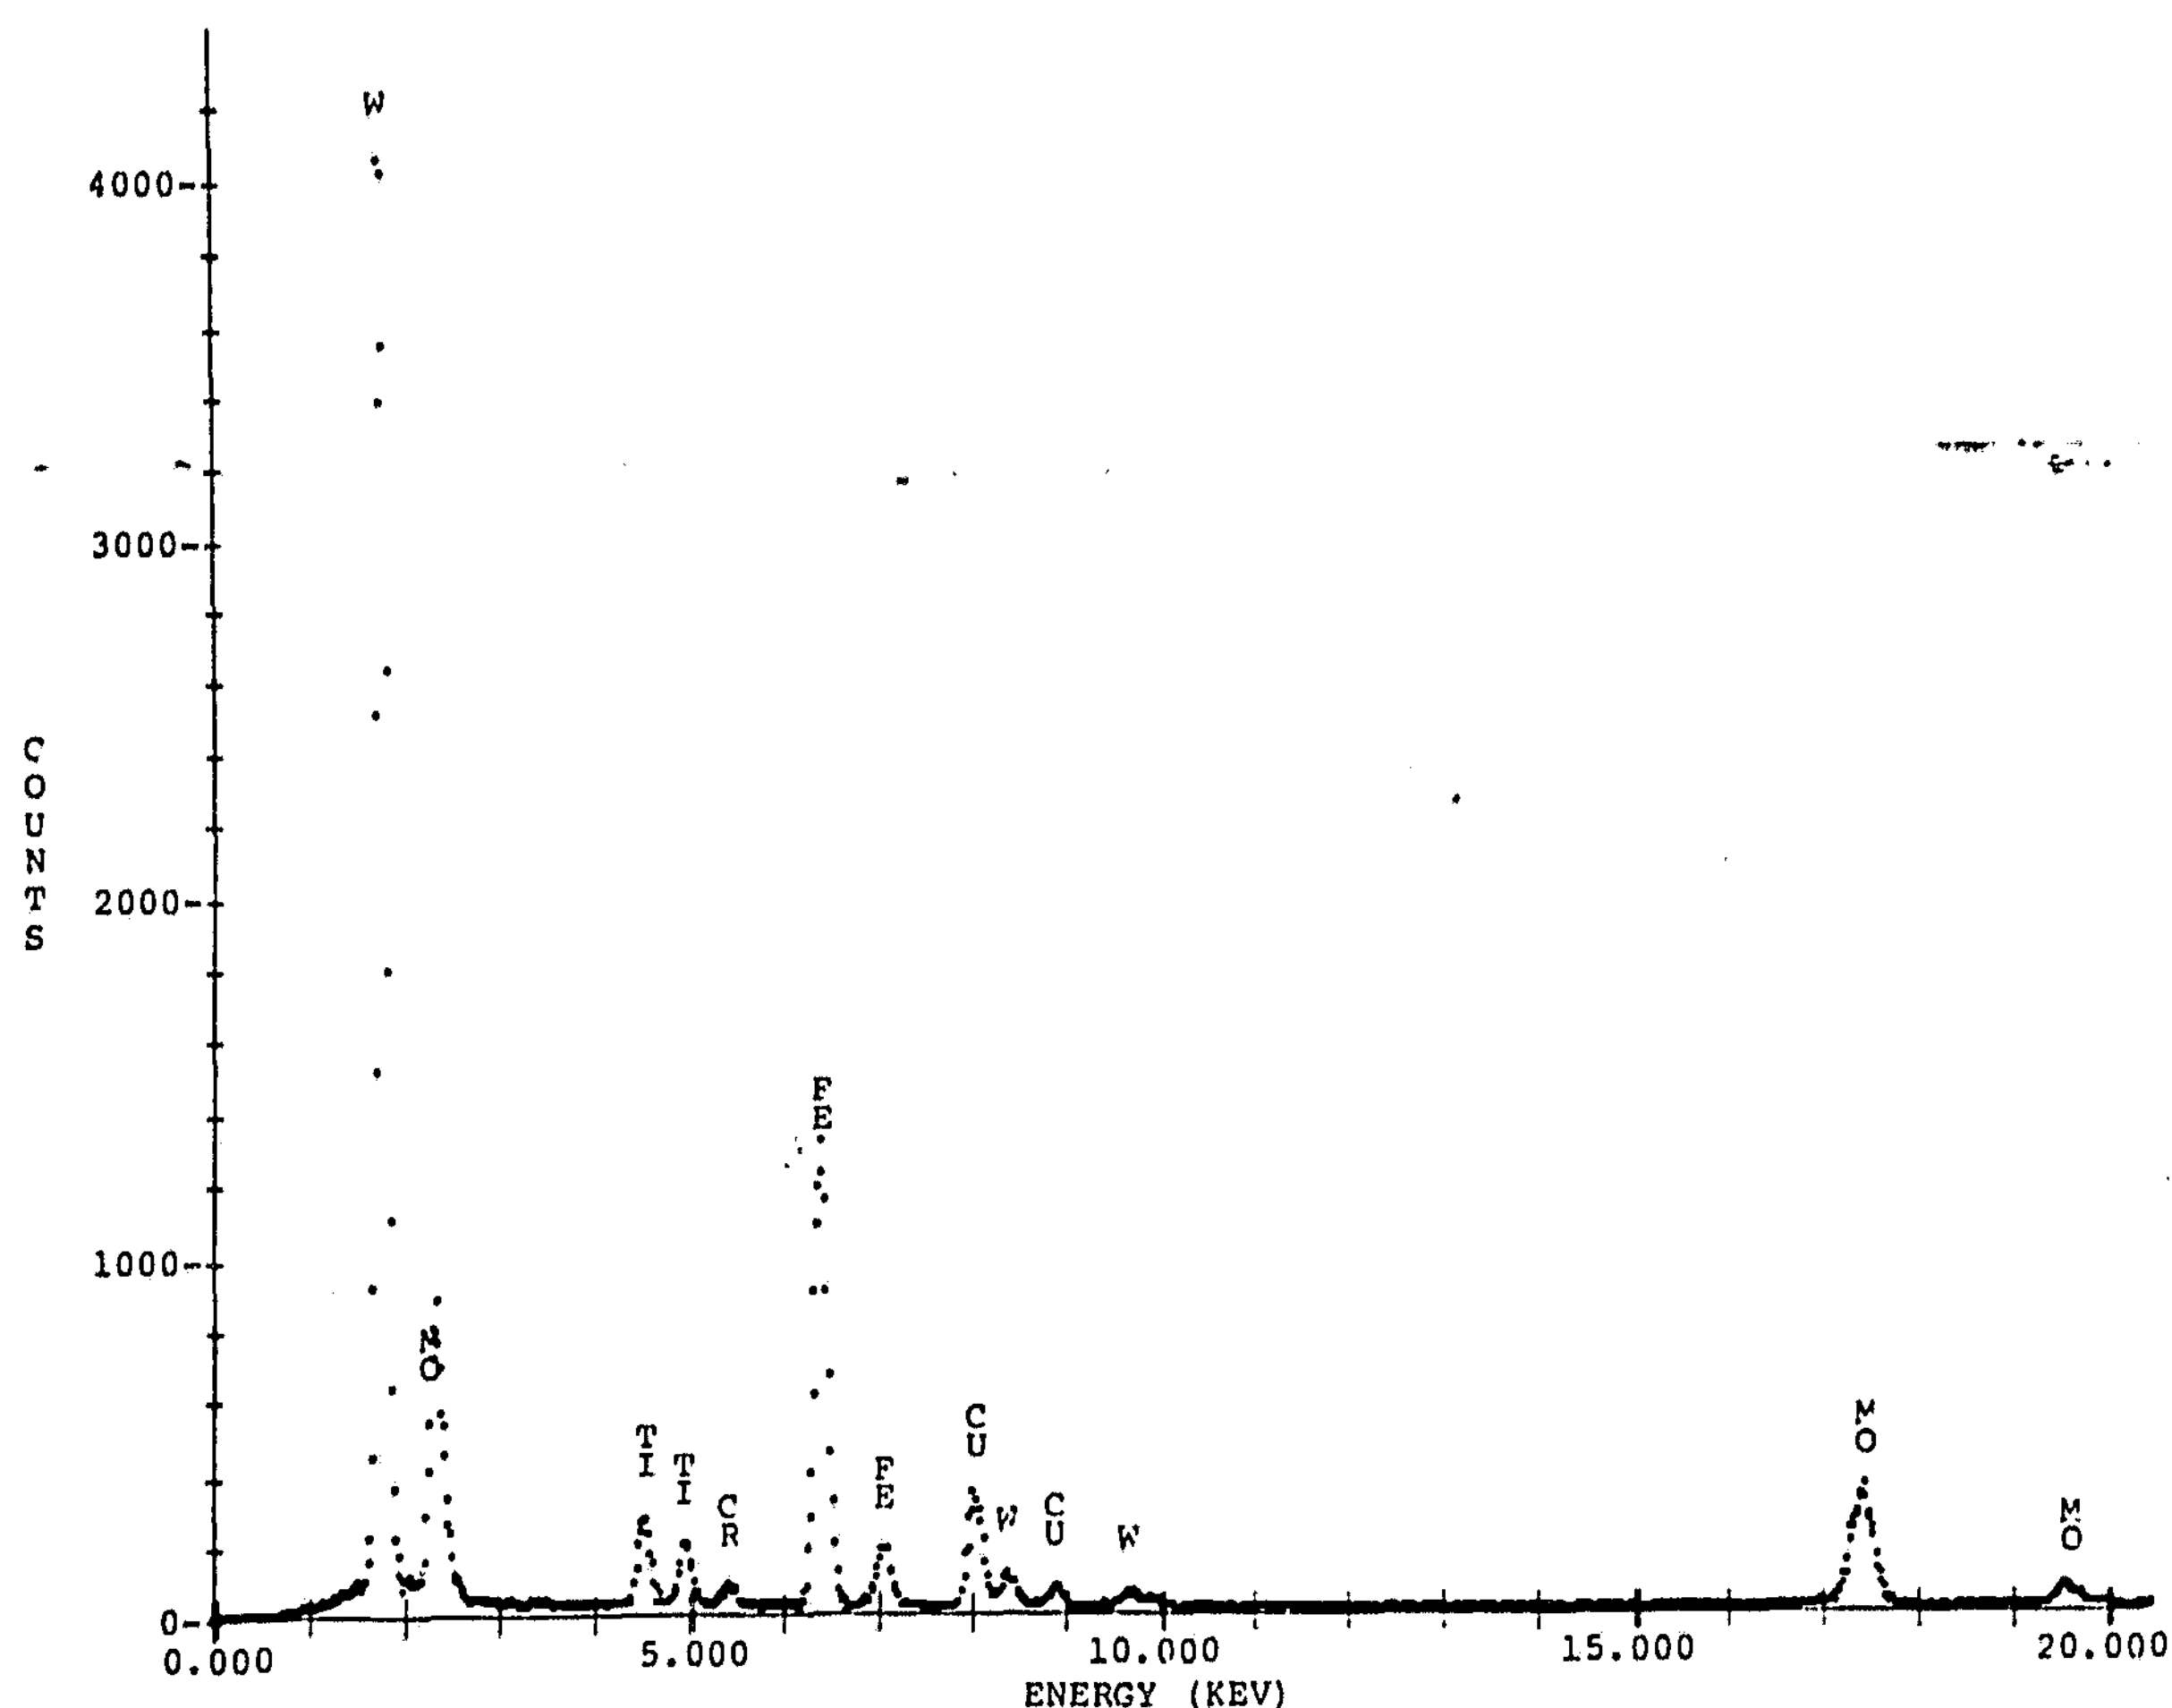
Fig.7. X-ray spectrum of precipitate A in Fig. 5.

The X-ray spectra from two of the precipitates shown in Figs. 5 and 6 are given in Figs 7 and 8. The large peak labeled W is a combined peak of both Si and W, whose peaks overlap within experimental resolution. For comparison, Fig. 9 shows a spectrum taken from the bulk of the sample. All spectra contain a weak Cu peak which is due to scattering from the Cu grid which supports the specimen. Several heavy metals are present in the precipitates, such as Fe, Mo and Ti. Metallic impurities, and in particular transition

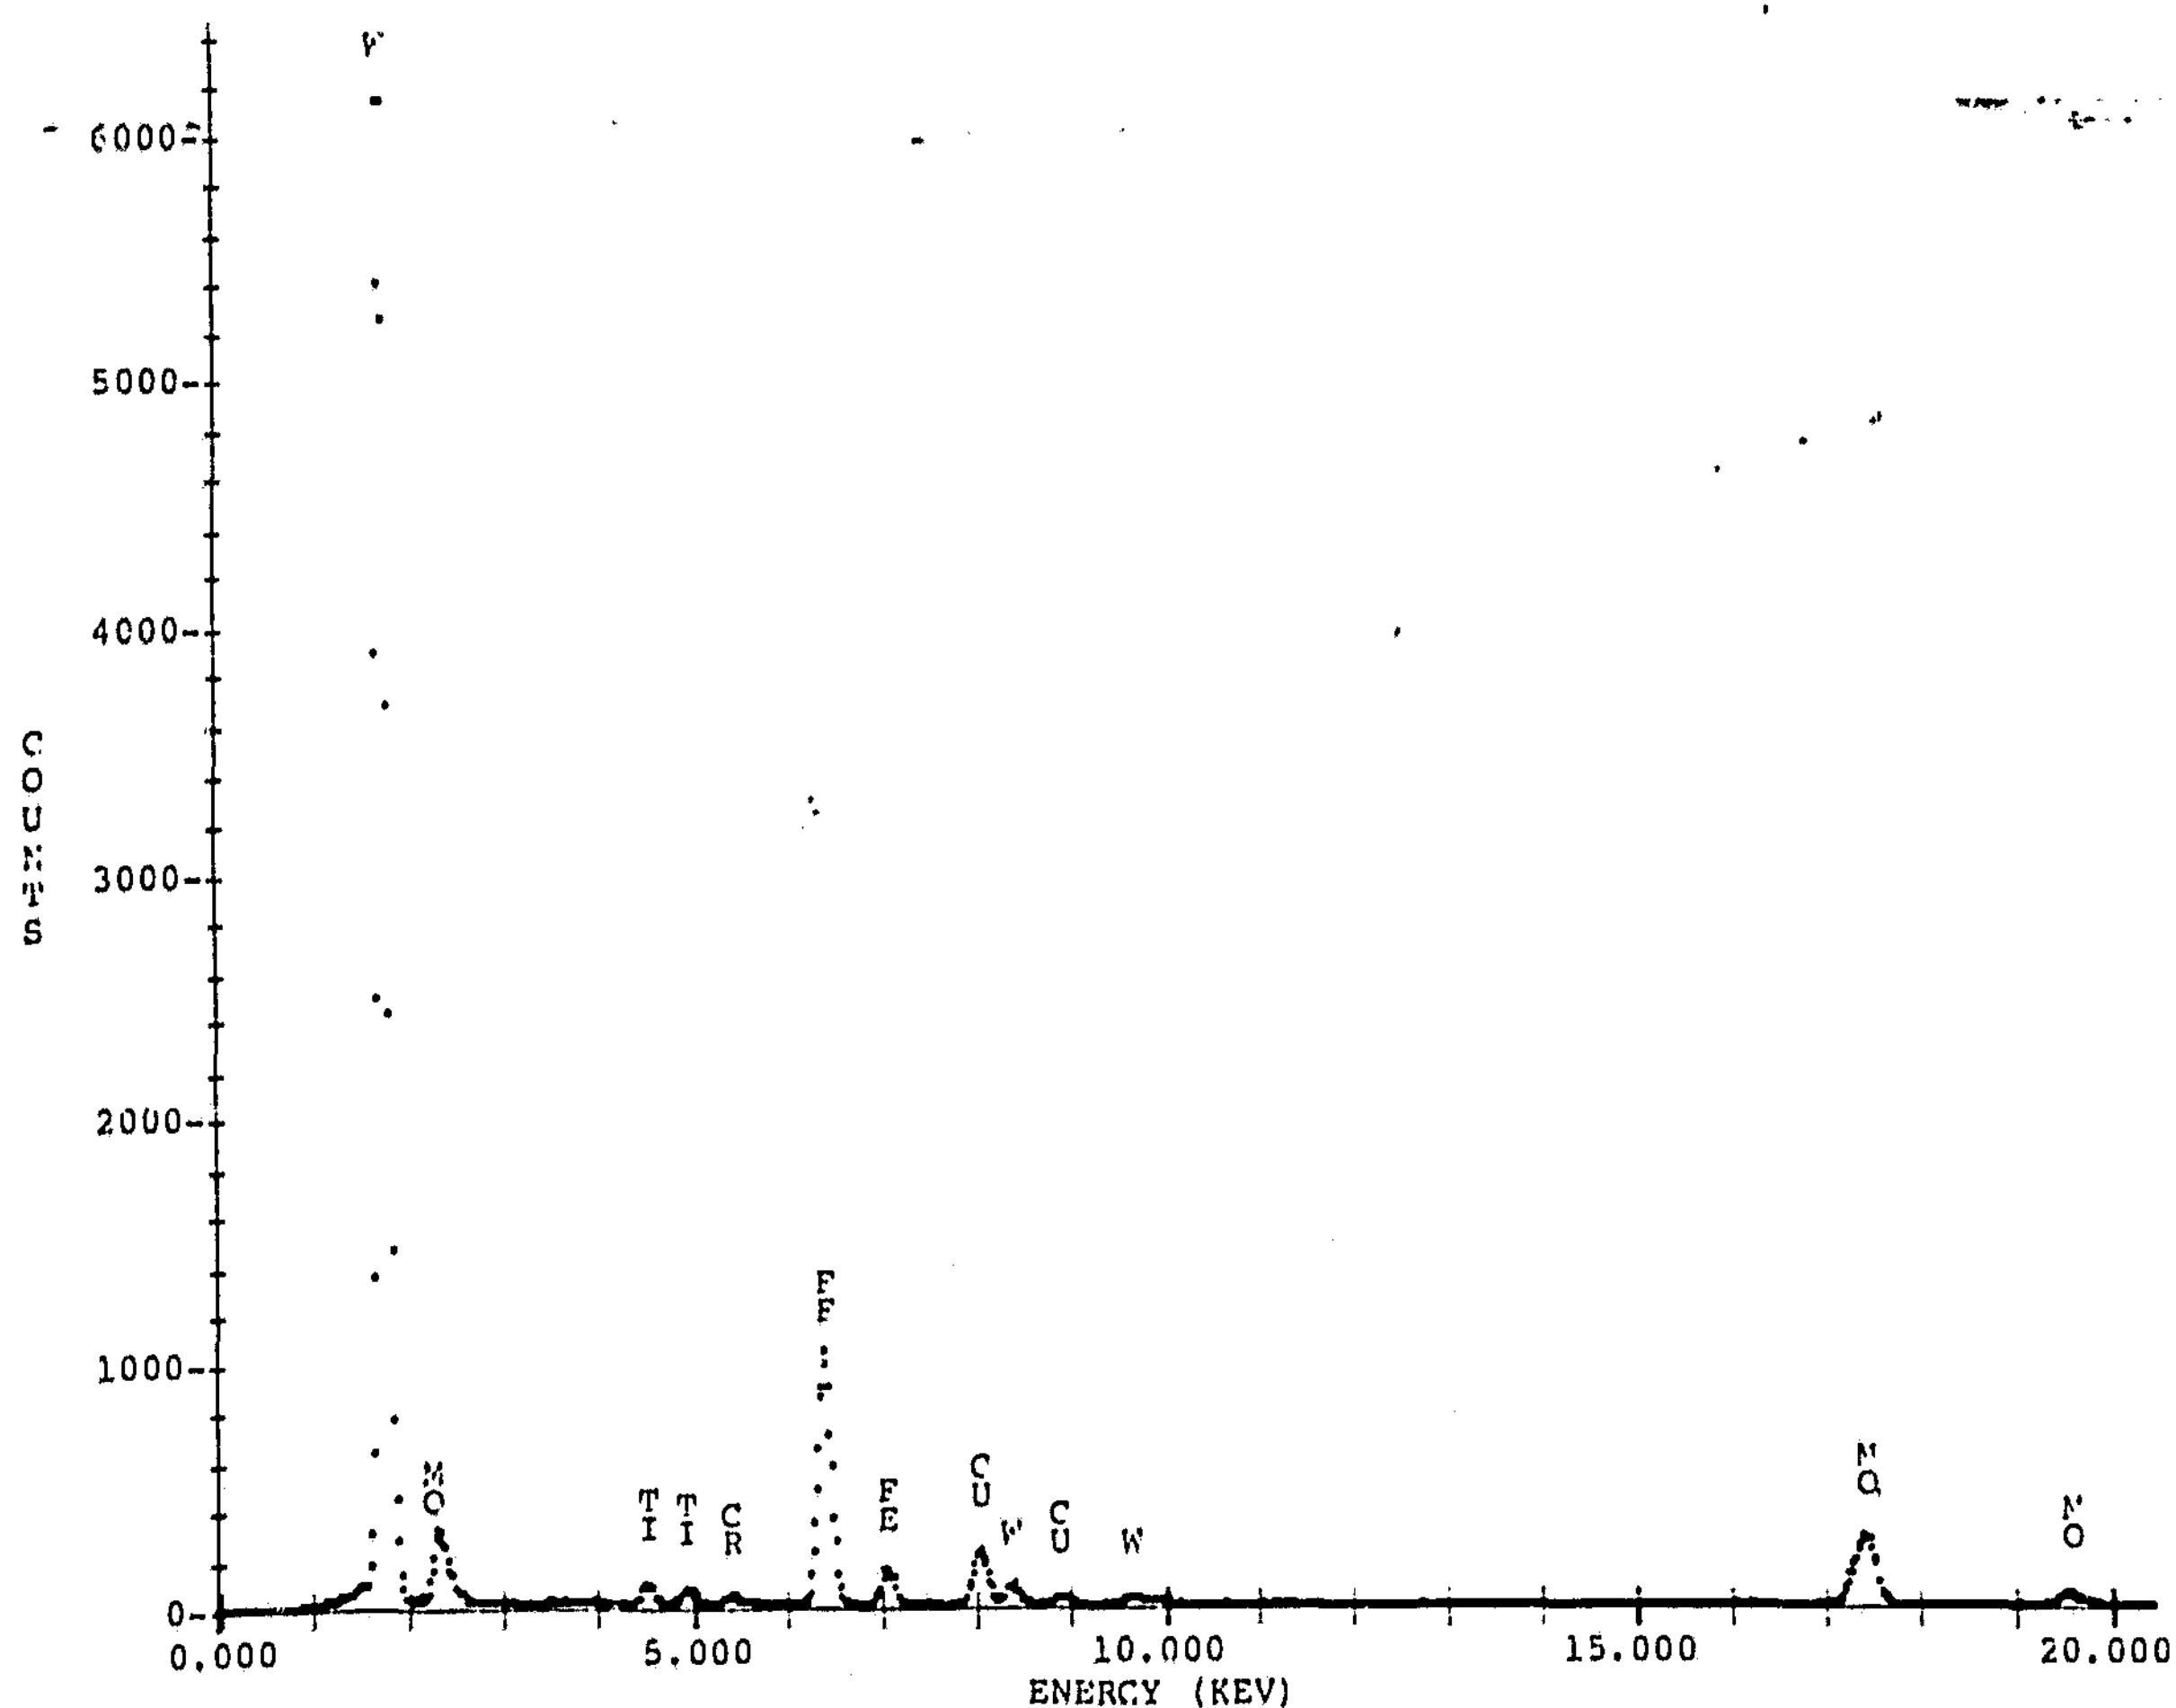
Fig.8. X-ray spectrum of precipitate B in Fig.5.

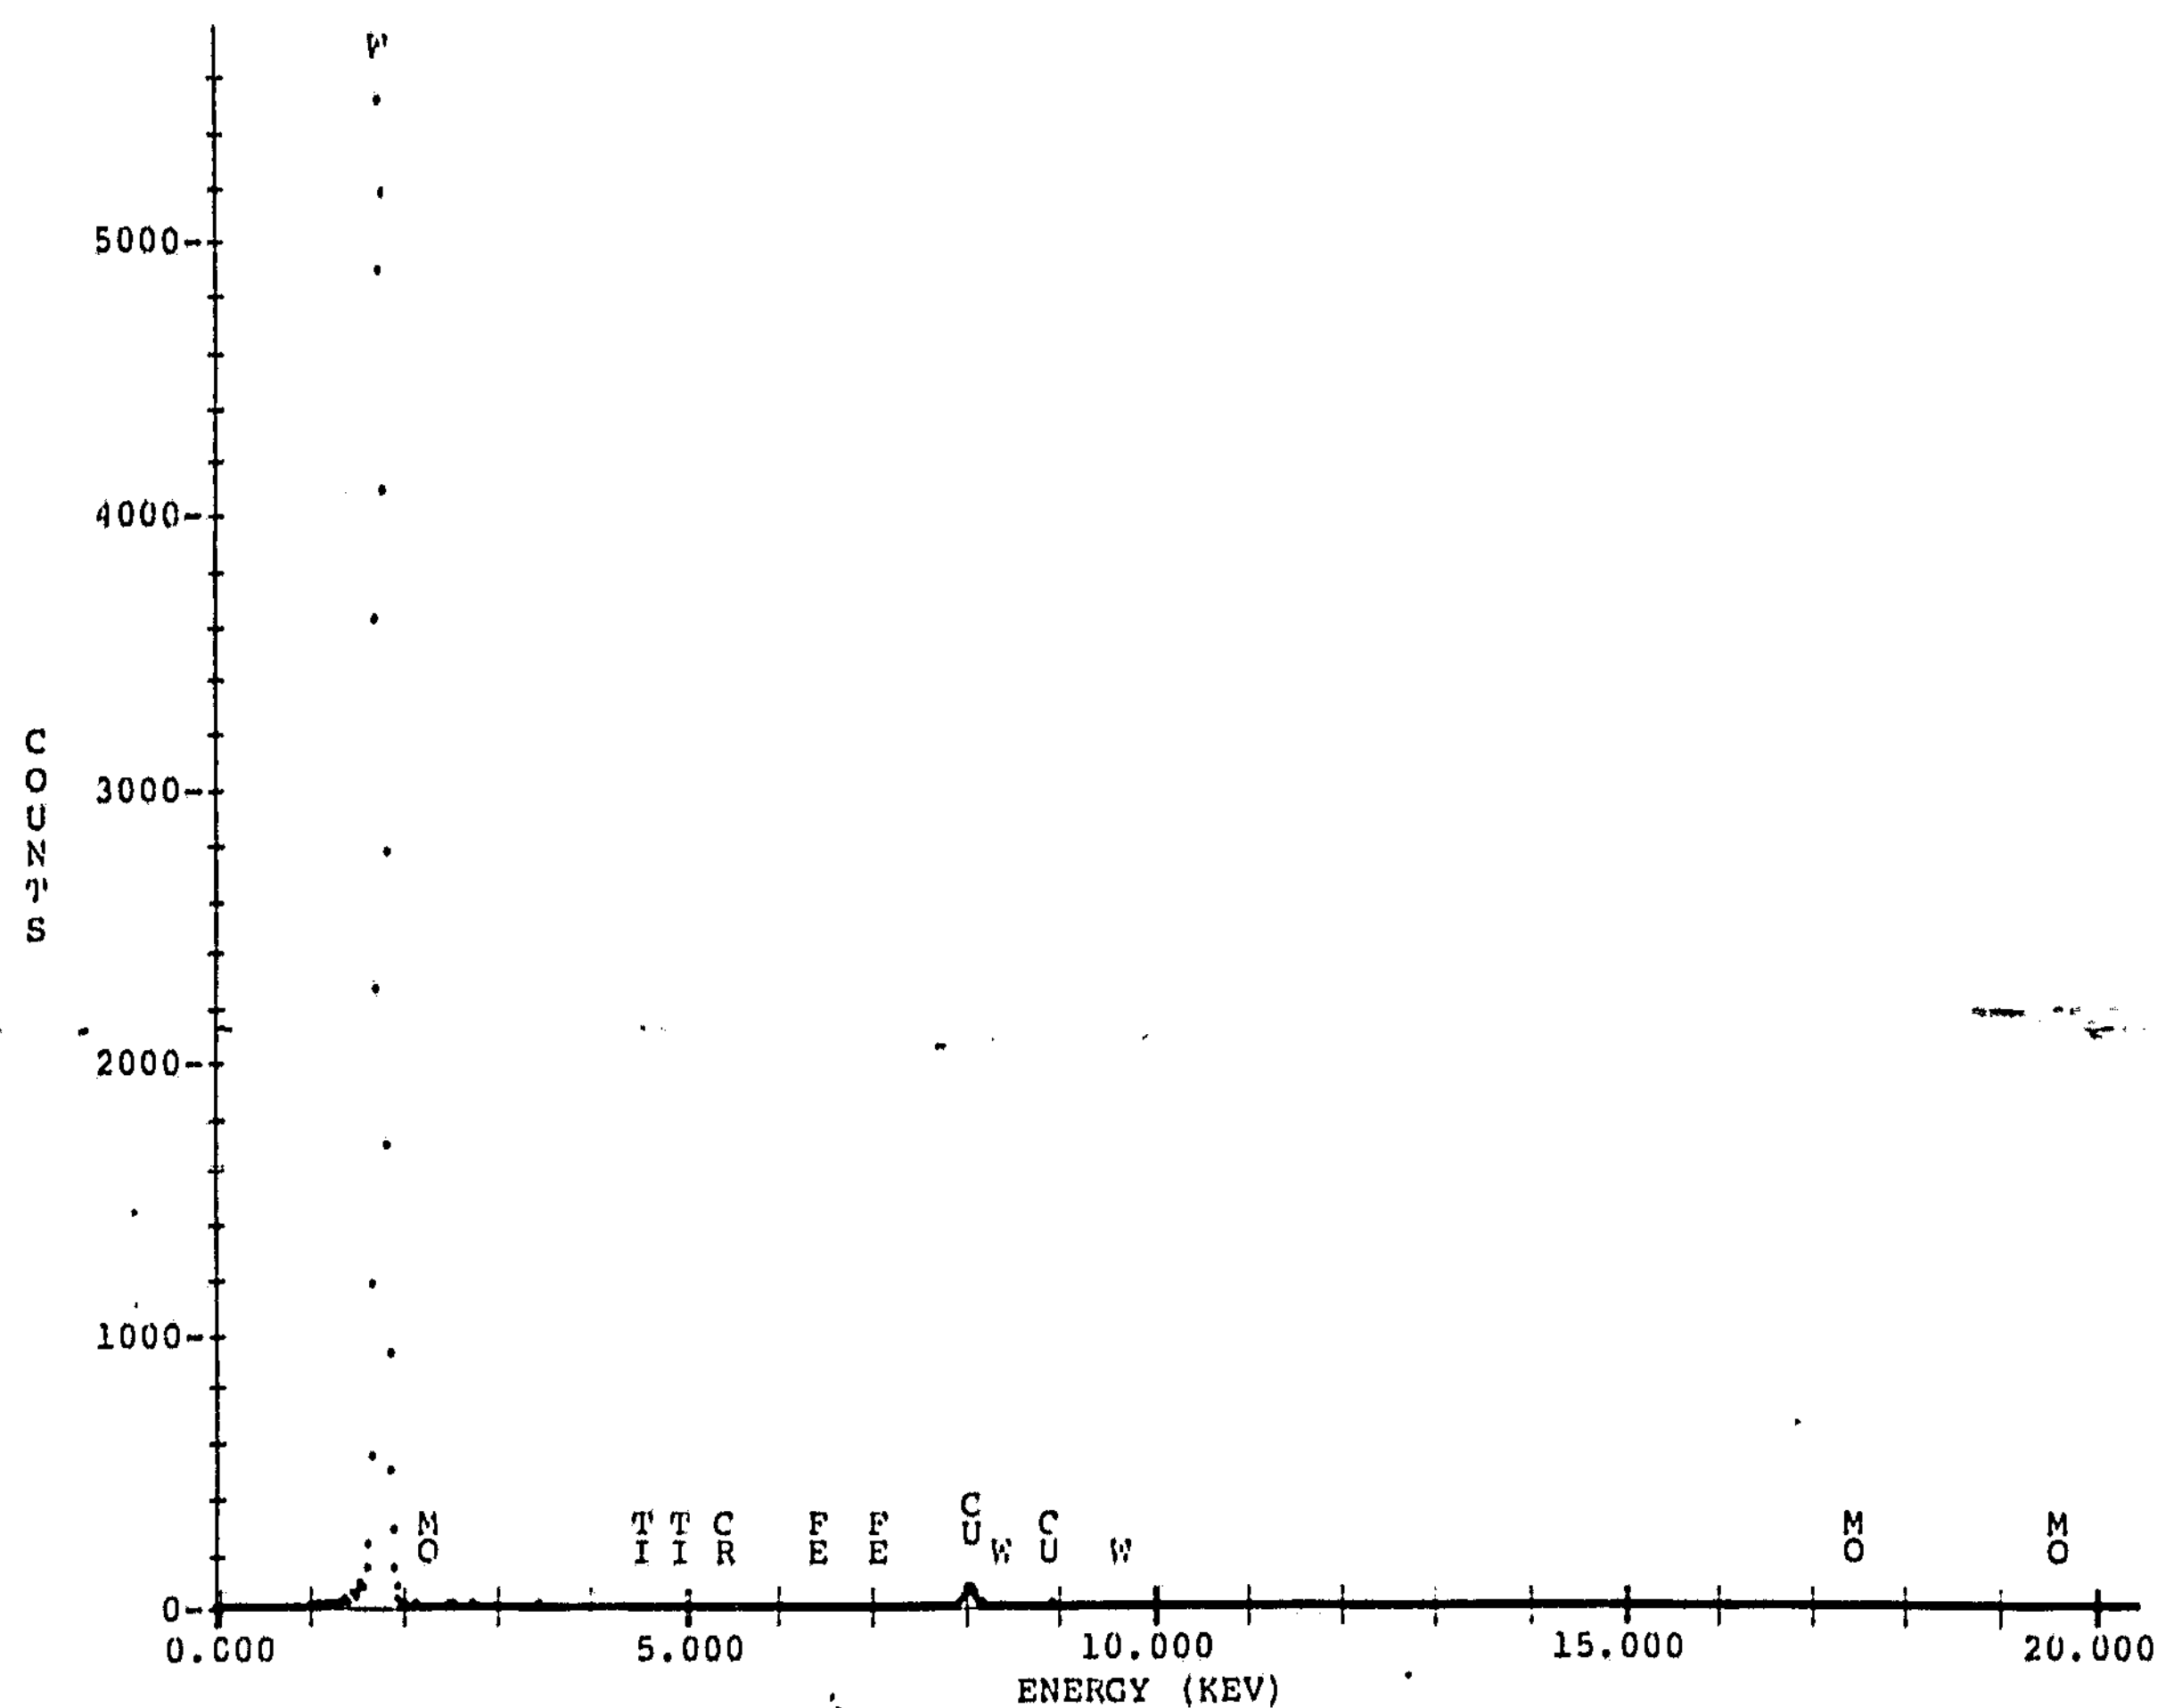
Fig.9. X-spectrum of matrix.
