FINAL REPORT

TRANSFER FILM EVALUATION FOR SHUTTLE
ENGINE TURBOPUMP BEARING

NATIONAL AERONAUTICS AND SPACE ADMINISTRATION
GEORGE C. MARSHALL SPACE FLIGHT CENTER

March 12, 1981

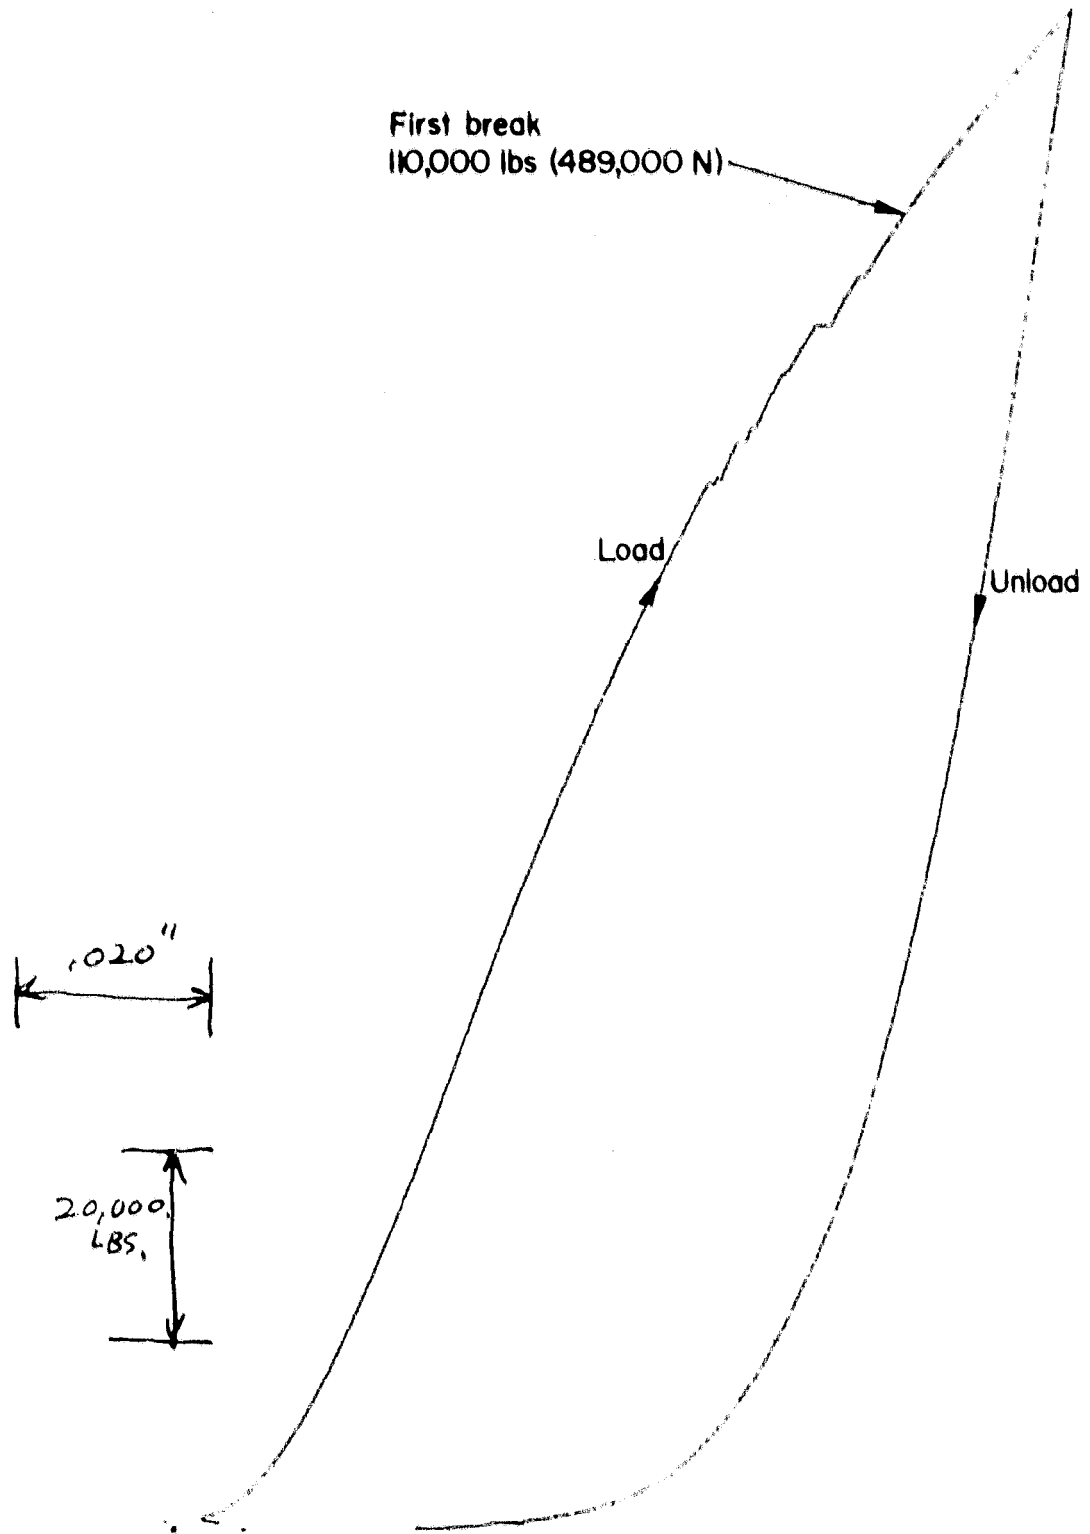
FIGURE 7.   CRUSH LOAD TEST WITH 7955 BEARING

A final test in the project was to determine the crush load of the bearing. For this experiment, a special housing was fabricated to contain the bearing outer race. The diametral clearance between the outer race and this housing was approximately 0.05 m (0.002 inch). The assembly was loaded in a universal testing machine with ultimate capacity in excess of 890,000 N (200,000 pounds). A load-deflection curve was developed by this machine in the course of the experiment, as shown in Figure 7. At a load of 489,000 N (110,000 pounds), the bearing emitted audible fracture sounds, which were accompanied by instantaneous increases in deflection. In our earlier report (Kannel and Merriman, August, 1980), it was predicted that the 7955 bearing would crush at loads on the order of 480,000 N (108,000 pounds). The measured fracture load is consistant with those predictions.

**First break**
**110,000 lbs (489,000 N)**

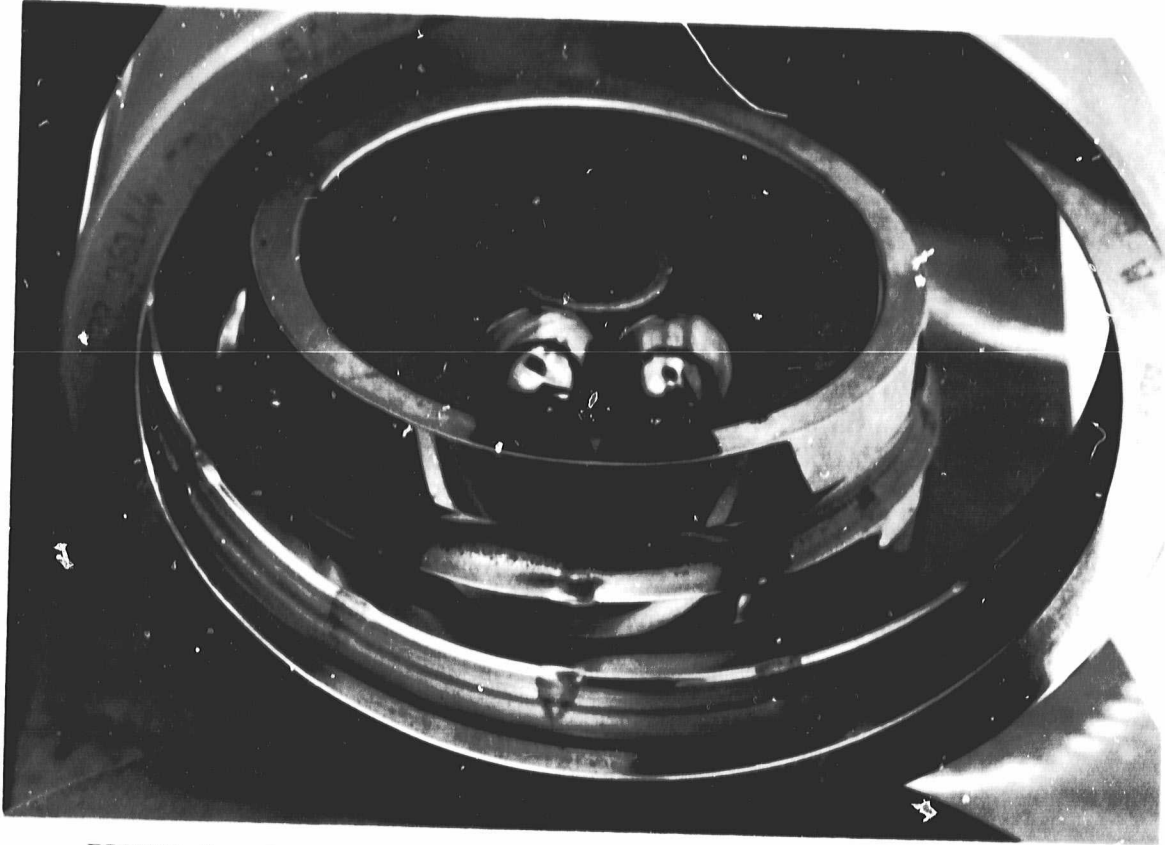
FIGURE 8.   PHOTOGRAPH OF 7955 BEARING AFTER CRUSHING EXPERIMENT

A photograph of the bearing (including the outer race containment system) is given in Figure 8. At the severe loading imposed in the experiment, gross plastic flow of the races and balls occurred. Also, the outer race was fractured under each ball location and 4 balls were fractured.
