DOE/NASA/2593-79/1
NASA TM-79076

AIRFOIL COOLING HOLE PLUGGING BY COMBUSTION GAS IMPURITIES OF THE TYPE FOUND IN COAL DERIVED FUELS

Daniel L. Deadmore and Carl E Lowell
National Aeronautics and Space Administration
Lewis Research Center

February 1979

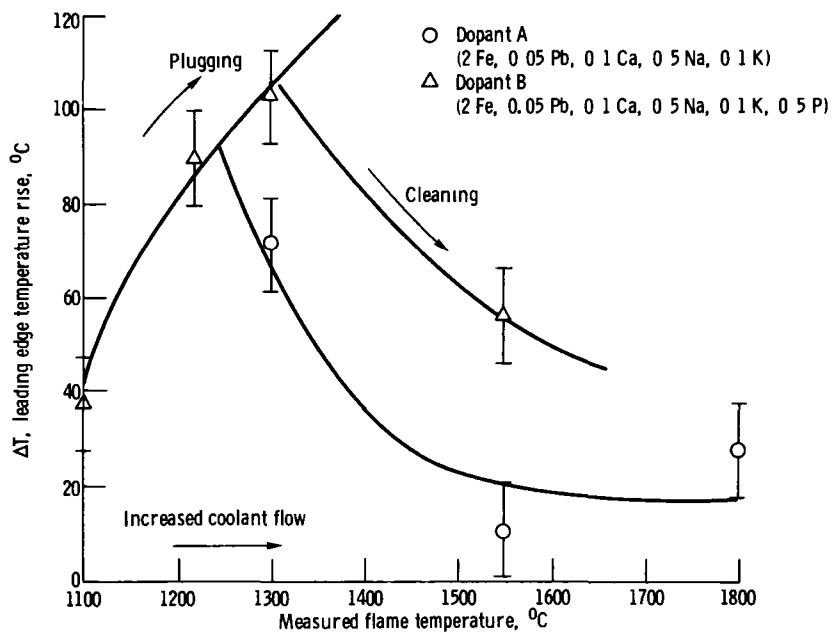
Figure 2. - Mass flow - temperature effects on cooling hole plugging.

Figure 2(a) is a photograph of a post-test blade which had very little leading edge temperature rise (11° C), a value close to the sensitivity of the tem-

perature measurement. The holes show very little evidence of plugging, although there is a measurable deposit along the leading edge. The coolant: hot gas mass flow ratio of 2.3 is quite high. In contrast, figure 2(b), which had a measurable leading edge increase of 39^{O} C shows complete closure of holes. The coolant: hot gas mass flow ratio of 0.4 for the latter is low for leading edge film cooling holes. These results are similar to the results of vane testing presented in reference 2.

(a) Flame temperature, 1550^0 C.
Dopant A, $(V \cdot \rho)_C/(V \cdot \rho)_H = 2.3$.

(b) Flame temperature, 1100^0 C.
Dopant B, $(V \cdot \rho)_C/(V \cdot \rho)_H = 0.4$.

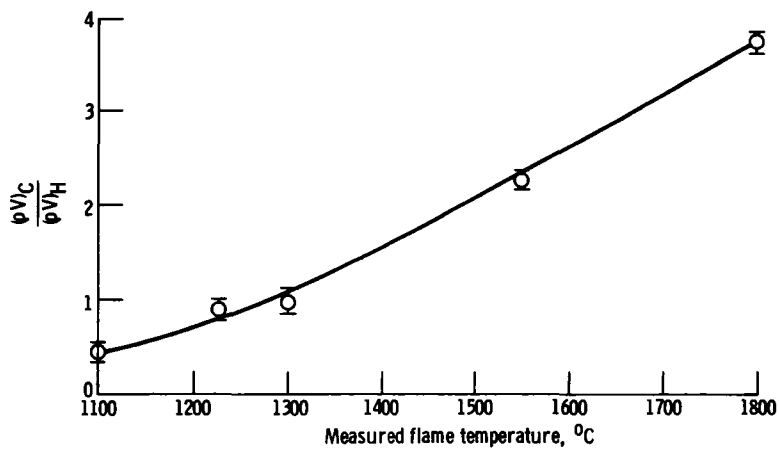
Figure 3 — Large cooling flows required to maintain leading edge temperature at 815° C reduce cooling hole plugging

This seems to be the case for the present data for Dopant B as plotted in figure 3. ΔT seems to go through a maximum as flame temperatures (and thus total cooling flow) increase. This also may be true for the Dopant A data, but, in the absence of low flame temperature data, some uncertainty exists. ΔT first rises as both cooling air flow and flame temperature increase. At some critical value of cooling air flow rate and flame temperature, ΔT begins to decrease as a result of high cooling air velocities sweeping the cooling holes clean The critical threshold appears to be approximately
