FINAL REPORT

A FUNDAMENTAL APPROACH TO ADHESION:
SYNTHESIS, SURFACE ANALYSIS,
THERMODYNAMICS AND MECHANICS

David W. Dwight and James P. Wightman

Grant NSG-1124

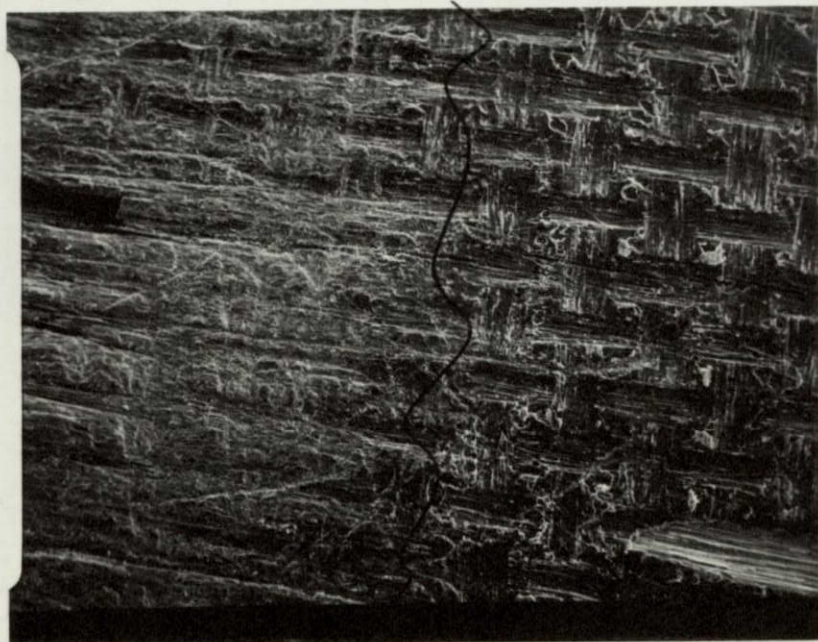
FIGURE 2.

<u>Figure 2</u>. Two higher magnifications (200X, 1000X) of HT-S
graphite fiber/P13N matrix composite; as received on the left
and after sanding on the right.

Smoothest composite as received. The upper layer
of fibers is barely covered with resin. Sanding appears
to scrape open surface voids and gouge out irregular
pits between 5μm and 50μm in size. Some debris (1-10μm),
but less than the other two types.

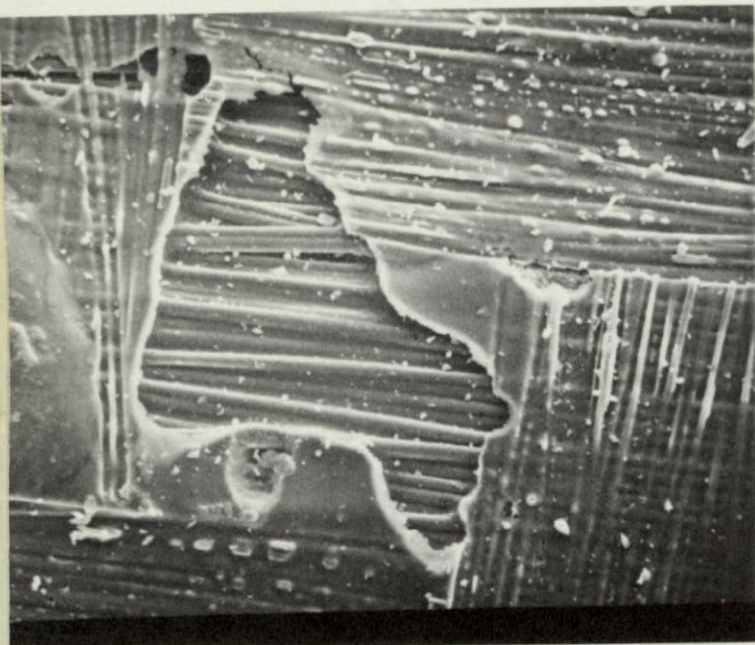
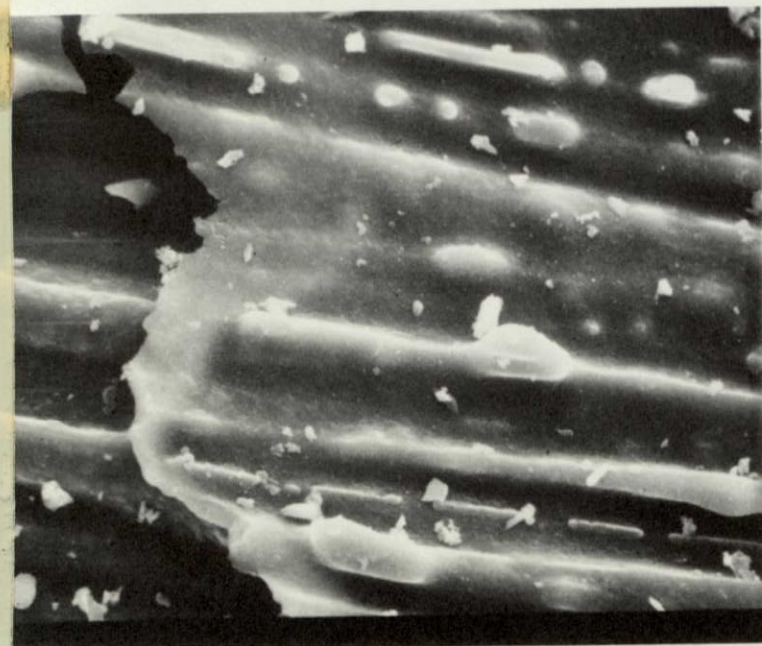
FIGURE 4.

Figure 4. Two higher magnifications (200X, 1000X) of HT-S graphite fiber/Skybond 710 matrix composite; as received on the left and after sanding on the right. (1975)

Relatively thickest polymer overlayer as received, also showing release-cloth imprint. Very similar to NR150-B2 composite after sanding.

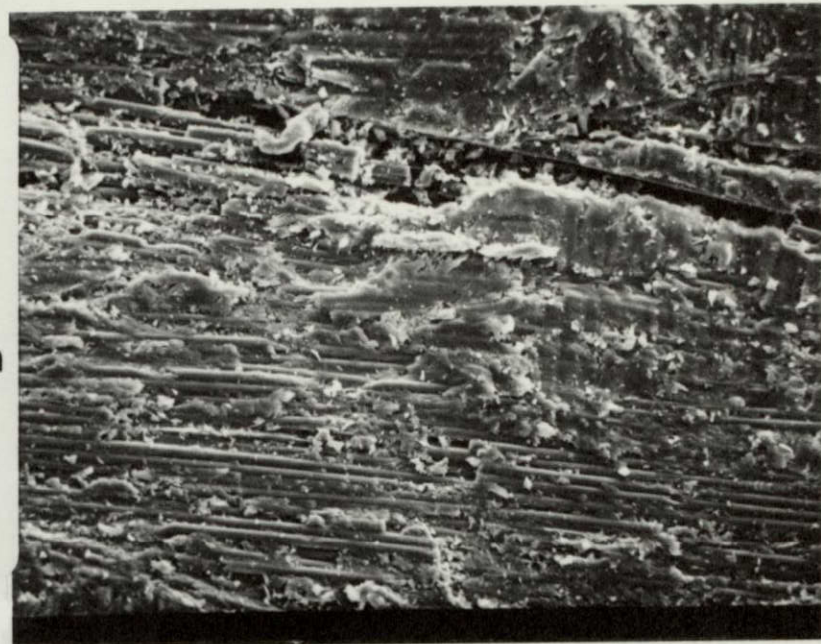
Figure 5. Two higher magnifications (200X, 1000X) of HT-S graphite fiber/Skybond 710 matrix composite; as received on the left and after sanding on the right. (1976)

Note crack extending into substrate as received. Also there appears to be a microporosity ($< 1\mu m$) that didn't show in the earlier examination in Figure 4.

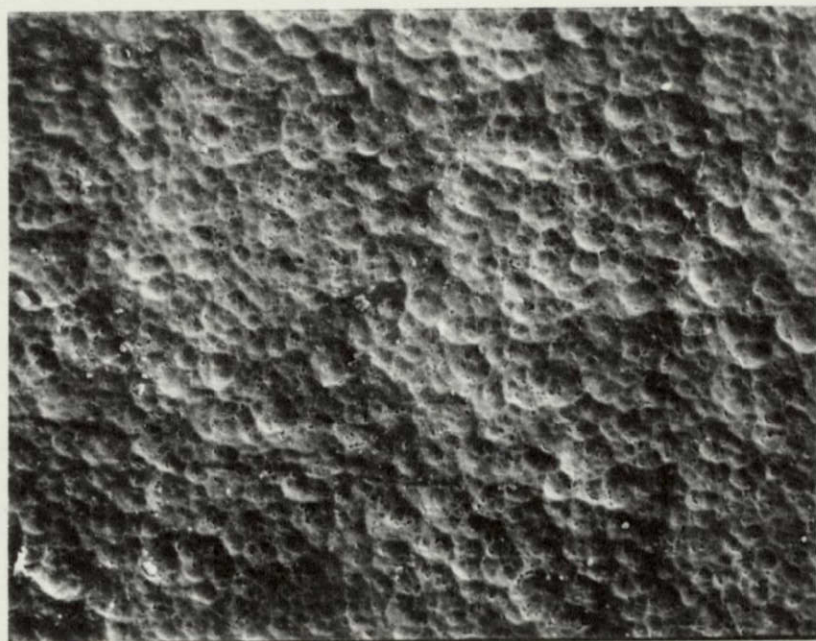
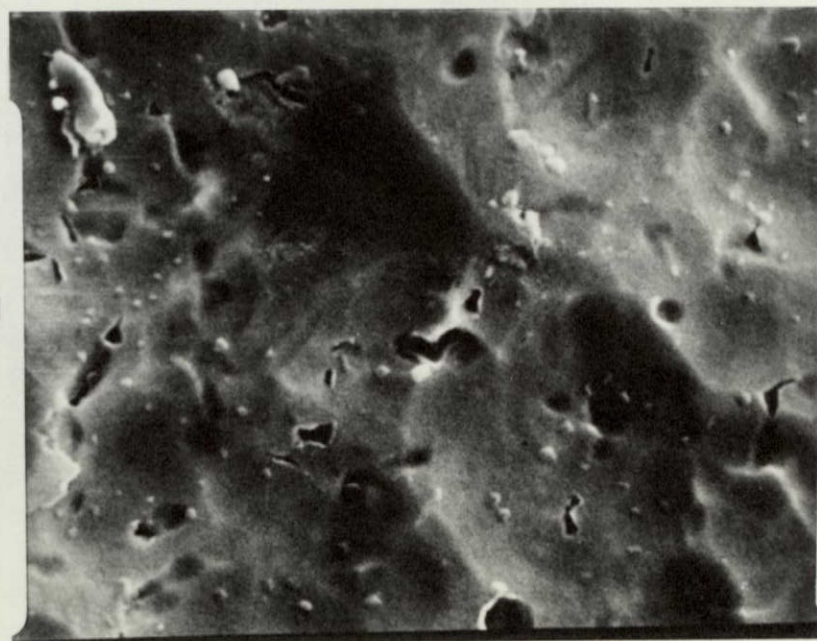
FIGURE 7.

Figure 7 displays the representative features of recent phosphate/fluoride treated titanium 6-4, and the irregular white, beta phase particles and rough, pitted, gray alpha phase resemble photomicrographs shown in the previous report (8). However, an important new feature is the distribution of 5-25μm, jagged particles on top of the substrate. Fracture surfaces (Figure 11) show a similar size and distribution of particles when these adherends were used. By focusing the SEM electron beam to a very small diameter, separate elemental analysis was performed on the particle and the adjacent substrate with the EDAX attachment. The results in Figure 8 show primarily aluminum from the particle and titanium from the adjacent matrix. During subsequent conversations with LaRC

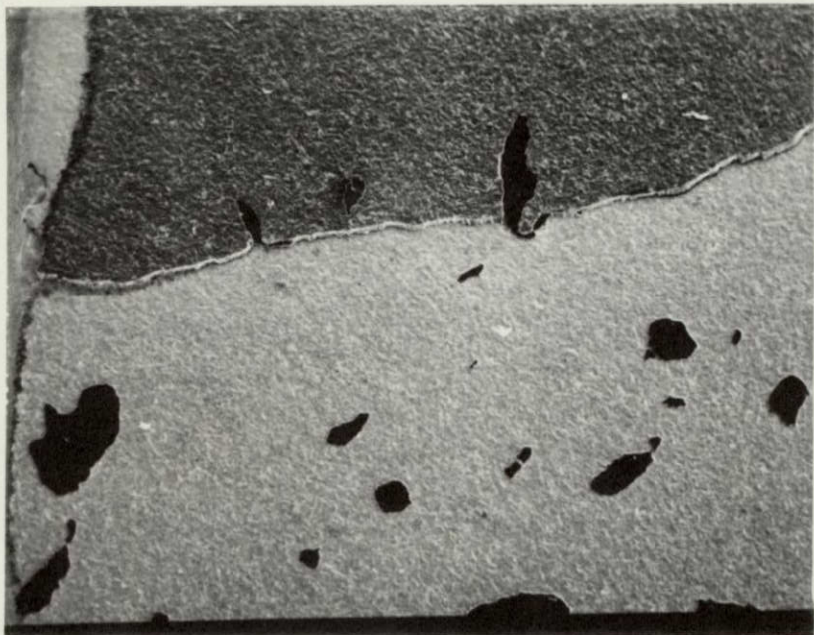
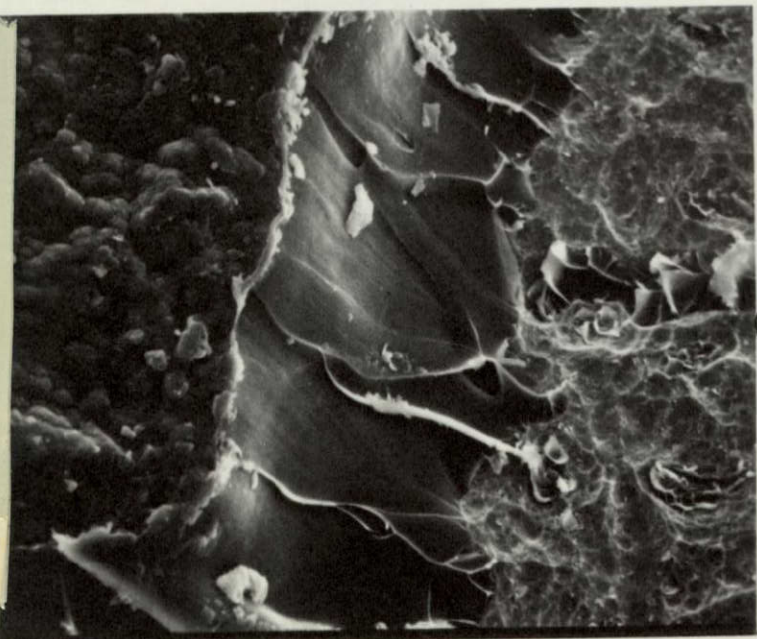
FIGURE 9.

Figure 9. Three magnifications (20X, 500X, 1000X) of the fracture surface of a PPQ 413/Ti 6-4 (phosphate/fluoride) sample that gave 1400 psi lap shear strength at room temperature.

95% interfacial failure with one main perpendicular fracture through the adhesive layer, leaving about half the adhesive on each adherend; about 5% delamination in the middle of the adhesive layer, shown in high magnification on the bottom right. Note that the total glue line appears to be about 30-40μm thick. Visual inspection of the joints indicated more "flash" or glue squeezed out of the bond line with PPQ 413 than with LARC-type adhesives.

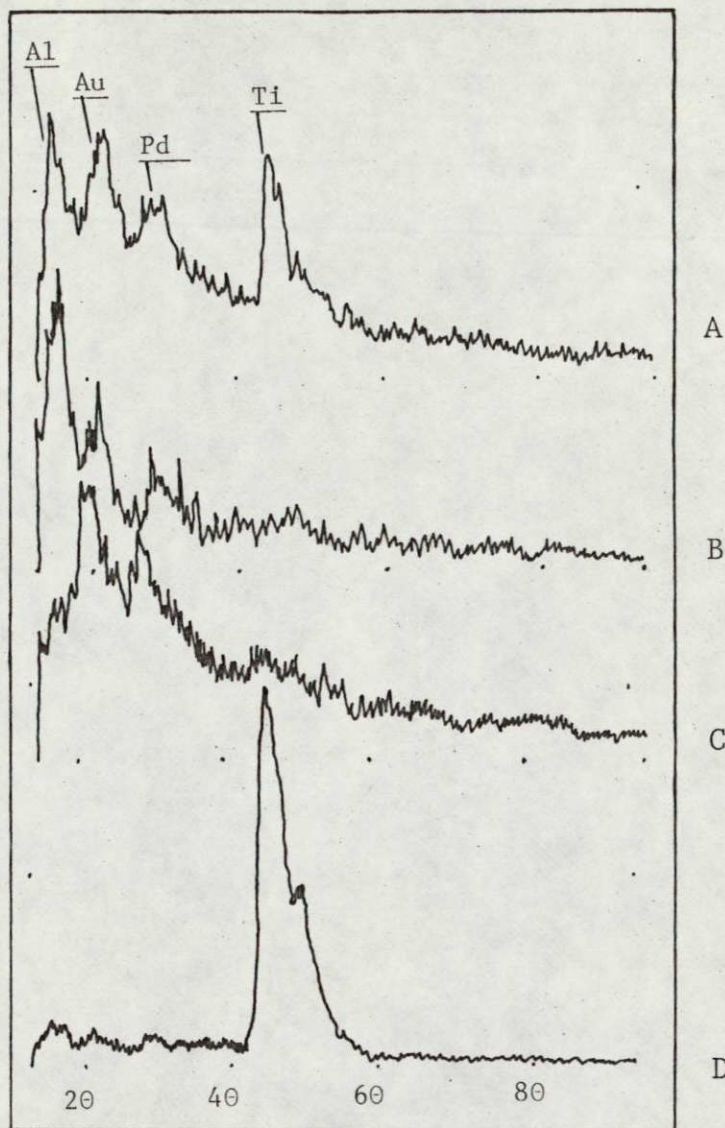
Figure 11. EDAX spectra collected from four different areas of the fracture surface shown in the photomicrographs of Figures 9 and 10. A. Polymer surface: Figure 10, top left. B. Particle: Figure 10, bottom right. C. Delaminated surface: Figure 9, bottom right. D. Adherend surface: Figure 9, top. The Au and Pd signals arise from ∿ 200 Å of alloy vacuum deposited on the sample.

An unexpected silicon peak in the EDAX spectrum (Figure 22B) arose from both the composite matrix and adhesive polymer, but not from bare HT-S fiber surfaces. Although we have not used EDAX analysis routinely on all samples, we have not seen silicon previously in composites. Perhaps in the present case, a silicone release agent was used in the preparation of the composite adherend and migrated into the polymer resin phases. —In future studies EDAX analysis will be a routine part of basic data on surface characterization. More systematic investigation should elucidate such apparent anomalies as the silicon signal above and the titanium signal from the polymer surface (Figure 11).

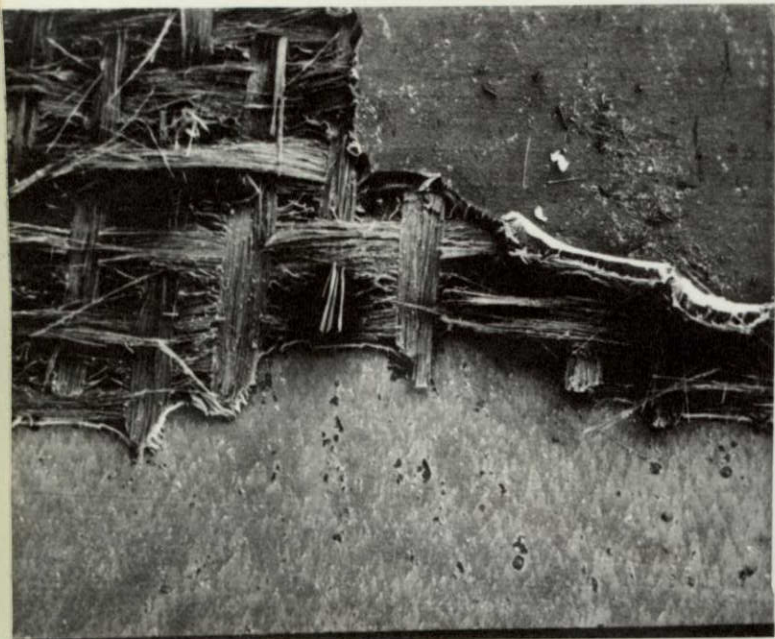
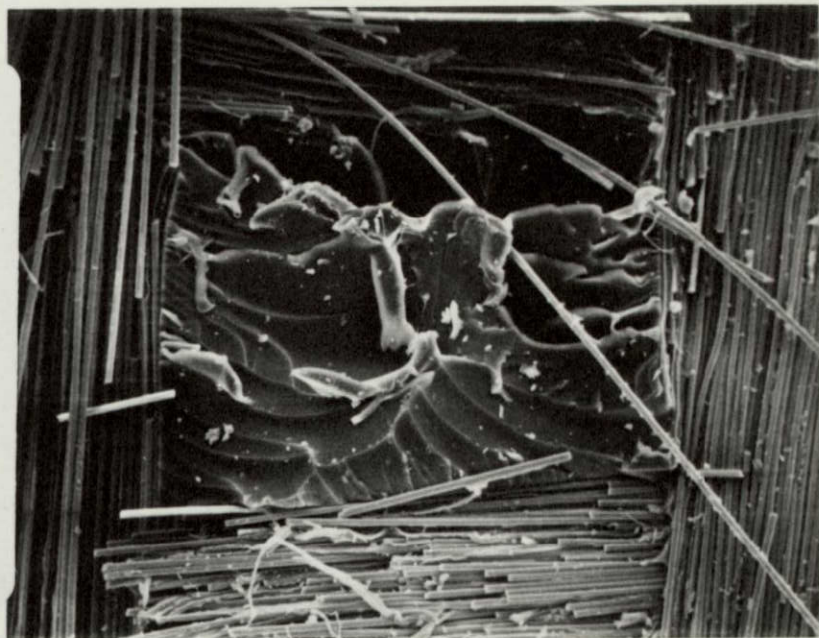
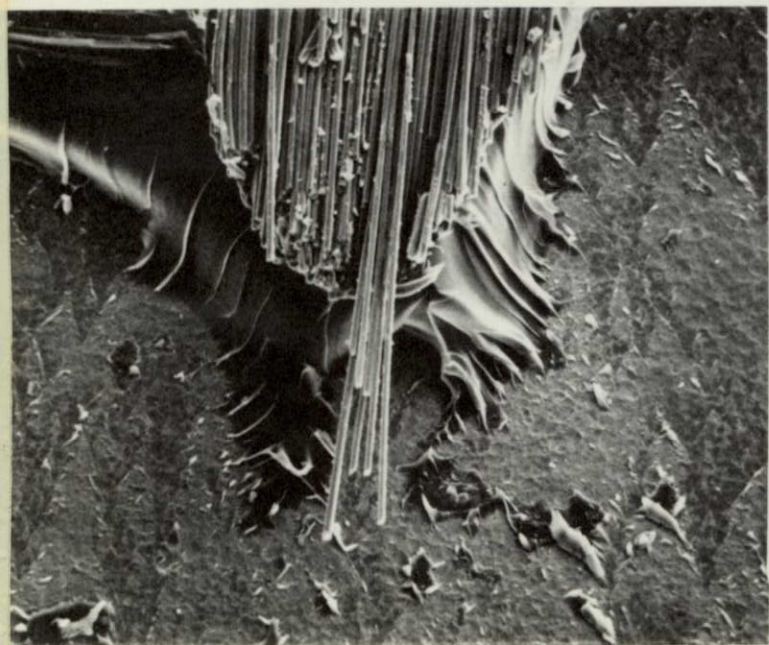
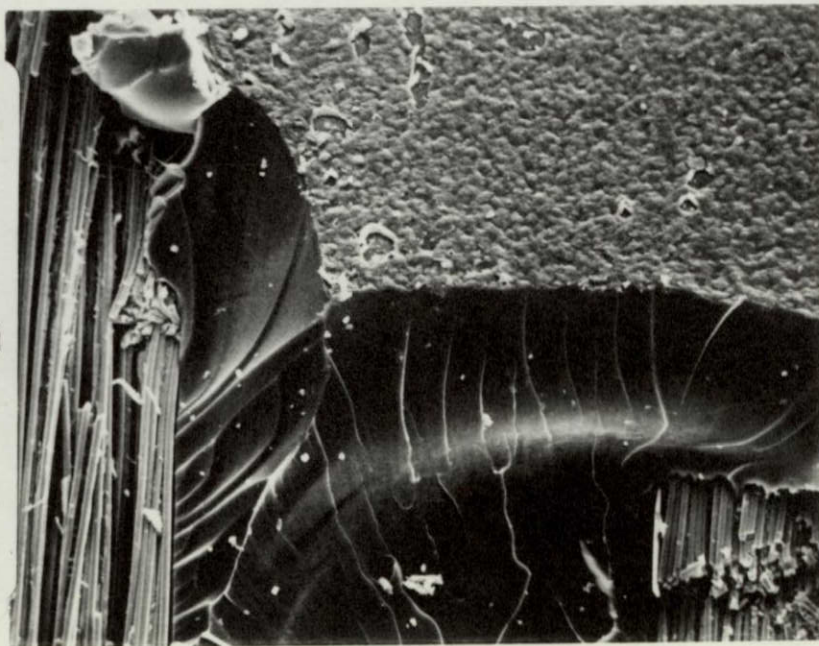
Figure 13. Four magnifications (2 @ 500X, 1000X, 2000X) of
the same samples shown in Figure 12.

Glass fiber/resin interfacial failure and
∿ 100μm glue line are confirmed. Comparing the
bottom left photomicrograph with Figure 6, a thin,
pinhole-filled overlayer of primer plus some flakey
fragments of the bulk adhesive remain below. The
adhesive side of the fracture interface, on the
bottom right, shows the eruptions where fragments were
plucked out by the substrate. The overall impression
is that low flow and interfacial incompatibility
weakened bonds at adherend/primer, primer/adhesive,
and adhesive/fiber glass cloth interfaces.

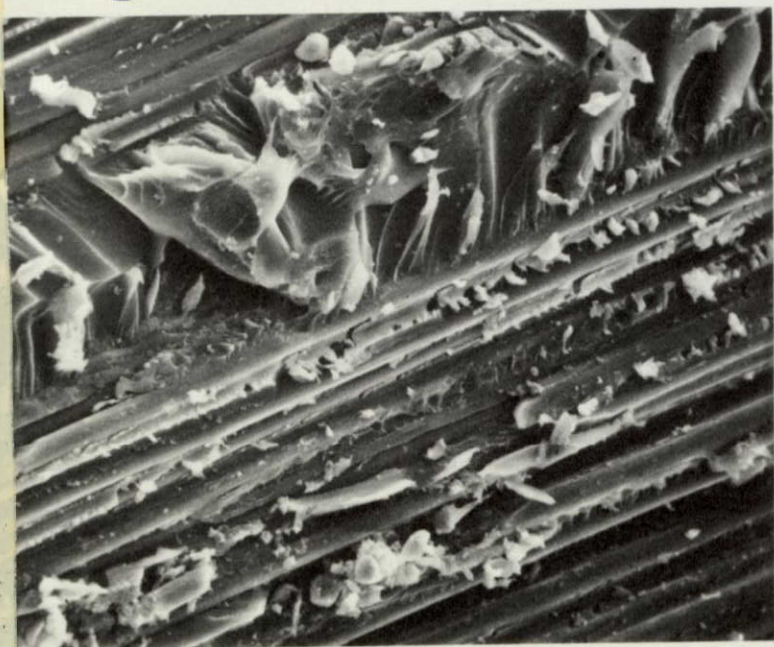
FIGURE 15.

At room temperature (Figure 15) fracture relatively deep in the adherends is dominant. A few cracks proceed through the brittle 0.1 mm thick bond line leaving patches of one adherend on the other. At the level of about 5-25μm, composite failure is distributed between matrix resin/HT-S fiber interfacial separation and high-area, brittle cleavage cracking of the matrix resin.

Figure 15. Four magnifications (20X, 200X, 500X, 2000X) of the fracture surface of a PPQ 413/NR-150B2 HT-S graphite fiber composite sample that gave 6200 psi lap shear strength at room temperature.

Part of failure in one adherend with brittle cracks through the bond line parallel to stress, and rest of failure in opposite adherend. Fracture modes are between HT-S fiber/NR-150B2 interface and high-area, louvered, brittle matrix fracture with some plastic deformation.

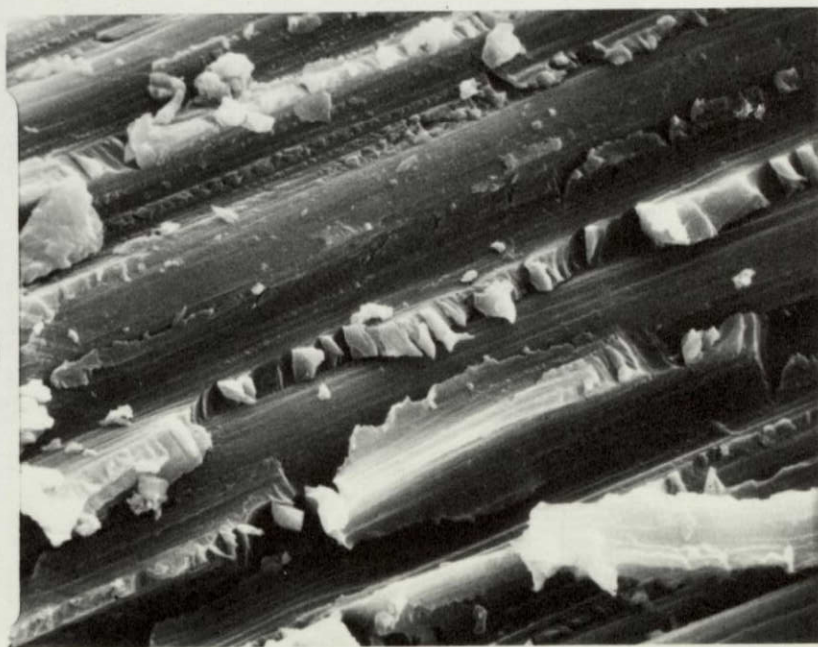
FIGURE 16.

Four magnifications (20X, 100X, 500X, 2000X) of the
fracture surface of a PPQ 413/NR-150B2 sample that gave
2500 psi lap shear strength at 286°C.

Failure in each adherend, and one fracture through the glue-line, mostly perpendicular to the stress direction. Plastic deformation in PPQ 413 glue-line, ∿ 0.2 mm thick. Adherend failure is closer to the adhesive interface than in Figure 15. Composite surface failure is basically similar to the previous, room-temperature sample, although there appears to be more broken fibers and plastic deformation and larger brittle-cleavage louvers. Also there is prominent resin/fiber interfacial failure.

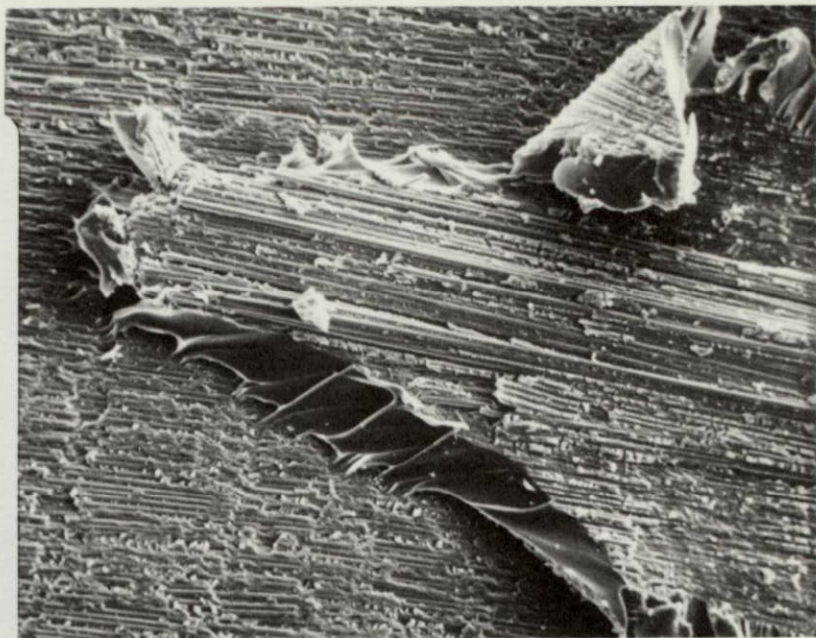
High temperatures result in plastic deformation of the PPQ bond line and an average locus of failure very near the original composite/adhesive interface. Figure 16 shows that at 286°C the glue line stretches to ∿ 0.2mm before a low-area, brittle crack propagated basically perpendicular to the adherends and stress direction, leaving part of the adhesive layer on each adherend. Close inspection of the interfacial line shows the adhesive pulling away from the surface of the adherend. Fracture area is mainly in the composite, near the surface, by mixed failure at fiber/matrix interfaces and rather large, brittle cleavage cracks. Perhaps there is also a plastic component in the deformation of louvers in the stress direction, and a contribution from fiber fracture. Figure 17 clearly shows voids (presumably due to residual solvent) and fluid-flow at 316°C. The glue line is now about 0.5 mm, penetrated by

<u>Figure 16.</u> Four magnifications (20X, 100X, 500X, 2000X) of the fracture surface of a PPQ 413/NR-150B2 sample that gave 2500 psi lap shear strength at 286°C.

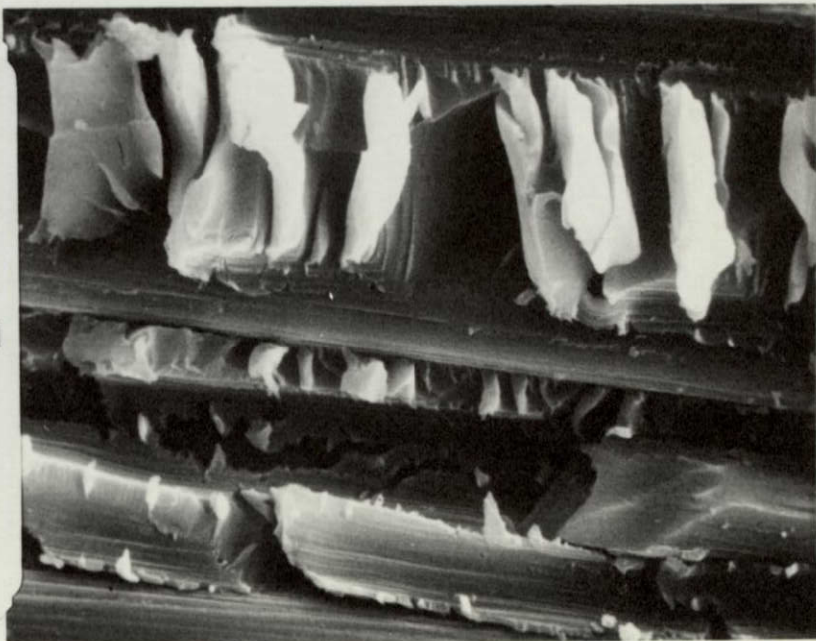
FIGURE 17.

Four magnifications (20X, 100X, 200X, 2000X) of the
fracture surface of a PPQ 413/NR150-B2 sample
that gave 1000 psi lap shear strength
at 316°C.

Failure is primarily in the composite surface between the resin and the first layer of fibers. Plastic deformation and decomposition are obvious in the $\sim$ 0.5 mm, stretched, bond line. Numerous cracks through the bond line leaving patches of adhesive on each adherend.

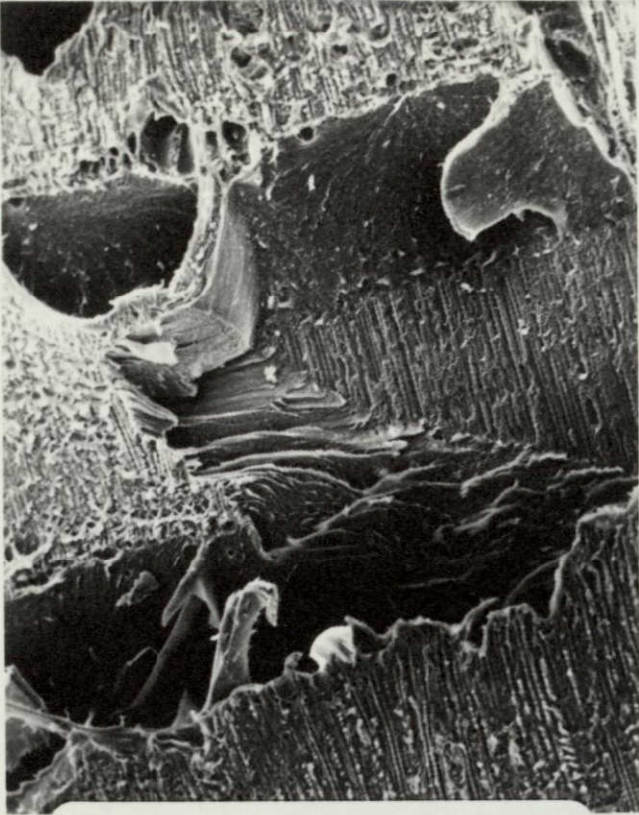
Figure 17. Four magnifications (20X, 100X, 200X, 2000X) of the fracture surface of a PPQ 413/NR150-B2 sample that gave 1000 psi lap shear strength at 316°C.

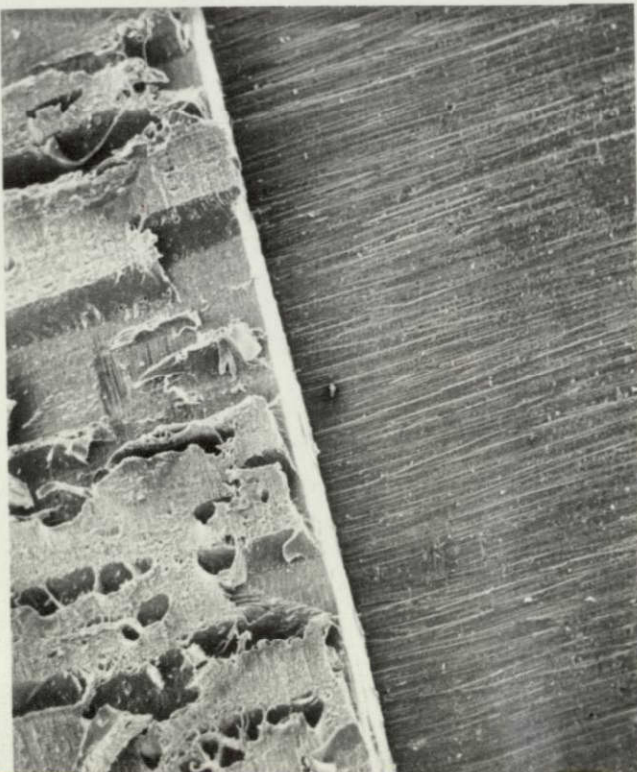
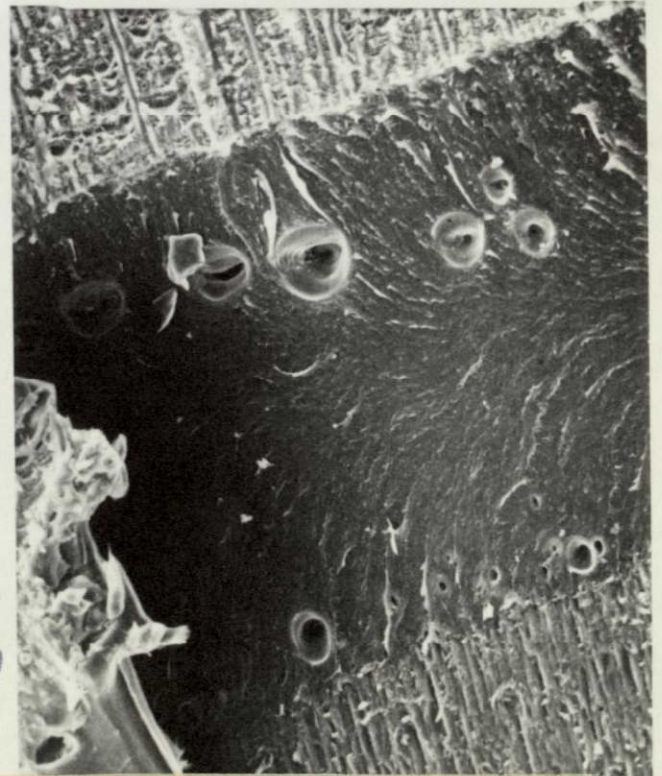
FIGURE 18.

Four magnifications (20X, 200X, 500X, 2000X) of the
fracture surface of a PPQ 413 (with scrim cloth)/NR150-B2
sample that gave 4000 psi lap shear strength
at room temperature.

The use of a scrim cloth is the only obvious difference from the example of Figure 15. About 30% failure is in the scrim cloth and strength is correspondingly less; apparently poor flow of resin into scrim and perhaps interfacial in-compatibility also. Glue between scrim cloth and adherend is > 0.1 mm thick. Composite surface fracture shows the same characteristics of previous, high strength samples; high-area, brittle cleavage cracking and fiber/resin inter-facial failure.

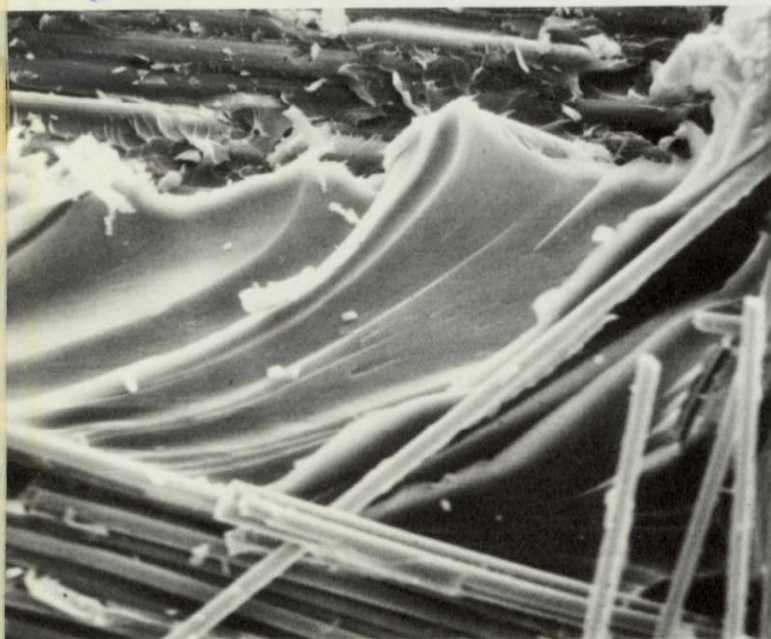
When scrim cloth was used to support PPQ413 adhesive for bonding to NR-150B2 composite adherends, room temperature strength dropped about 30%. Figure 18 shows a corresponding decrease in composite fracture area, because significant failure occurs now in the scrim, which appears poorly penetrated with adhesive. Also note that over 0.1mm of adhesive are on each side of the scrim cloth.

<u>Figure 18.</u> Four magnifications (20X, 200X, 500X, 2000X) of the fracture surface of a PPQ 413 (with scrim cloth)/NR150-B2 sample that gave 4000 psi lap shear strength at room temperature.

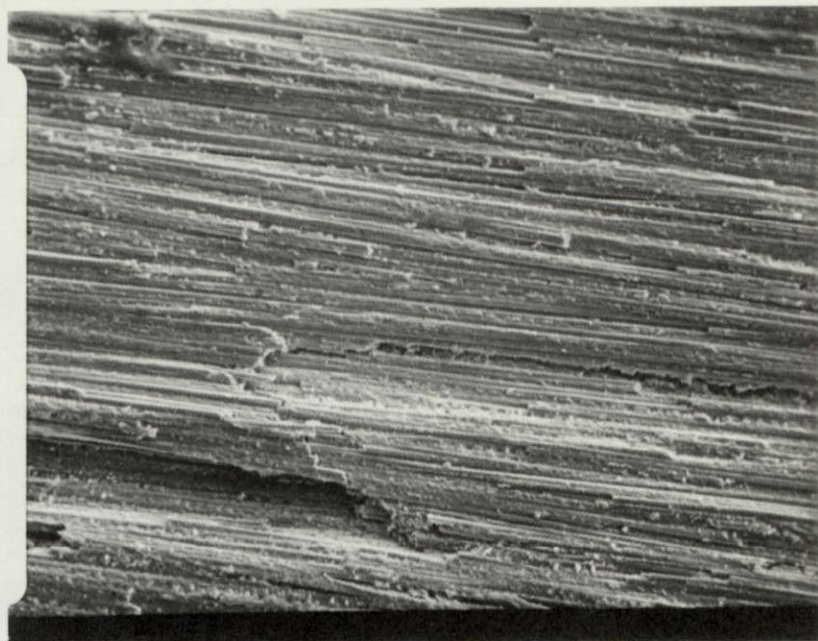
Failure in the adherends at all temperatures and a surprising morphology for the composite matrix resin are the important features in this series. At room temperature, Figure 19 shows that fracture alternates between plies in the adherend and from one adherend to the other via brittle cracks through the adhesive layer. Close inspection of the composite failure shows that the Skybond 710 matrix resin is not a uniform solid, but appears to be a porous aggregate of chunks about 5-10µm in size. This is seen even more

Figure 19. Four magnifications (20X, 100X, 500X, 2000X) of the fracture surface of a PPQ 413/Skybond 710 sample that gave 3400 psi lap shear strength at room temperature.

Failure is essentially in the composite, alternating frequently from one adherend to the other via brittle cracks through the bond line (lower left). The Skybond 710 matrix is porous; discontinuous "chunks" about 5-10 μm in size seem to be packed tightly around the graphite fibers. Interfacial failure between the fibers and lumpy matrix particles is predominant.

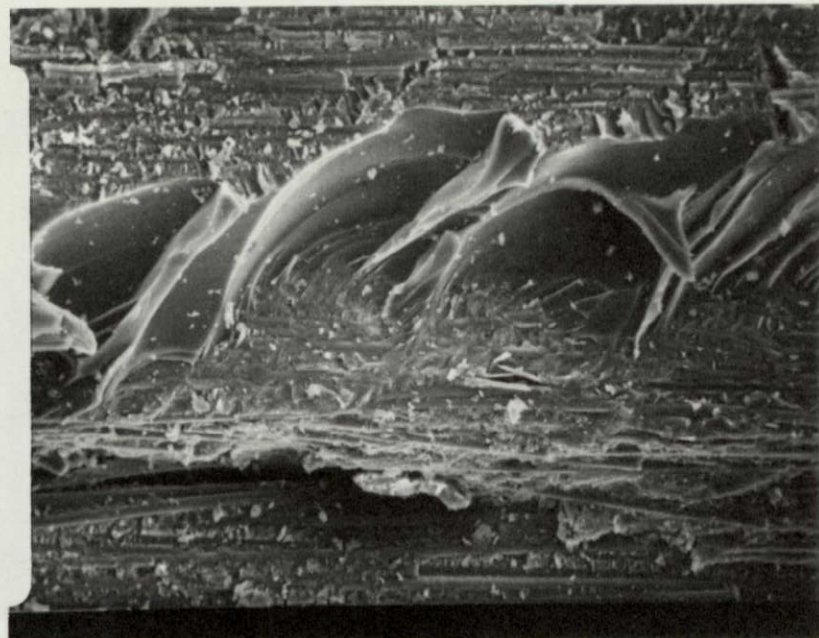
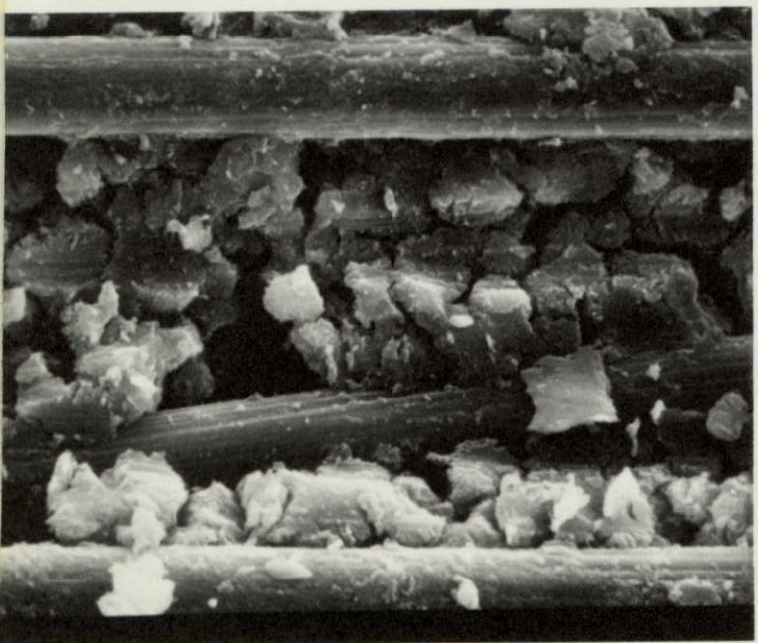
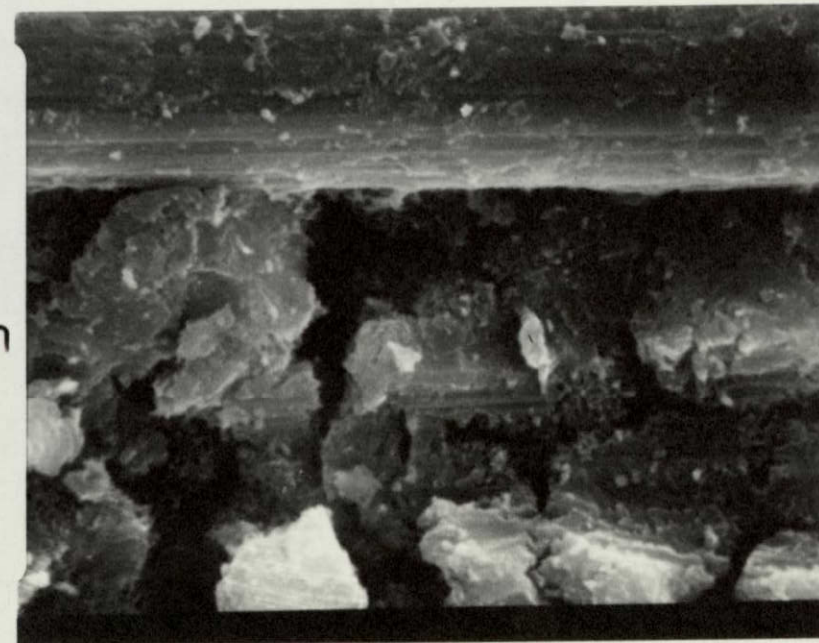
clearly in Figure 20, where the chunks seem to have a lumpy <0.4μm substructure at the higher temperature. Failure is predominantly in one adherend and there is one crack through the glue line where plastic deformation has apparently taken place. At the highest temperature, further deformation of the glueline is the only different feature (Figure 21). In each case the composite adherend was the weakest member. Interfacial separation between fibers and matrix, and polymer fracture mechanisms are limited by the void-filled structure.

Failure is primarily in the composite adherend surface
on one side, leaving a rough surface because of fracturing
through fibers and plys. Some low-area, brittle fracture
through the adhesive to the opposite adherend, and the
glue line appears to have deformed plastically to a thick-
ness of about 0.2 mm (upper right). The "chunky" Skybond
710 matrix is even more apparent and shows a lumpy sub-
structure < 0.4µm. Interfacial failure between the HT-S
fibers and the Skybond 710 matrix is again the major
fractographic feature.

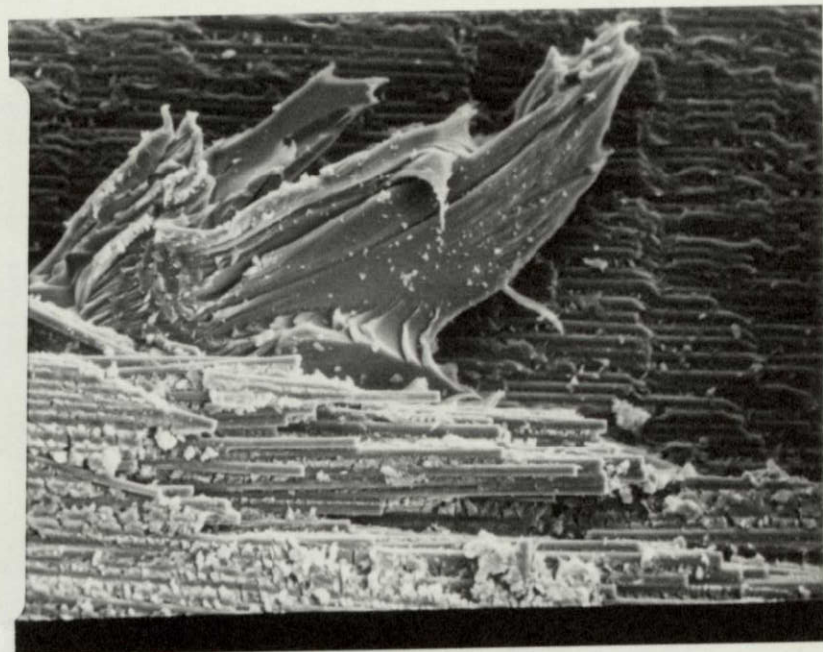
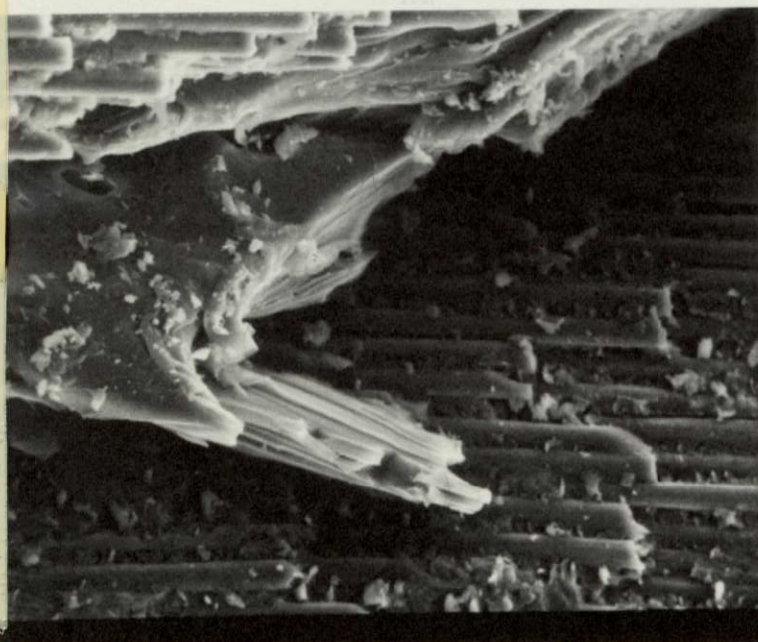
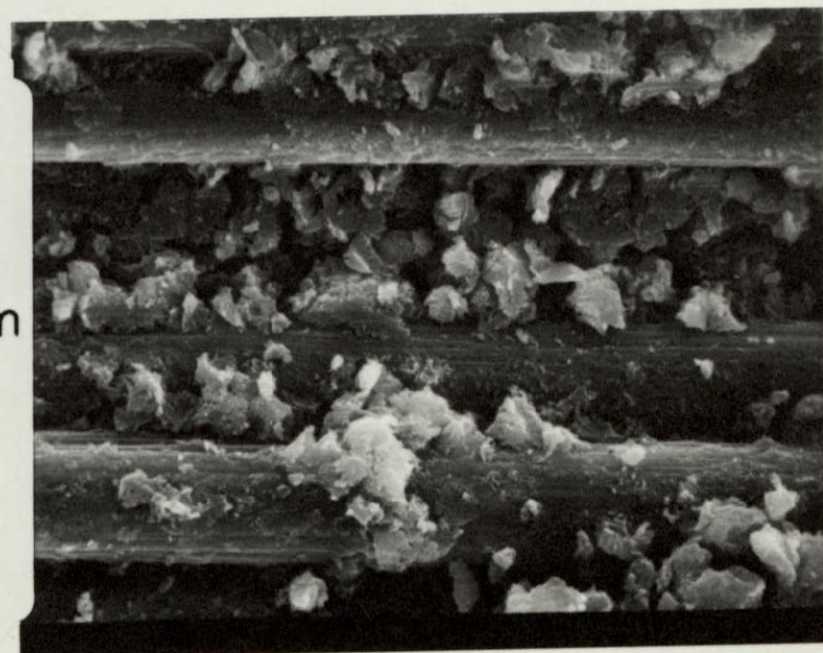
FIGURE 21.

Fracture is nearly identical to the previous example, except the glue line has deformed further to about 0.5 mm. Interfacial failure between HT-S fibers and Skybond 710 matrix is the predominant failure mechanism. EDAX (Figure 22) shows a silicon signal from the PPQ 413 and Skybond 710 resins, but not from HT-S fiber surfaces; possibly a residual mold release silicone. There was no calcium signal, ruling out glass.

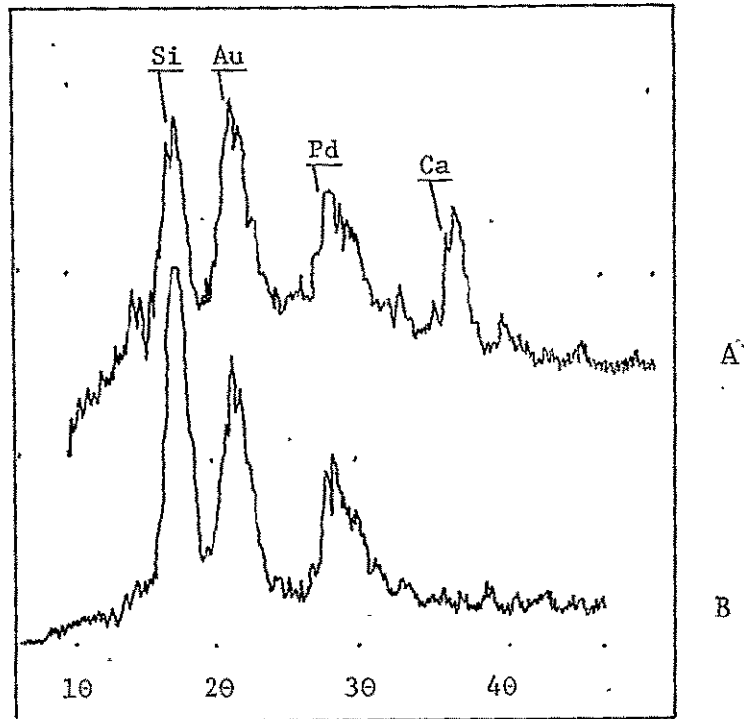
Figure 22. EDAX spectra that show a calcium and silicon
peak from a fiber glass (SiO$_2$) containing substrate (A),
while only silicon was found on adhesive and matrix resin
fracture surfaces (B)

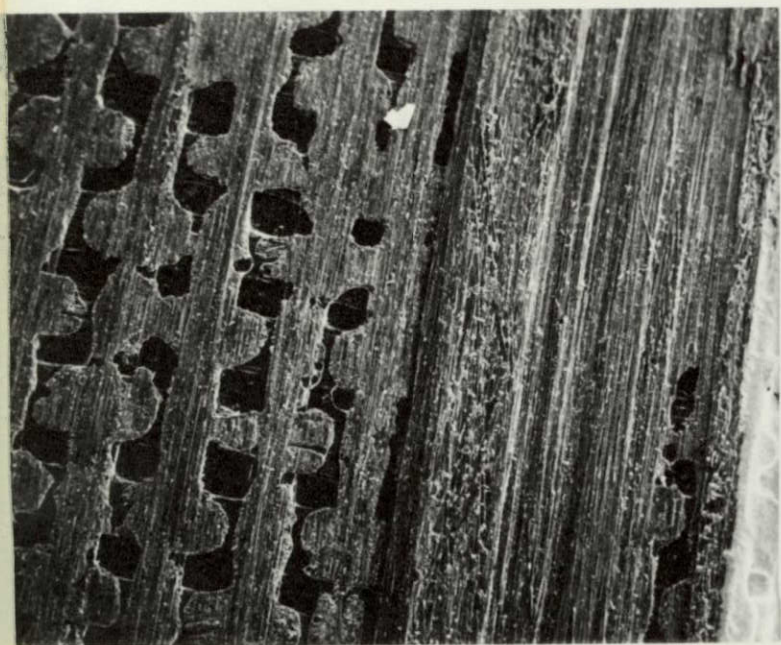
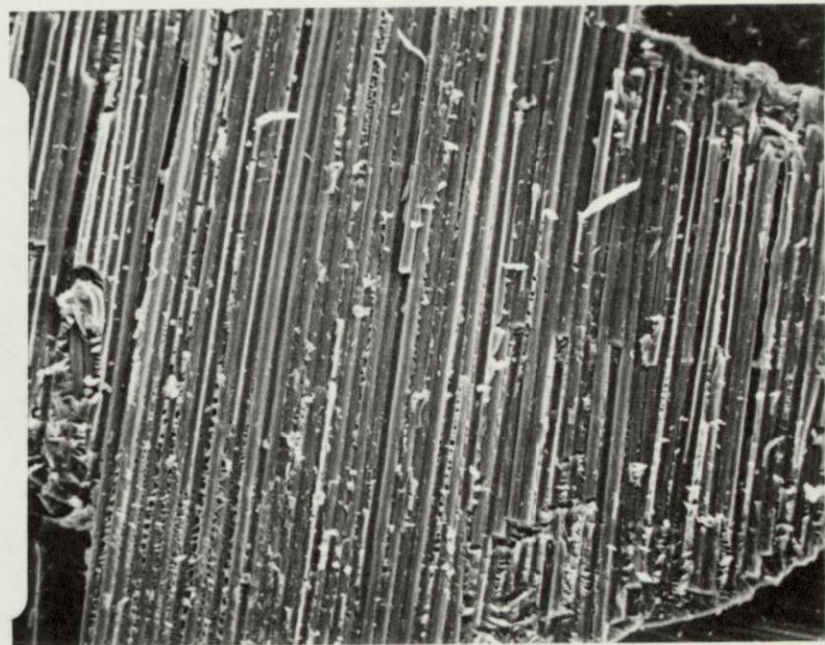
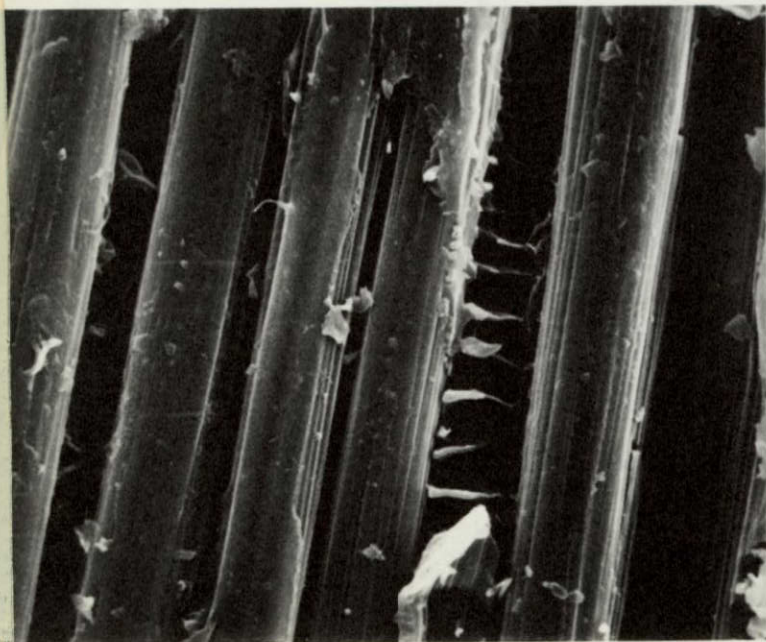
FIGURE 24.

At higher temperatures the locus of failure shifts toward the surface of the scrim cloth. Figure 24 indicates that about half the failure is in the adherend and the remainder in the voidy scrim cloth surface at 286°C. In the latter areas, patches of glass fibers have been removed from the scrim cloth and remain on the adherend. High-area, brittle cleavage cracking occurs in the

Four magnifications (20X, 200X, 2 @ 1000X) of the fracture
surface of a LARC-13 (with scrim cloth)/NR-150B2 sample
that gave 3200 psi lap shear strength at 286°C.

About 50% failure in the composite adherend and 50% in the scrim cloth surface and voids. Lumps of aluminum powder filler are clearly visible under the resin surface on the bottom right, as well as a glue line of about 25μm between the void bottom and the composite. Patches of the surface of the scrim cloth are transferred; glass fibers and aluminum particles are seen on the lower left. The composite failure is the same as before. Adhesive resin fracture is by high-area, louvered, brittle modes with perhaps some plastic deformation. EDAX shows silicon and calcium from areas like bottom left, but not elsewhere.

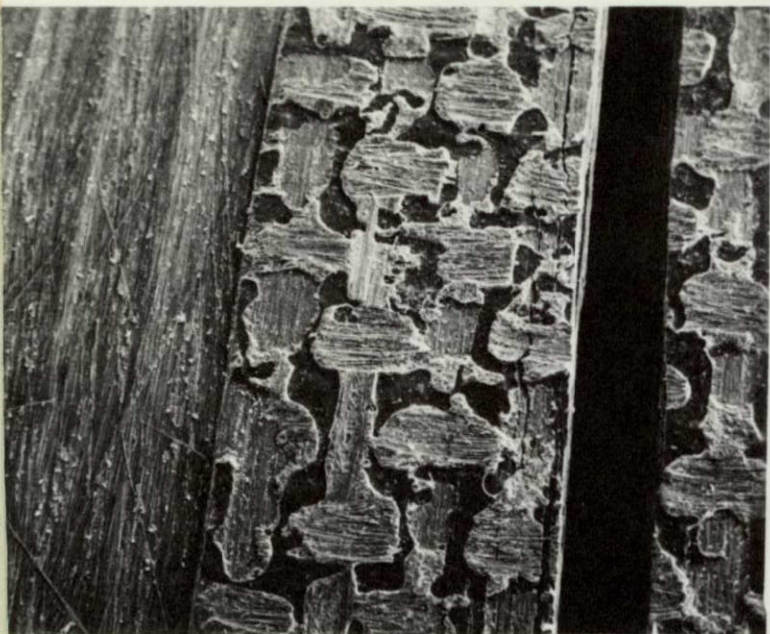
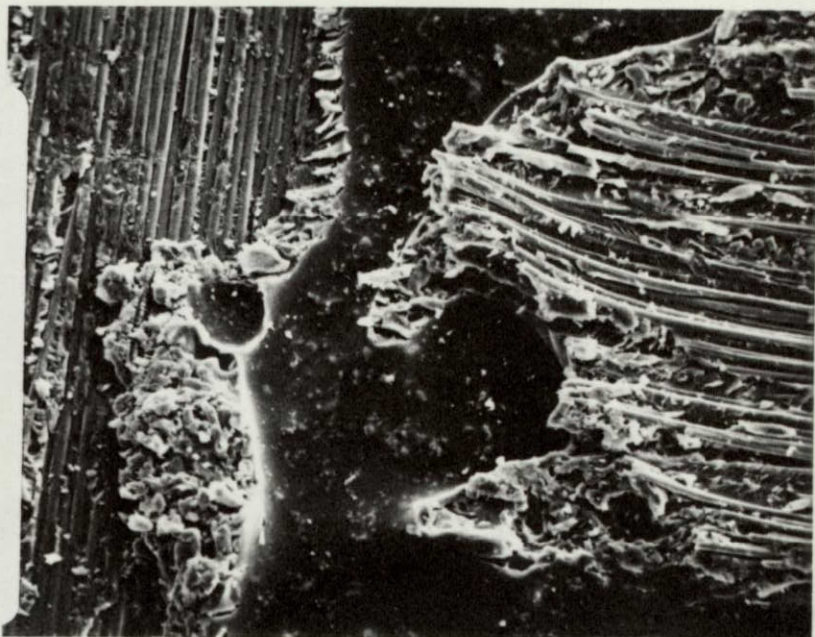
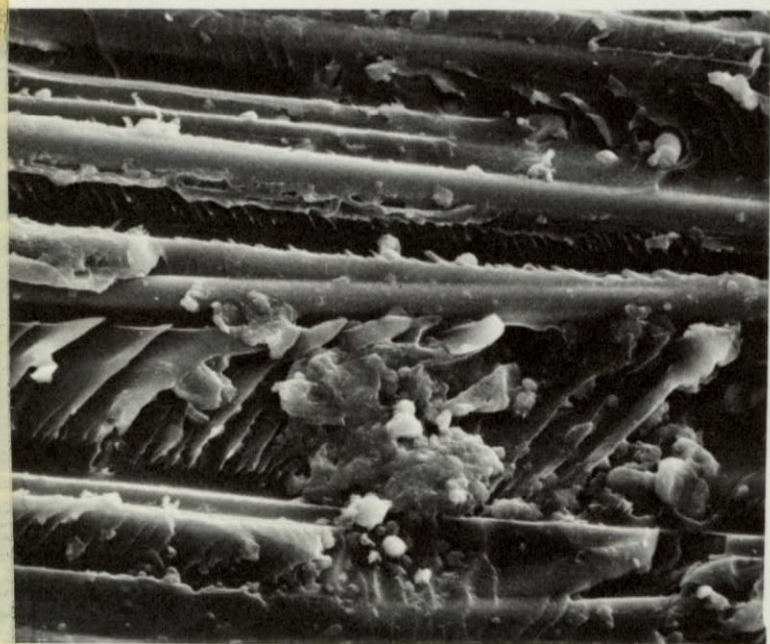
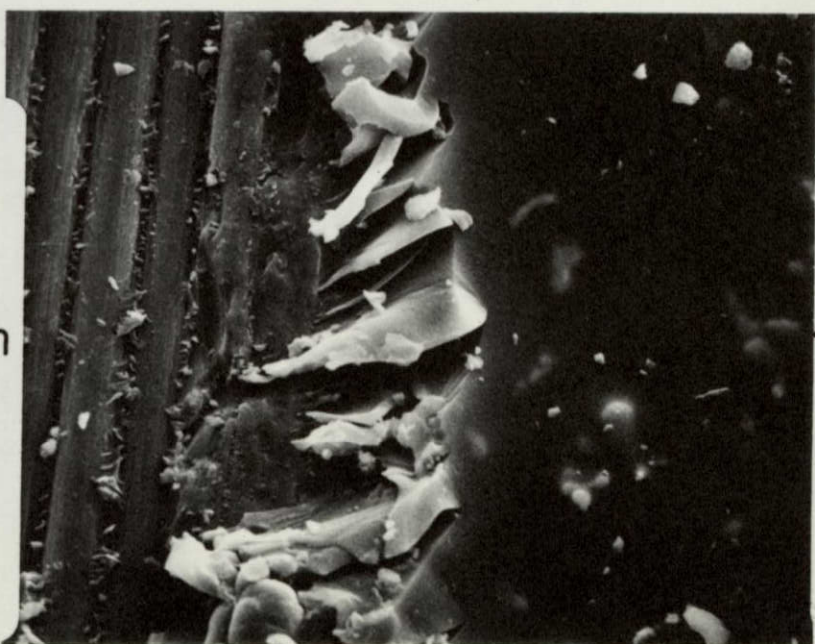
FIGURE 25.

LARC-13 matrix around the glass fibers, and the adherend fracture mechanisms are identical to the previous case. At $316^{O}C$ (Figure 25), failure is predominantly in the scrim cloth which has fractured in two, leaving one half the adhesive layer on each adherend. Closer inspection of the adhesive matrix resin between the smooth glass fibers reveals numerous voids about 5 to $20\mu m$ in size, and the fracture surfaces have no brittle cleavage cracks, indicating the possibility of thermal decomposition and softening at the highest temperature. The small amount of composite adherend failure still has the same fractography as at room temperature.

Four magnifications (20X, 500X, 1000X, 2000X) of the fracture
surface of a LARC-13 (with scrim cloth)/NR150-B2 sample
that gave 1700 psi lap shear strength at $316^{\circ}C$.

Mostly failure in the scrim cloth surface, with a vertical fracture through the scrim leaving about half the adhesive layer on each adherend. Considerable glass fiber apparent, confirmed by EDAX (Figure 26). Fracture through the adhesive matrix reveals many small (5-20µm) voids; perhaps a result of decomposition by the combined effects of temperature and stress. About 10% of failure is in the composite, with familiar features as seen on the bottom right.
