FINAL REPORT

A FUNDAMENTAL APPROACH TO ADHESION:
SYNTHESIS, SURFACE ANALYSIS,
THERMODYNAMICS AND MECHANICS

David W. Dwight and James P. Wightman

Grant NSG-1124

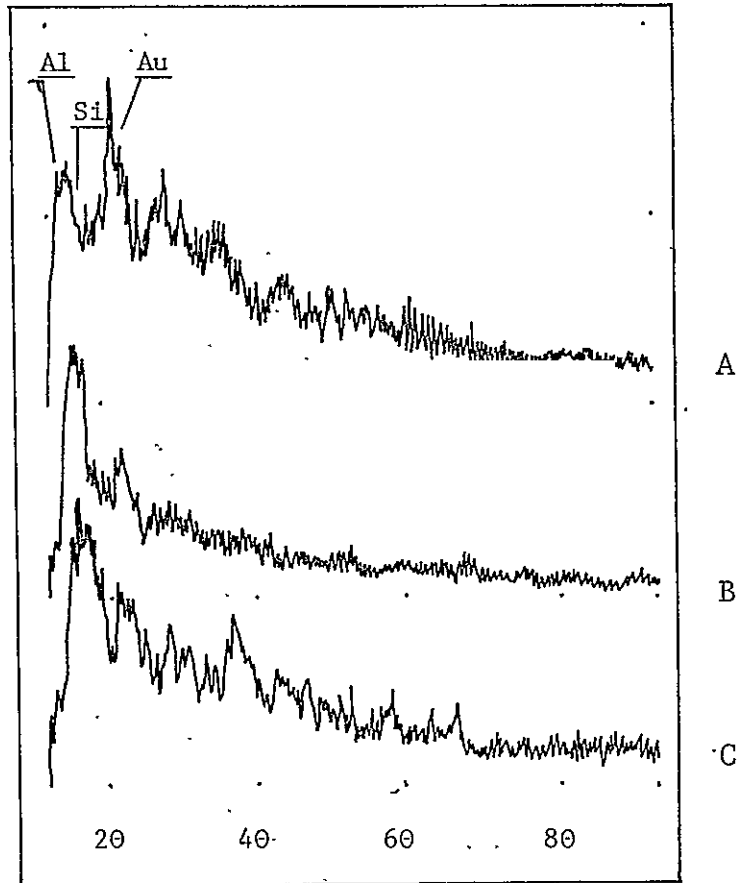
Figure 26. EDAX spectra taken from a wide area (50X) of the samples shown in Figures 23-A.,24-B., and 25-C. Although there is overlap of the aluminum peak from the adhesive filler with the silicon peak from the fiber glass scrim cloth, the peak increases on the right-hand side (silicon) in going from A. to C.. Also C. shows the strongest calcium peak.

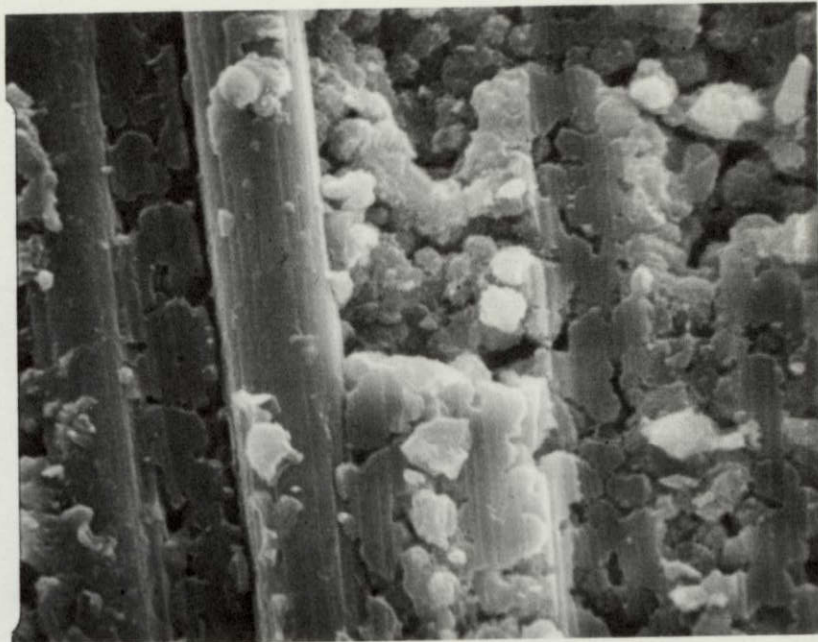
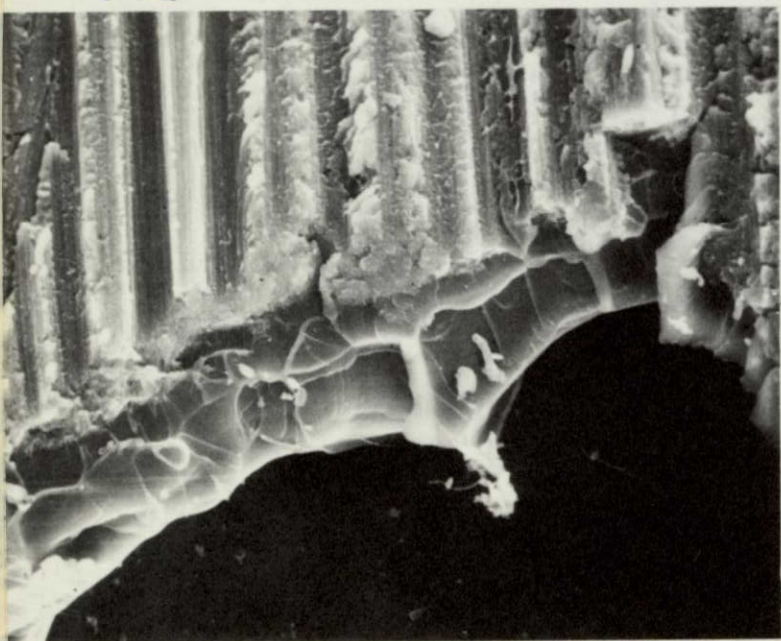
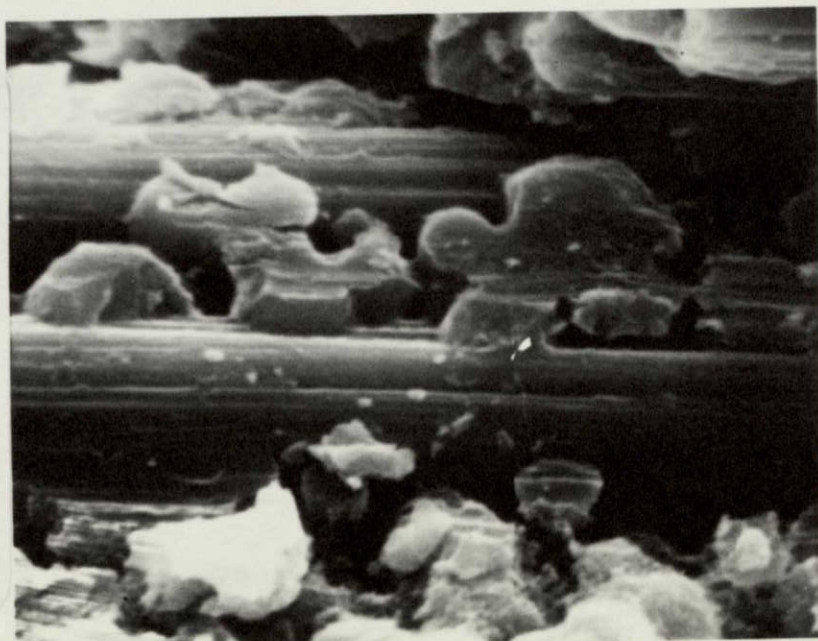
FIGURE 28.

Three magnifications (20X and 2 @ 200X) of the
fracture surface of a LARC-3/Skybond 710
sample that gave 3300 lap shear strength
at room temperature.

This sample was fractured without the usual shim in the shear tester grips, and the strength increased 50% over the previous example. The locus of failure is now more than half in the very voidy (0.2 - 2 mm in size) glue line, where there seems to be considerable plastic deformation and high-area, louvered, brittle fracture.

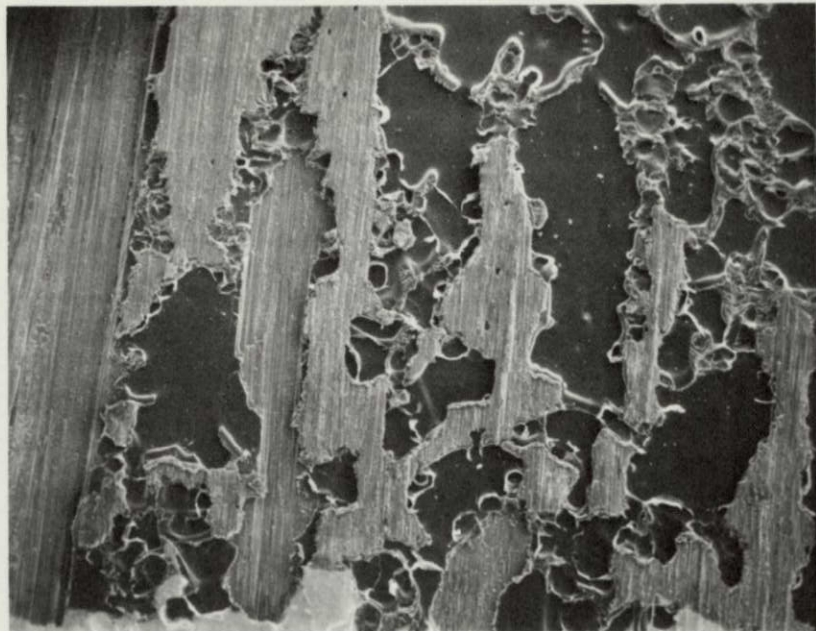
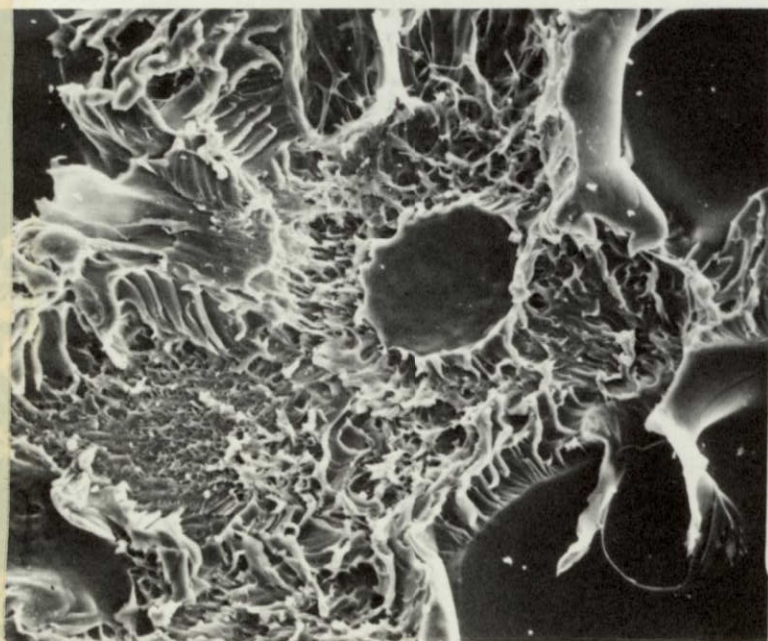
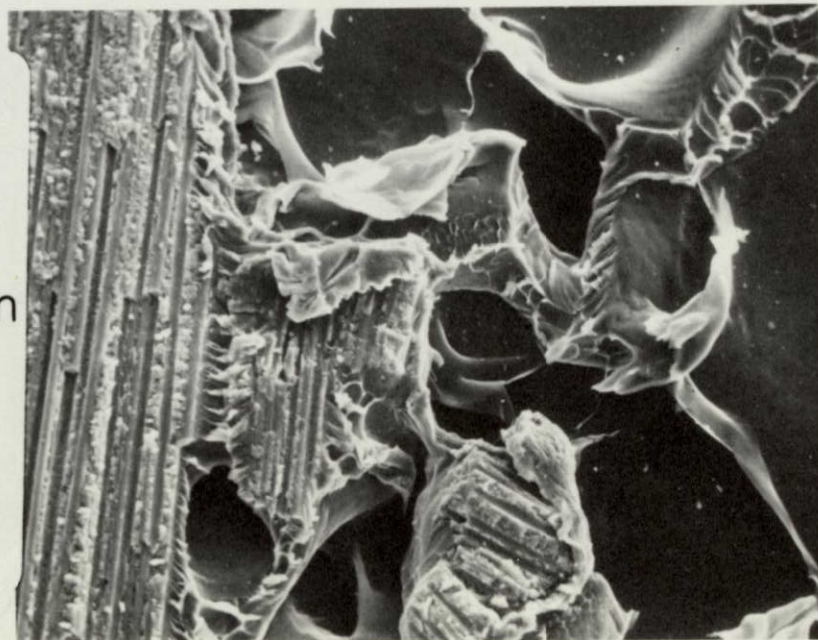
Failure is entirely in the adhesive layer at 250°C (Figure 29).
Void area is dominant and softening and flow of the adhesive under

stress is obvious: thick void-cell walls have deformed plasti-
cally in the stress direction. The actual area of material
fracture is small, and appears ductile and splintered, with a
few brittle cleavage cracks. The addition of aluminum powder
filler improved high-temperature strength on titanium adherends
(8,9), and also doubled strength on composite adherends. 'Figure
30 shows that the locus and features of fracture are also changed.
About half the failure is in the composite adherend with the
familiar fiber/matrix interfacial mechanism dominant. In the glue
line fracture is characterized by very fine plastic deformation and
ductile fracture in the walls of microvoids around the aluminum
filler particles. The very large volume of stretched polymer that
results is likely to contribute to the observed strength.

Figure 29. Two magnifications (20X, 200X) of the fracture surface of a LARC-3/Skybond 710 sample that gave 1300 psi lap shear strength at 250°C.

At least 75% void area and flow of adhesive in the direction of stress is obvious. The strength is accounted for by gross plastic deformation of thick (0.1 - 1 mm) void-cell walls and ductile, splintery fracture.

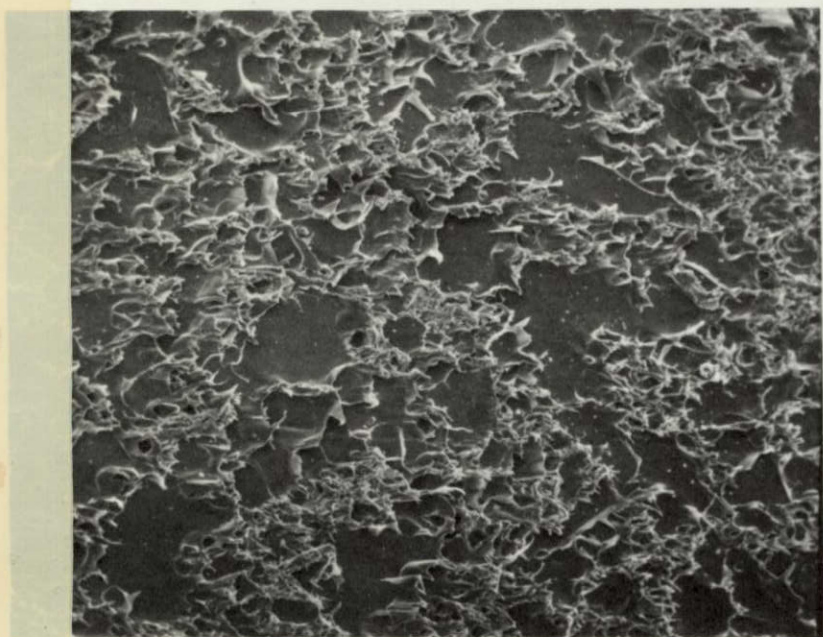
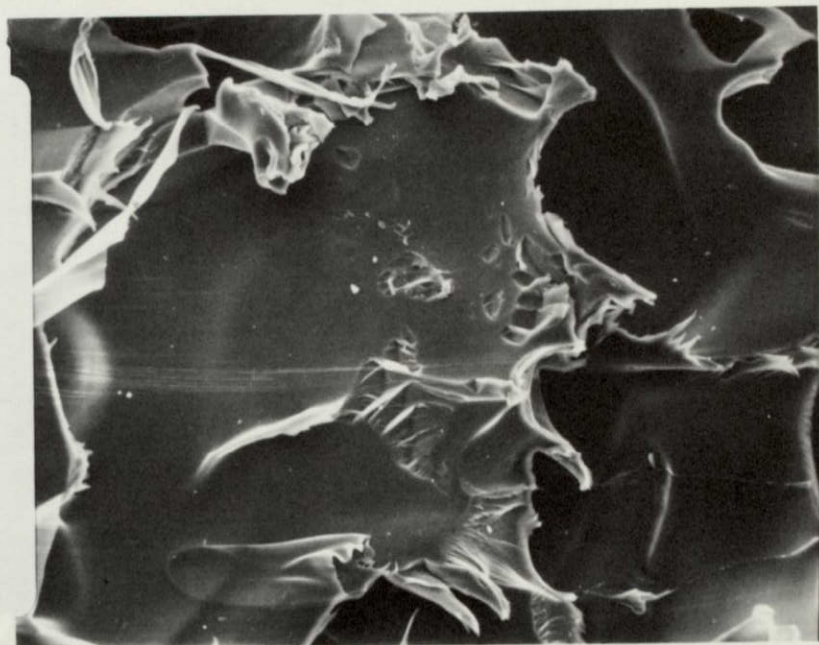
FIGURE 30.

Figure 30. Four magnifications (20X, 200X, 2 @ 2000X) of the fracture surface of a LARC-3 (with Al powder filler)/Skybond 710 sample that gave 2400 psi lap shear strength at 250°C.

Including filler doubled strength compared to the previous example. About half the failure is in the composite surface with the same interfacial mechanism seen before. Fracture in the glue line is characterized by very fine plastic deformation and ductile fracture apparently nucleated by the aluminum filler particles, similar to that observed earlier with Ti 6-4 adherends(8).

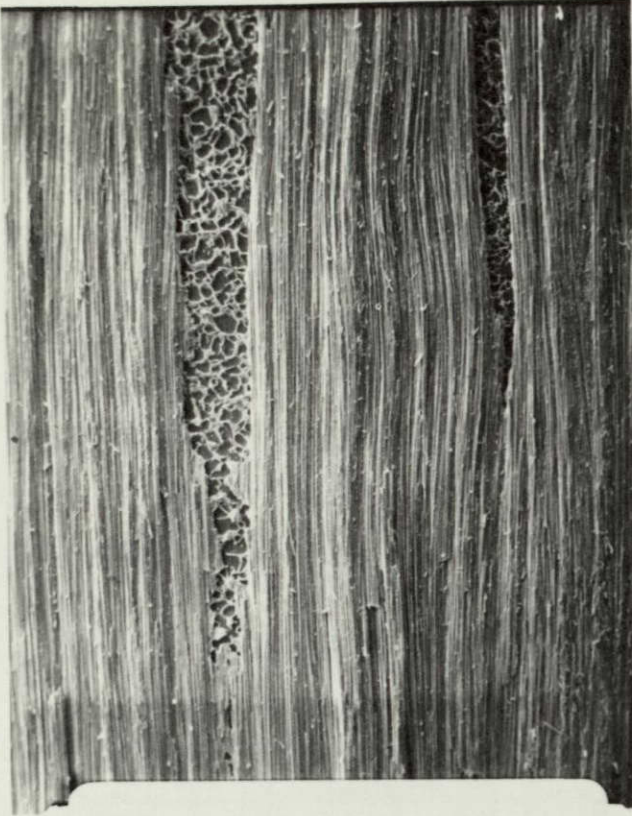
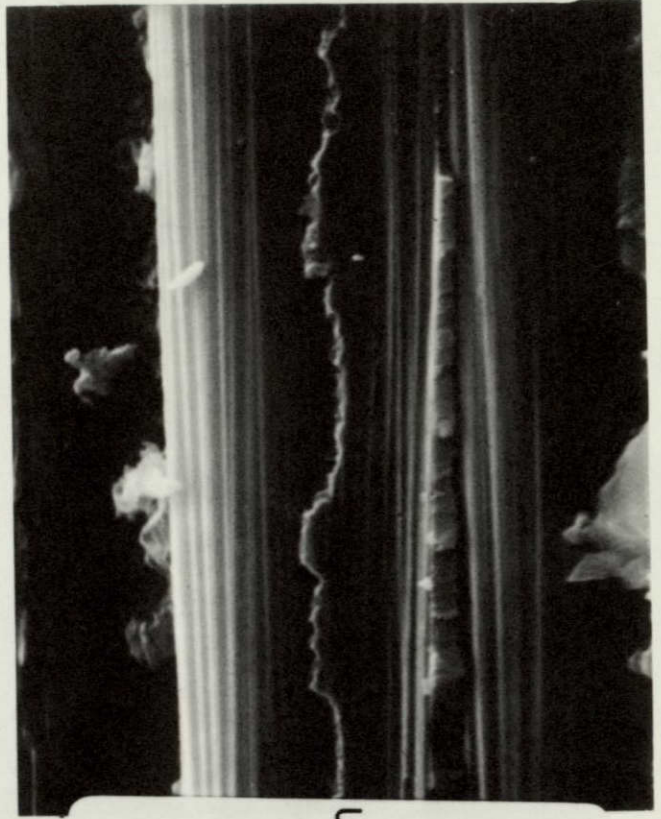
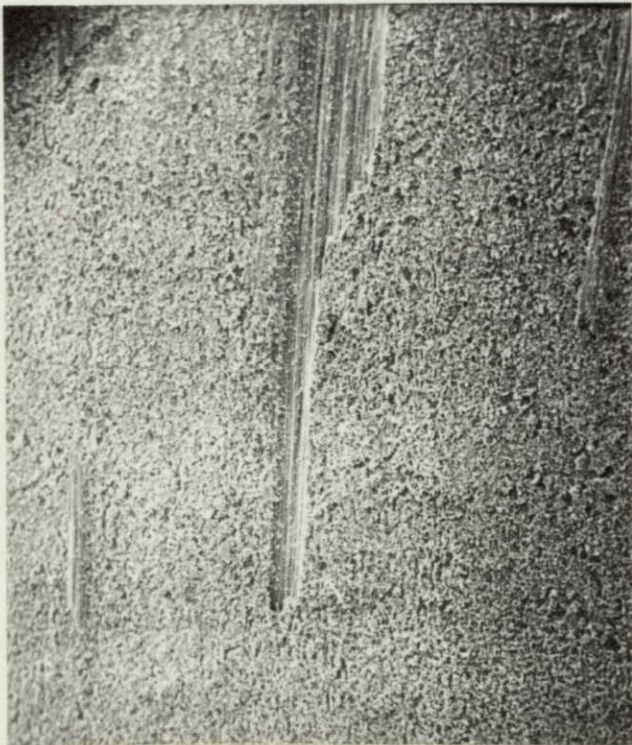
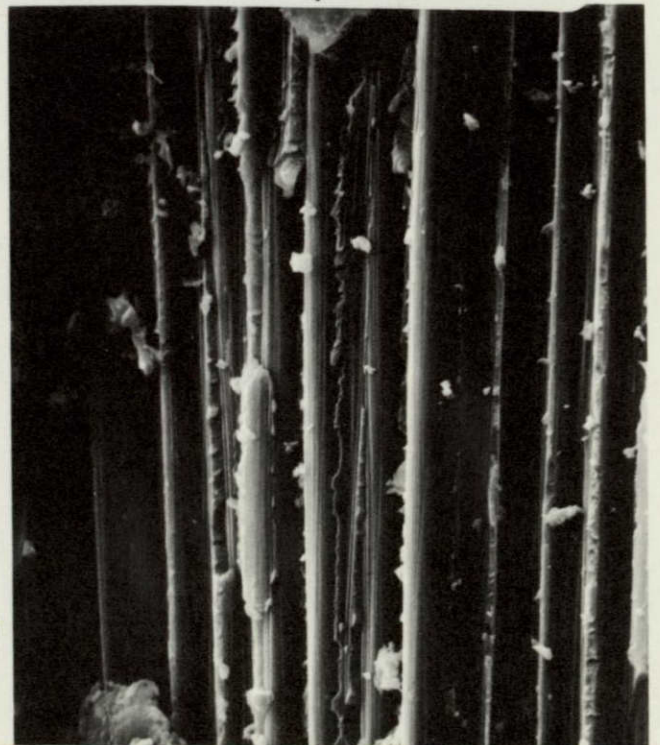
FIGURE 32.

The use of P13N as the matrix polymer for HT-S graphite fiber
composites gave good, reproducable strength even when the locus of
failure shifted from the adherend to the adhesive layer, shown in
Figure 32. Again, composite failure proceeds via fiber/matrix
interfacial failure and brittle fracture of the P13N matrix between
the fibers. This matrix polymer is continuous and fractures like
NR-150B2, whereas Skybond 710 is distinctly different.

Figure 32. Four magnifications (2 @ 20X, 1000X, 5000X) of
the fracture surface of a LARC-3/P13N sample that gave 3500 psi
lap shear strength at room temperature.

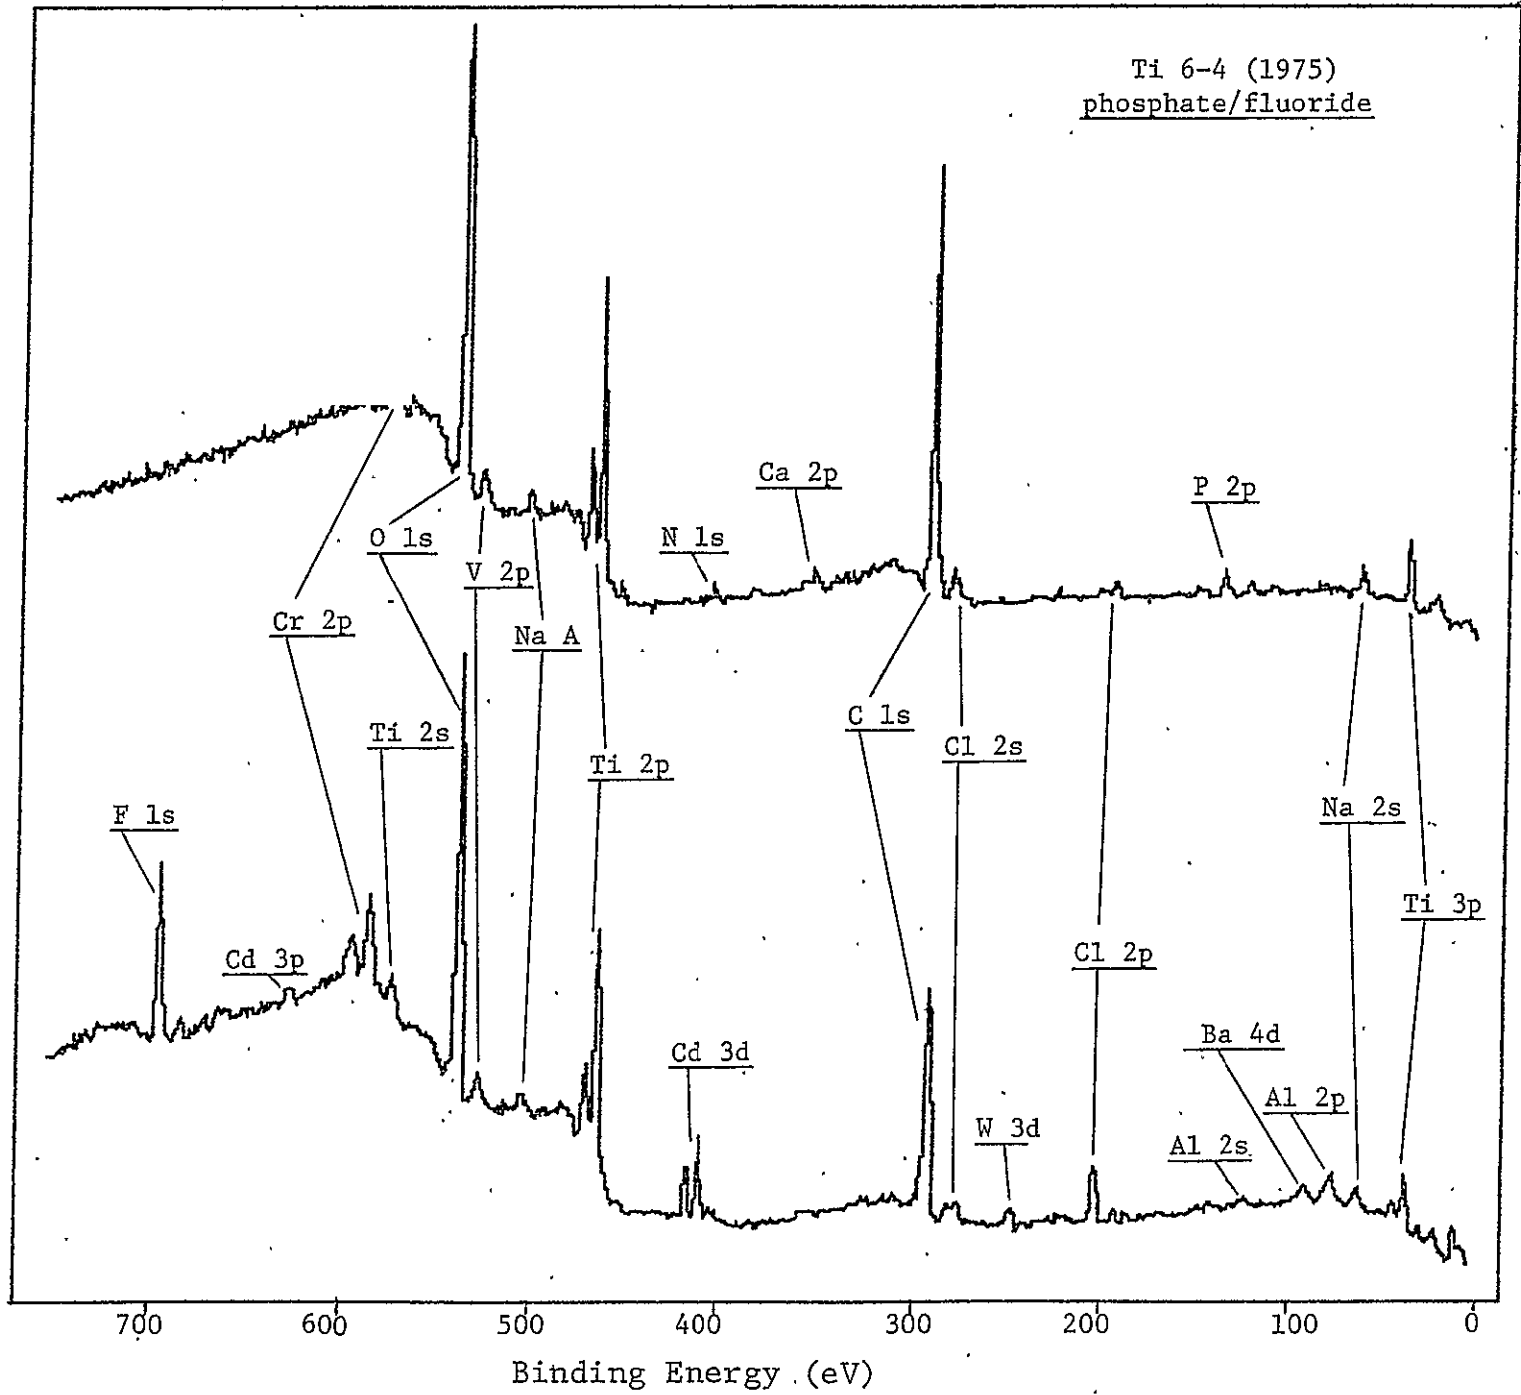
FIGURE 35.

Figures 34 and 35 show wide scan ESCA spectra of titanium 6-4 adherends treated by the phosphate/fluoride process last year and this year, respectively. Also the effect of in situ ion etching is shown in each case. In 1975, aluminum did not appear until some of the carbon contamination was removed by ion etching. The initially present aluminum signal in 1976 may be due to the residual grit particles observed on this adherend by SEM/EDAX (Figures 7 and 8). It may also be significant that the initial carbon contamination in 1976 is greater than in 1975, even though the latter sample was in storage for a year. In both cases a notable result of etching was the appearance of a major fluorine peak. Presumably the treatment solutions left this element behind, and it has been observed by ISS/SIMS and Auger Spectroscopy on similar substrates (17,18). But then the questions of the disappearance of phosphorous in Figure 34 after etching is puzzling. Chromium appears after etching in both cases and is probably an impurity in the bulk alloy. The cadmium peaks are an artifact of the ion etching procedure. Assignment of an elemental core level to each peak in ESCA wide scans is usually difficult and sometimes arbitrary, especially for low intensity peaks. Thus some peaks are not assigned and others tentatively identified, but without rationalizing why they are components of these systems.

Figure 35. Wide scan ESCA spectra, before and after in situ
ion etching, of a titanium 6-4 adherend after phosphate/fluoride
treatment (1976)

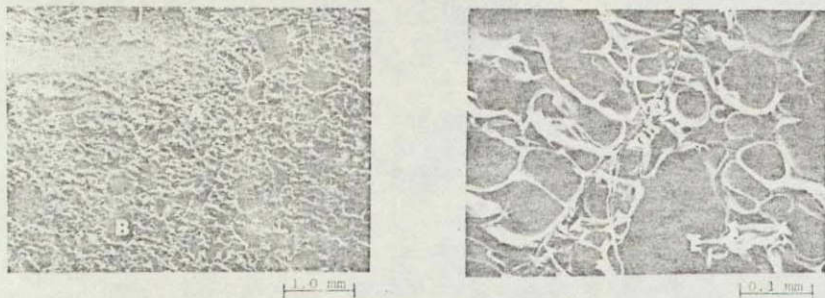
Fig. 1. Photomicrographs of the fracture surface of
BTDA + m,m'-DABP/DG adhesive after aging 30 days at 295°C;
3570 psi shear strength at room temperature. Features sim-
ilar to previous, (unaged) room temperature results (3).

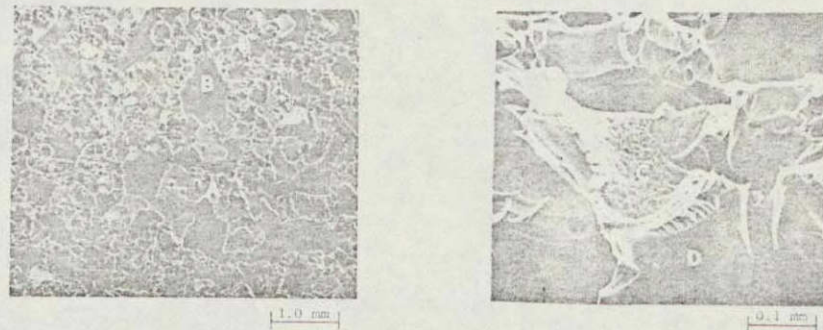
Fig. 2. Same as Fig. 1 except 2065 psi strength, tested
at 225°C.

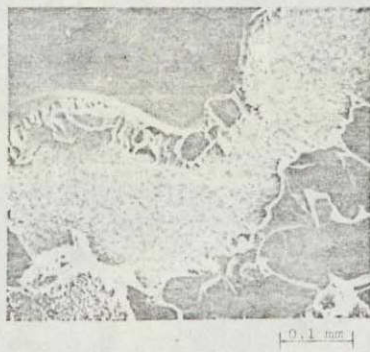
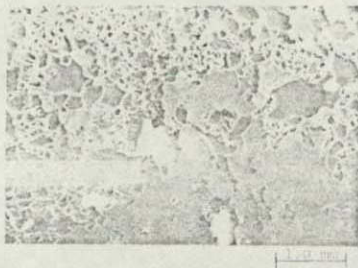
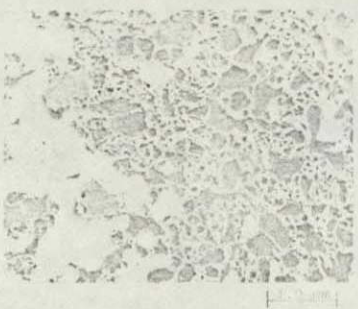
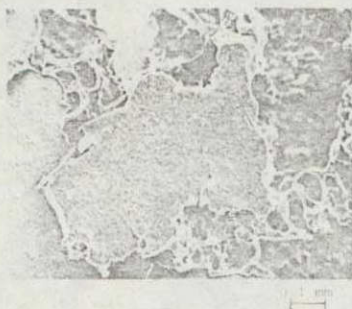
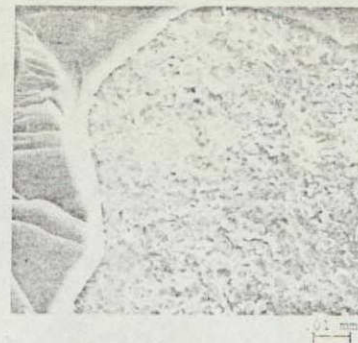
Figure 3 shows that interfacial failure and void area
increase with temperature (250°C). Large void spaces are
almost completely interconnected across the sample. At higher
magnification, some strength across the interface is indicated
by continuity where the brittle, cleavage-crack louvers meet
the exposed substrate. Interfacial failure predominates in
the 270°C test. The opposite sides of mating fracture sur-
faces are shown in Figure 4; it is quite simple and instruc-
tive to locate the matching features. There is very little
plastic deformation, hence little strength. Brittle cleavage

Fig. 5. High magnification view of area circled in
Fig. 4. Note the brittle cleavage-crack louvers on the left
and the discontinuity at the polymer/metal interface.

Fig. 3. Same as Fig. 1 except 1465 psi strength, tested
at 250°C.

Fig. 4. Same as Fig. 1 except 760 psi strength, tested
at 270°C; opposite sides of mating fracture surfaces.

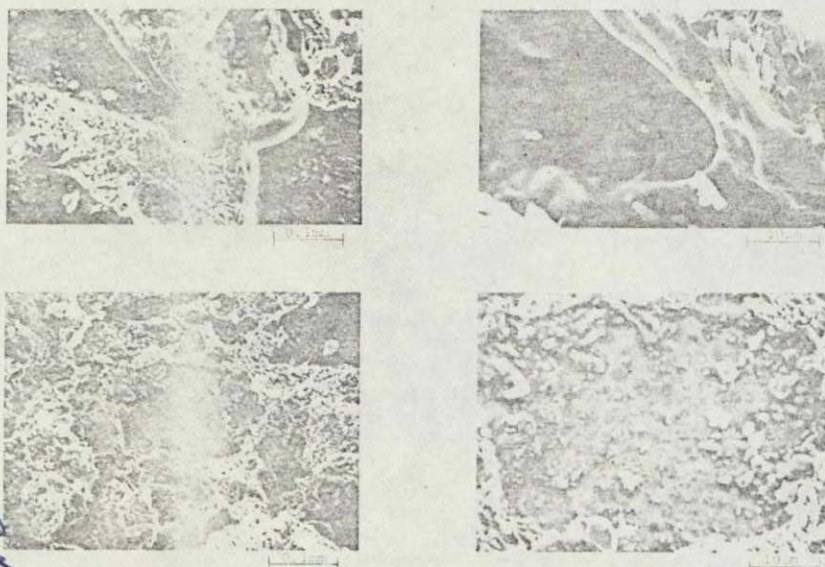
Fig. 6. Photomicrographs of the fracture surface of
65/35 BTDA/PMDA + m,m'-DABP/DG adhesive filled with 50% (top)
and 70% (bottom) aluminum powder.

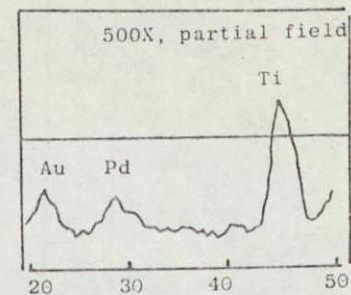
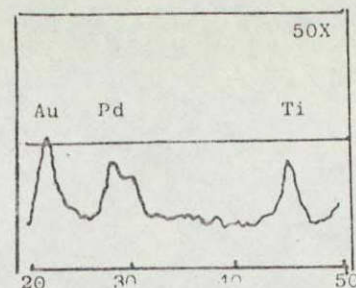
samples are shown in Figure 7. The gold and palladium peaks
are due to the ~200 Å conductive coating layer; they are use-
ful for approximate internal standards. The aluminum filler
actually gave the largest peak in the original spectra,
omitted here for clarity. In line A (50% Al), all the adher-
end (Ti) signal was found to be coming from small holes, seen
in Figure 6 (top) at high magnification; no Ti signal could be
obtained at the bottom of voids. The opposite was true at 70%
Al. More Ti appears on the survey scan, and it dominates the
spectrum from void bottoms. Figure 6 (bottom) shows the area
from which the last EDAX spectrum was taken. Clearly there
is a layer of polymer there, but it seems to be so thin that
titanium surface features show through vaguely. EDAX examina-
tion of both high temperature samples failed to uncover a Ti
signal at any magnification. Thus it can be concluded that
the room temperature fracture occasionally penetrates nearer

Fig. 7. Elemental analysis, using EDAX at two magnifi-
cations, of the same samples shown in Fig. 6. Top - Some ad-
herend shows through on the 50X "survey" on the left, but all
the Ti signal originated from holes like the one shown in
Fig. 6. Bottom - More adherend signal at 50X, and it domin-
ates the spectrum when the beam was focussed into the void
bottom.

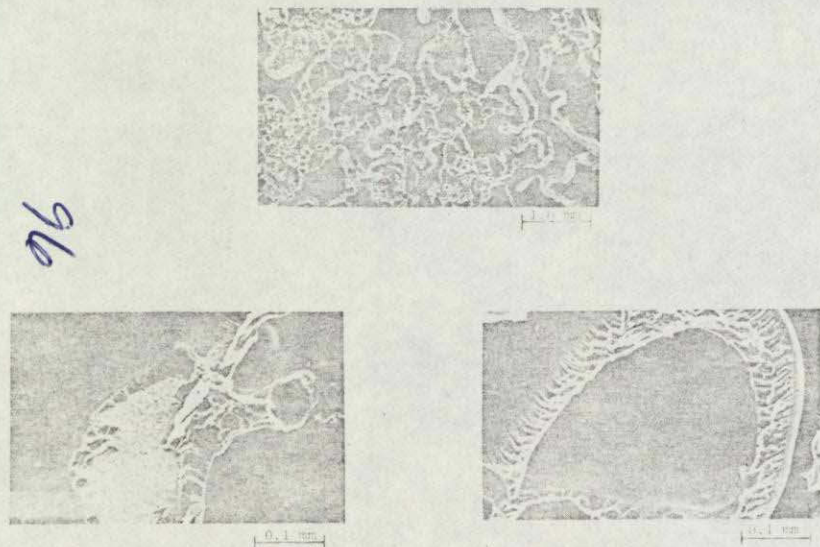
The use of DMF as solvent for standard polyimide gives little interfacial failure, but a large proportion of connected-void area compared to fracture area, shown in Figure 8.

Fig. 8. *Photomicrographs of the fracture surface of BTDA + m,m'-DABP adhesive in DMF solvent; 3700 psi shear strength.*

Apparently the 3700 psi strength is developed by the initiation and annihilation of a large number of brittle cleavage cracks illustrated by numerous louvers in the higher magnification photomicrographs. Figure 9 shows a large proportion

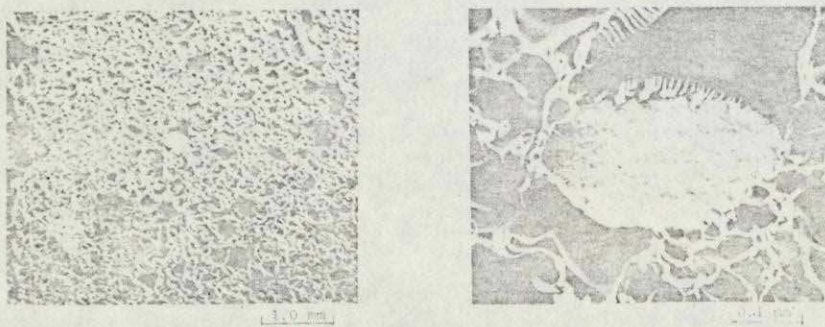
Fig. 9. *Photomicrographs of the fracture surface of OPDA + m,m'-DABP/DG adhesive; 4500 psi shear strength.*

of drawn and fractured polymer in a high-strength sample prepared with anhydride comonomer, ODPA. At higher magnification, a balance between moderate plastic deformation and brittle fracture is apparent, as well as exposed substrate and an indication of strong polymer/metal bond (continuity at the interface).

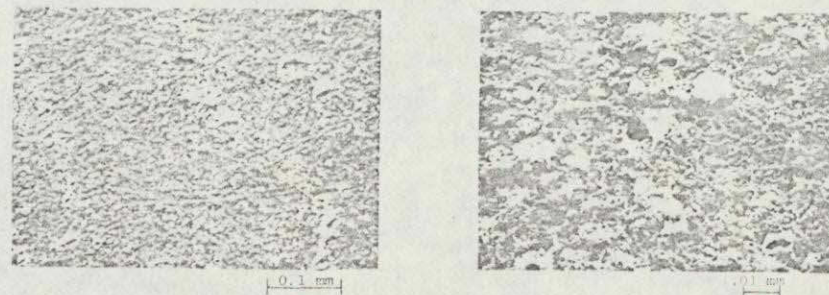
Fig. 10. *Photomicrographs of the fracture surface of BTDA + EAH-13/DMAC, "imidized flow-bonding" adhesive; 3500 psi shear strength. Note the replication of the titanium adherend surface, and the absence of voids or plastic deformation: failure was completely interfacial.*

that the polymer has formed a detailed replica of the titanium surface. Failure is totally interfacial on one side of the joint. It is unusual for good strength to be obtained without contributions from plastic and brittle mechanisms. Perhaps elastic deformation occurred. Otherwise, the true area over which polymer/metal polar and dispersion forces interact must be many times the geometrical joint area, due to the adherend roughness. Most important is the absence of the typical void structures so characteristic of joints prepared by imidization during bonding.
