PRELIMINARY EVALUATION OF FIBER COMPOSITE REINFORCEMENT OF TRUCK FRAME RAILS

James R. Faddoul

E-9044

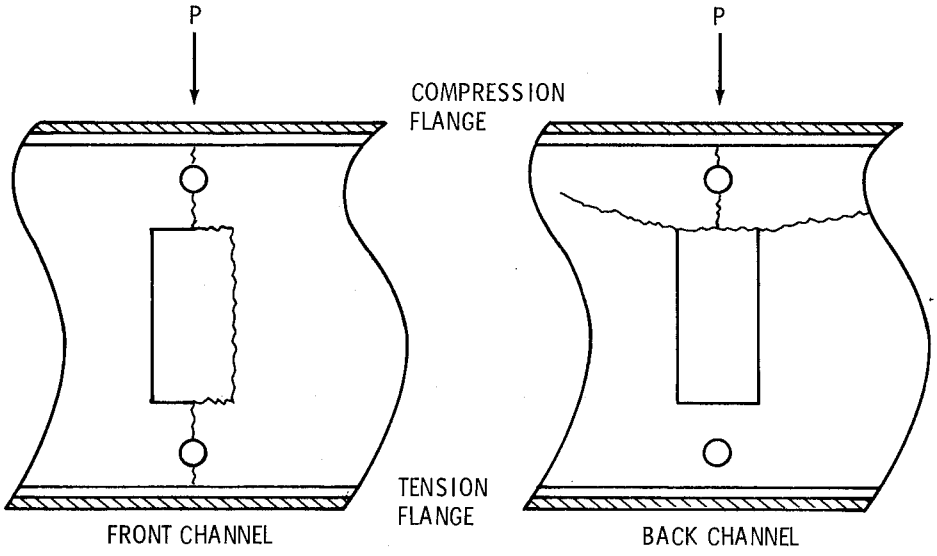
Figure 12. - Sketch of crack location and extent after 450, 000 fatigue cycles.

After 250,000 cycles, it was noted that a fatigue crack was growing from a bolt hole for the center load pad (this was an open hole since the center pad was welded) in one of the rails. The crack was on the tensile side of the rail and extended from the hole towards the flange. No cracks were observed in the other rail. At 330,000 cycles, the crack had grown from the bolt hole through the metal part of the flange. The graphite composite, which was now carrying all of the flange load, appeared to be unaffected by the crack.

At 400,000 cycles, several cracks were noted in the other rail section. These cracks had not been noticed earlier since they were in the compression side of the web where rigorous inspection had not been made. The configuration of these cracks is shown in Figure 12.

At 450,000 cycles, the cracking had become so extensive that the test was terminated to reweld the center load pad. At this point, all the cracks were welded including the one in the flange underneath the graphite composite. Welding of the cracked flange severely overheated the composite, charred the resin, and destroyed the bond between the composite and the steel in the immediate vicinity of the weld. It was,however, decided to continue the test. An additional 80,000 cycles (530,000 total) were conducted at which point the cracking of the steel around the center load pad had again become very extensive. No evidence of composite deterioration could be found but the test was terminated because of inability to transfer load from the center load pad to the rail. The part was removed from the test machine and given a close visual inspection. The only defect in the reinforcement that could be found was an area of disbond of the composite from the metal in the area where the flange crack had been welded. The disbond extended for about 1" on each side of the crack. There was no additional degradation of the composite in the area that had been overheated by the weld. In every other area, the composite and bond appeared to be unaffected by the fatigue test.

While the composite stiffens the flanges, it adds no strength to the web and thus use of the composite reinforced channel at stress levels commensurate with its stiffness could shift the failure zone to the web in areas where holes and discontinuities exist. The cracking of the web which occurred during the fatigue test was evidence of this problem even though the stress level in the metal (flange stress equal to the yield strength) was significantly higher than would be experienced during normal use of a truck frame. Further testing to evaluate the effect of web stress level on cracking is recommended.

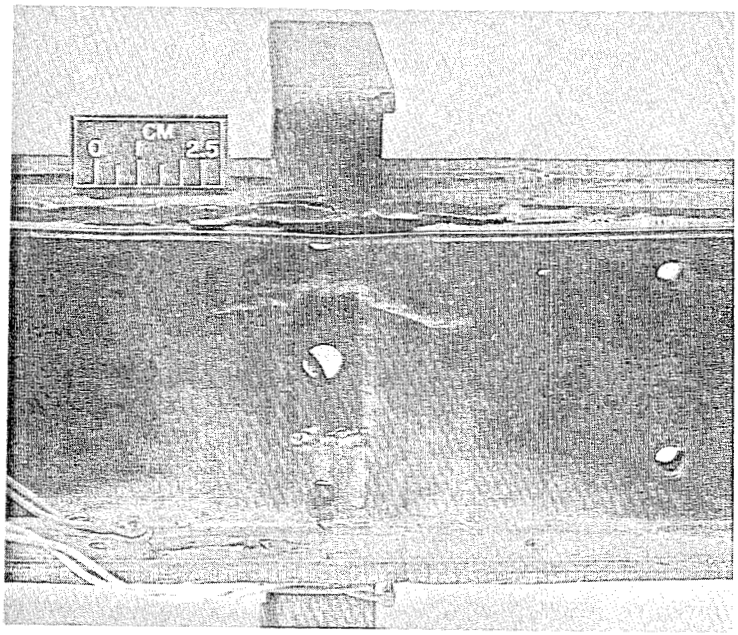
Figure 13. - Buckled flange after ultimate load failure.

After removing the test assembly from the fatigue test machine, the cracks in the webs and center load pad welds were again welded. The test assembly was then subjected to a 3 point bend-to-failure test. The test procedure was similar to that used for the load deflection test. The ultimate load carried by the test specimen was 12,700 pounds. Failure initiated due to buckling of one of the compression flanges and resulted in a load drop-off to 9000 pounds. Further attempts to load the test assembly resulted in failure of the tensile flange of the other rail section. The tensile failure was through the area where the flange was cracked and the composite had been charred by the weld repair procedure. This second failure resulted in another load drop which stabilized at 7000 pounds. The test was terminated at this point. A photograph of the buckled flange failure may be seen in Figure 13.

Although the failure load of 12,700 pounds was about 15% lower than the 15,000 pounds which is the calculated

buckling load for the composite reinforced beam or a channel with conventional full "C" reinforcement, the test specimen still withstood a load some 50% greater than would be expected for the ideal case of a non- reinforced beam. When related to the load history to which this specimen had been subjected, the ultimate load carrying capability was considered to be acceptable.
