EFFECT OF BALL GEOMETRY ON ENDURANCE LIMIT IN BENDING OF DRILLED BALLS

HAROLD E. MUNSON

TRW MARLIN ROCKWELL DIVISION

CONTRACT NAS3-17351

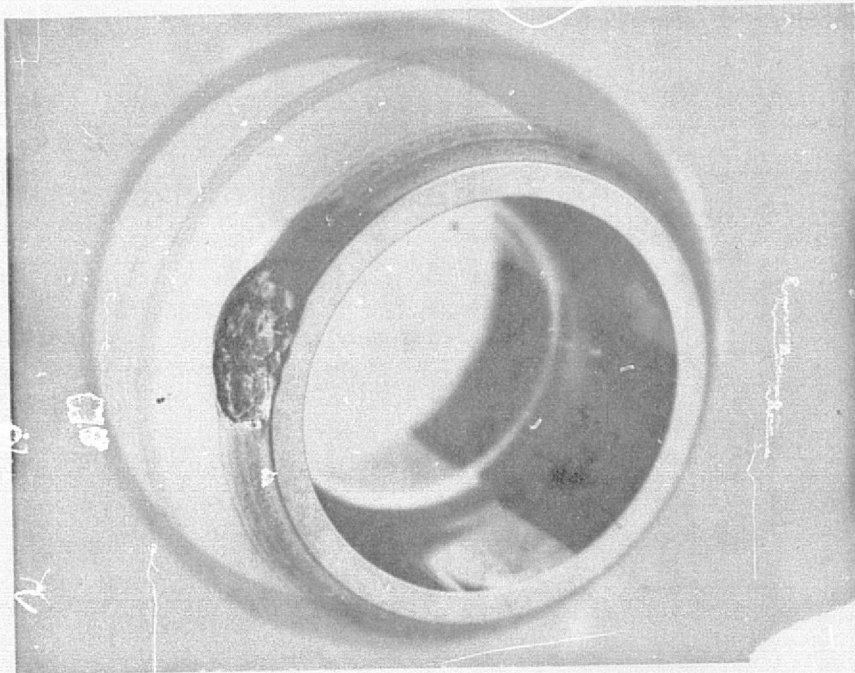
In a further evaluation, to determine the effect of a high angle contact load on the Design B ball, ten balls were run between a standard race and a V-groove. Loads were heavy enough to produce rolling contact fatigue failures, as well as bending fatigue failures, at the V-groove interface. Under the two higher loads, life was measured in minutes. At failure, a chunk of the ball tended to break out. In one of the balls tested at 5,340 newtons (1,200 lbs.), the failure appeared to have started as a contact fatigue spall, and the test was stopped before cracked areas at the bore had actually broken loose. Lives at 4,450 and 3,560 newtons (1,000 lbs. and 800 lbs.) radial load were longer, significantly so at the lowest load. Failures started as spalls, with cracks then progressing to the bore. (See Figure 9). One test was stopped before cracks from the spall had reached the bore. (See Figure 10).

Design B balls were most successful in that no failures occurred under originally scheduled testing. When these balls were run under very high Hertz stresses against a V-groove race, the reinforced design demonstrated an ability to retain structural integrity after failure had initiated. Figures 9 and 10 show spalls on Design B balls run against a V-groove race.

FIGURE 10 - Design B Ball No. 75, Run on a V-Groove Race,
with Fatigue Spall.

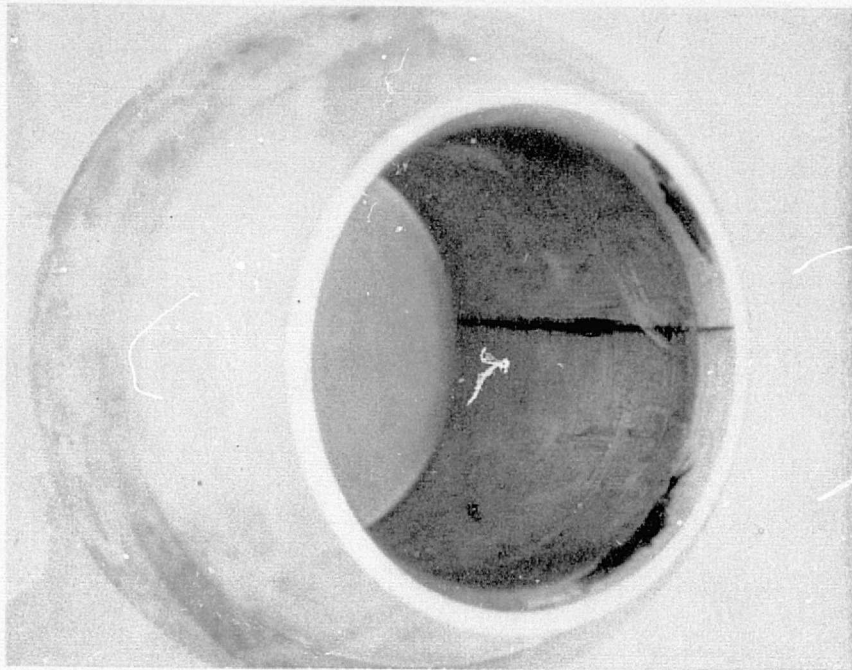
Examination of ball failures indicated that fractures started at the bore, then progressed more or less radially outward. Figure 11 shows a ball failure in which the crack is only in the bore. In some breaks the crack was distinctly radial. In others the crack moved outward at an angle from a true radial plane. The two break patterns are described as "radial" and "diagonal" in Table II. A pictorial representation of the various break patterns is shown below:

FIGURE 11 - Design A Ball No. 19, Showing Failure Which Did Not Progress to Ball Outer Surface. (Crack is accentuated with Magnaflux Solution)

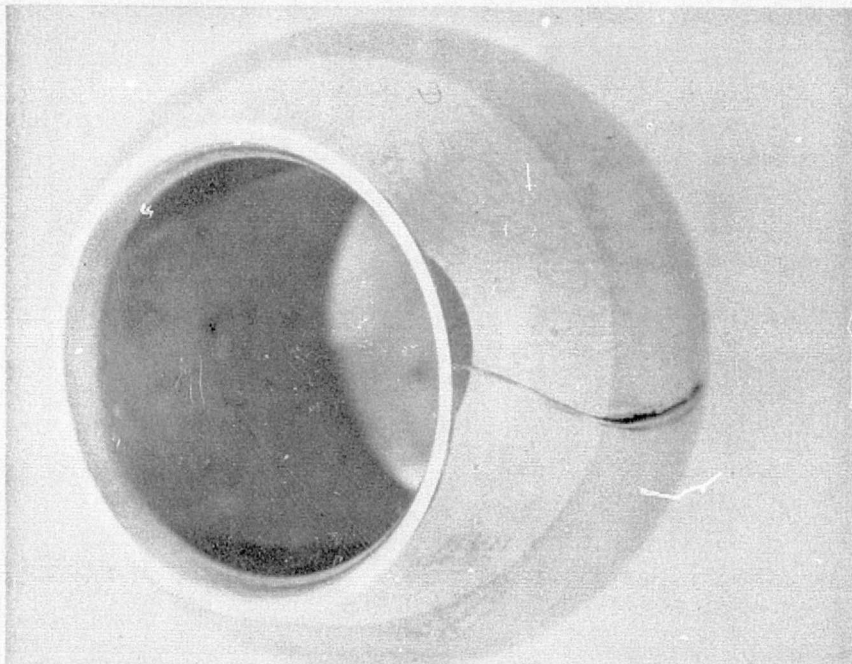
If a ball with diagonal break was permitted to run for a few seconds, a second diagonal break would often occur. The resulting chunk would drop out of the ball. See Figures 12 and 13 for representative failures.

FIGURE 12 - Design A Ball No. 11, Showing Failure With Diagonal Crack.

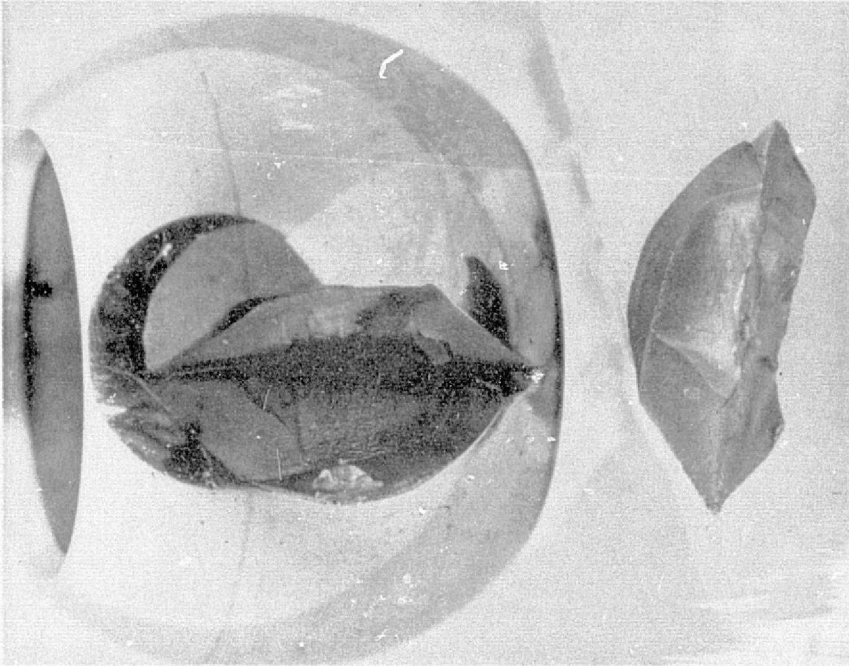
FIGURE 13 - Design A Ball No. 4, Showing Ball With Aggravated
Diagonal Break.

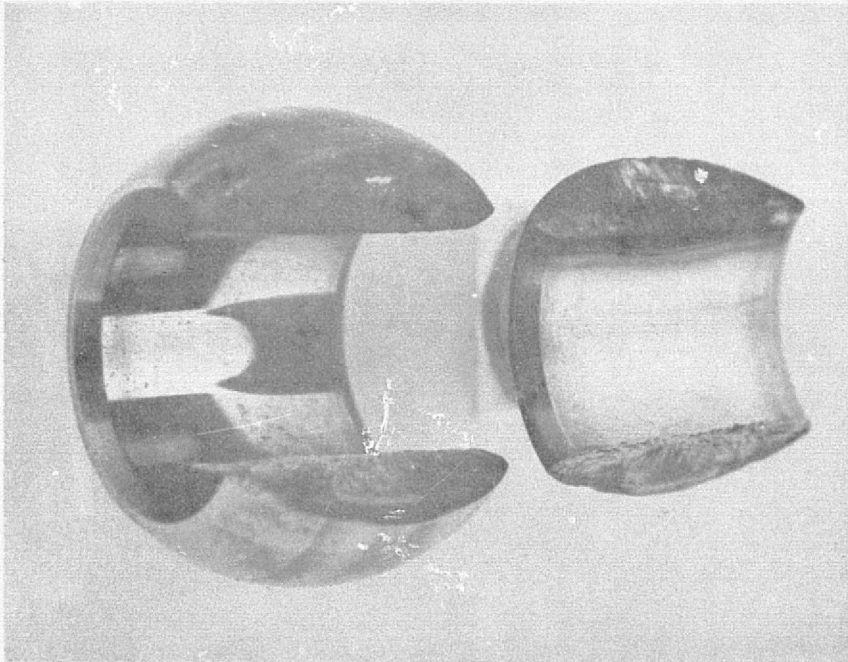
If a ball with a radial break were permitted to run for a few seconds, another radial break would often occur, with a catastrophic failure. (See Figure 14).

FIGURE 14 - Design A Ball No. 6, which Suffered Two Radial
Fractures. Initial Crack is Discolored from Frictional Heat.

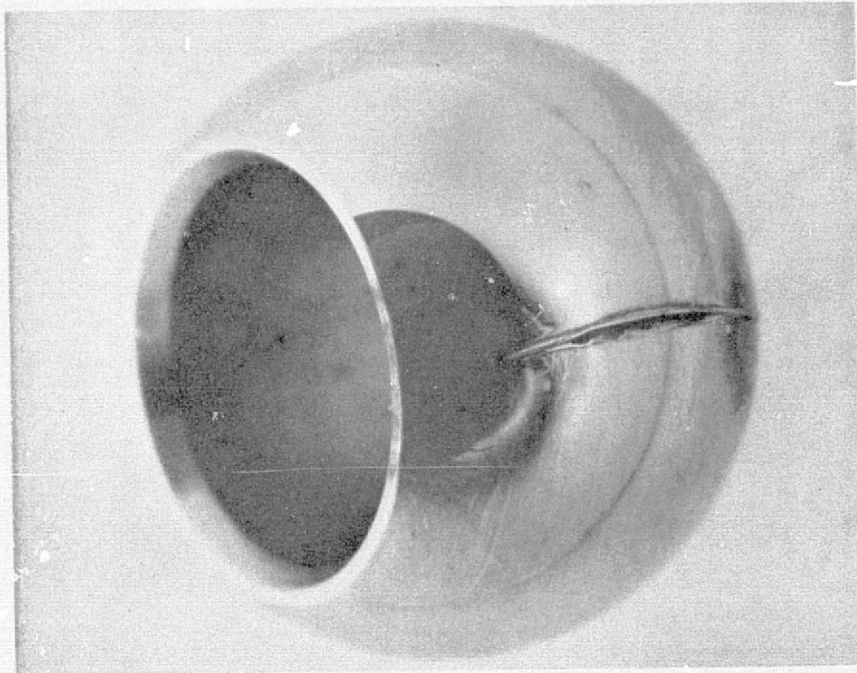
FIGURE 15 - Design A Ball No. 13, Showing Failure Which Overheated at the Crack.

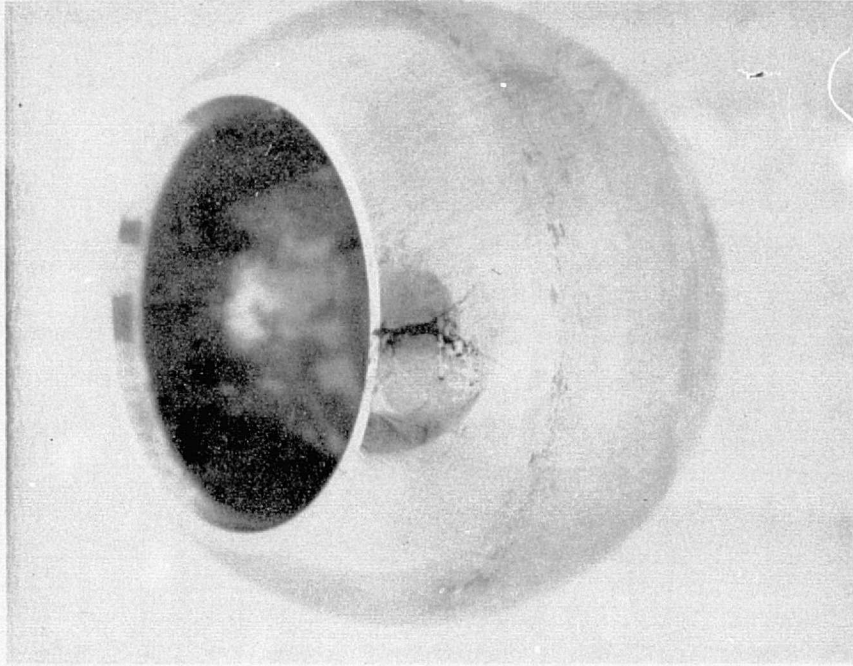
In Design D balls, breaks tended to be non-planar, as contrasted with breaks in the through-hardened balls. Figures 16, 17, and 18 show characteristic failures in Design D balls.

FIGURE 17 - Design D Ball No. 58, Showing Arrested Crack in Carburized Ball. (Crack is accentuated with Magnaflux Solution)

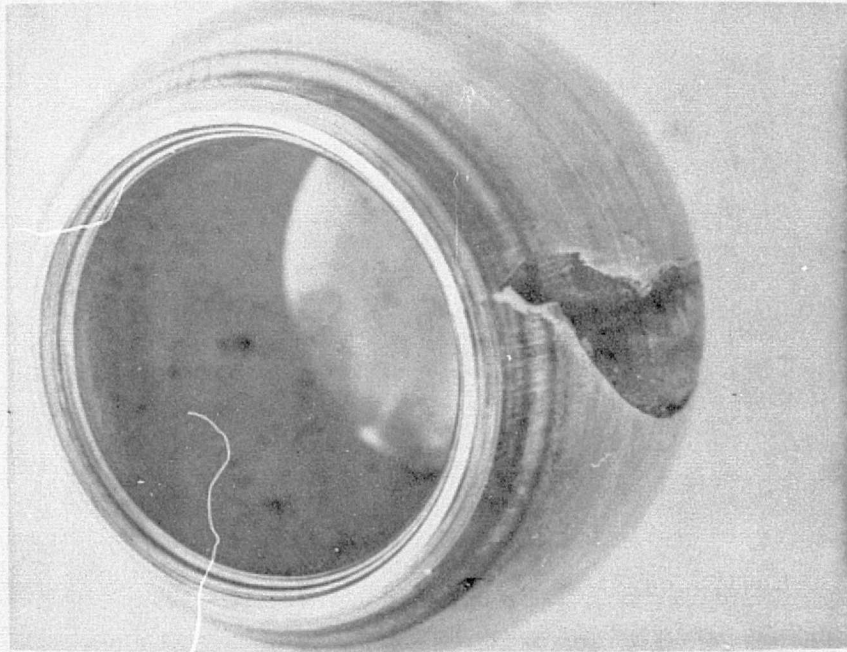
FIGURE 18 - Design D Ball No. 60, Showing Fractured Carburized Ball.

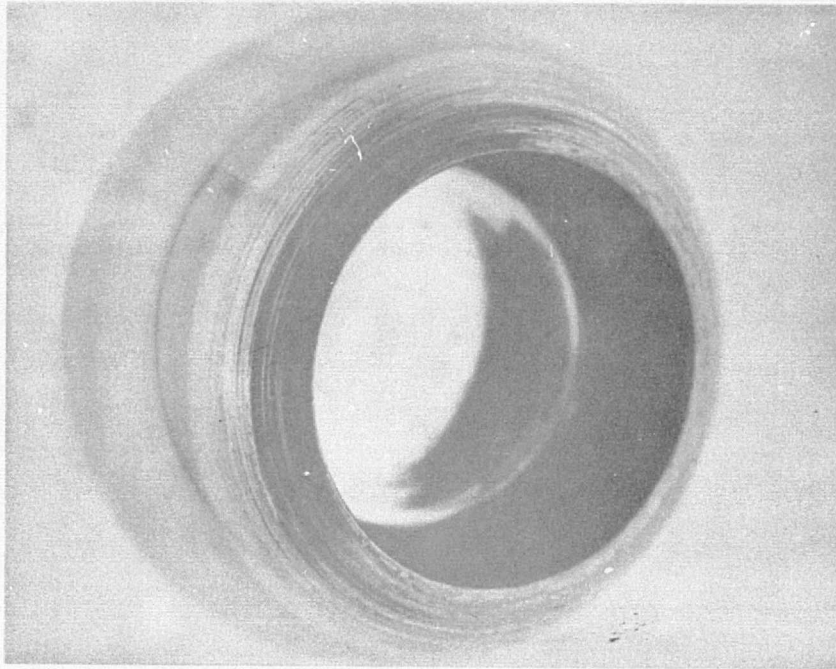
Bearings incorporating Design B balls were run at 20,000 rpm (3,000,000 DN) but were unable to operate at scheduled load, 30480 newtons (6,850 lbs.). Several tests were made. In each test, one or more balls tilted excessively, wearing into the restraining ribs in the ball pocket, and abrading one or both sides of the ball. (See Figures 19 and 20.) With the braking action which occurred at this time, there was light skidding on the races. In each case, audible indications of bearing distress were observed as load was being increased through the 15,575 newtons (3,500 lbs.) range.

FIGURE 19 - Design B Ball from Ball Bearing Test, Showing Abraded Side which Scrubbed Cage Rib.

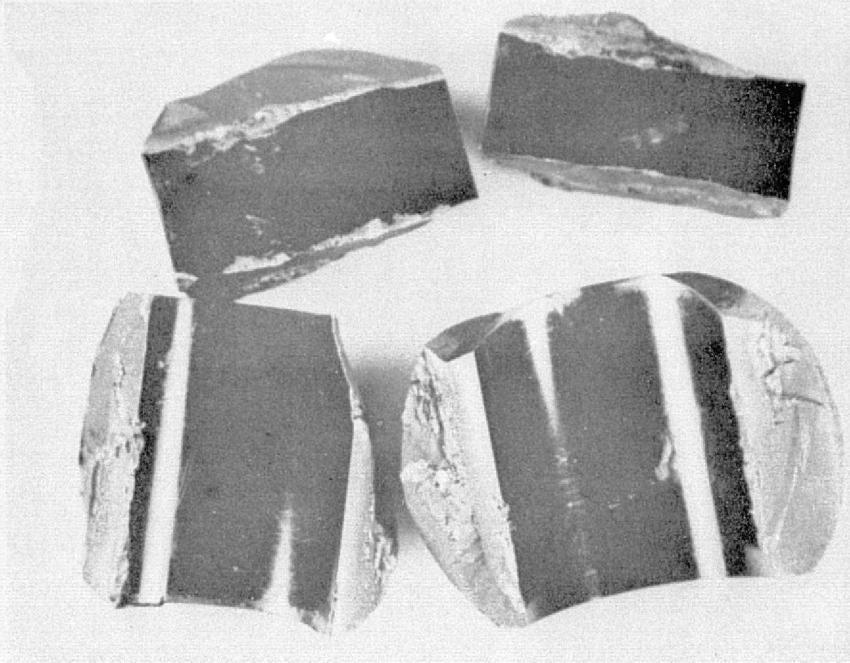
Examination of the bearing revealed that one ball had broken into several pieces. See Figure 21. In addition, all balls had tilted in their pockets with the result that the sides of the balls scrubbed heavily into the alinement restraints in both sides of each pocket. All balls had tilted in the same basic orientation - so that the axis of a drilled ball was essentially perpendicular to the line of contact from outer race through the ball to inner race. Markings on the sides of the broken ball indicated that it had also scrubbed on the cage alinement restraints before it collapsed.

Apparently, the initial cracking of the failed ball threw the bearing into an unstable operational mode; the bearing continued to run until manual shut down, by which time the one ball had received multiple fractures.

FIGURE 21 - Fractured Design C Ball After 28.9 Hours Operation in MRC 9130-UK-29 Ball Bearing at 20000 rpm with Full Bearing Thrust Load of 20500 N (6850 lb.)

A bearing incorporating these balls operated at three million DN under heavy axial load for 28.9 hours. Failure of this bearing was due to fracture of a ball. It appears that a still heavier walled design, or a more fatigue resistant material is required for general application of the concept.

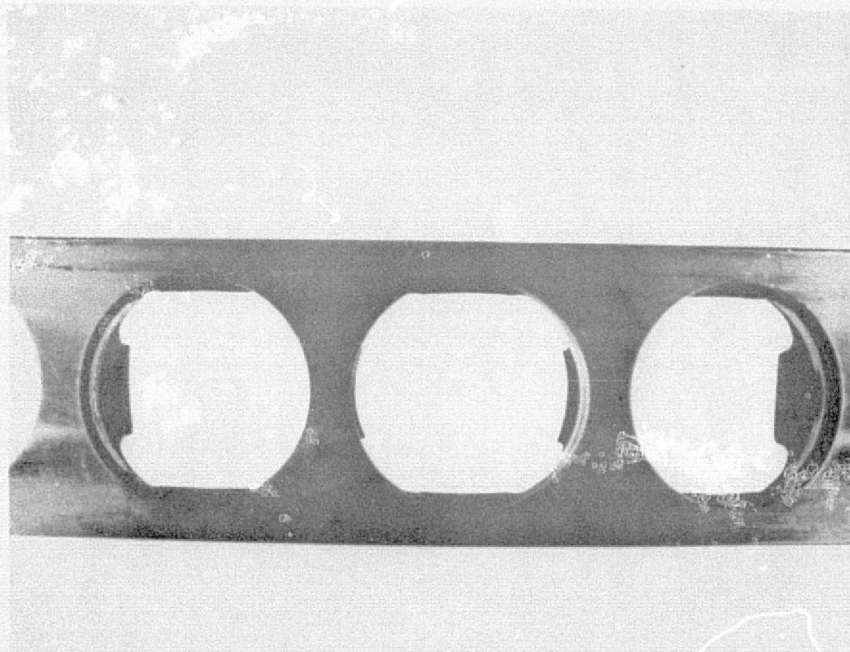
The bearing had been completely disassembled and examined after approximately 20 hours and again after 25 hours of full speed-full load operation. These examinations showed a number of dents in balls and races and some incidental contact between sides of drilled balls and pocket restraints, but no serious damage. Figure 22 is a photograph of a section of the cage taken at the 20 hour examination, showing only normal wear.

FIGURE 22 - Cage from MRC 9130-UK-29 Ball Bearing after 20 Hours Operation at Full Load and Speed. Cage was in Good Condition.

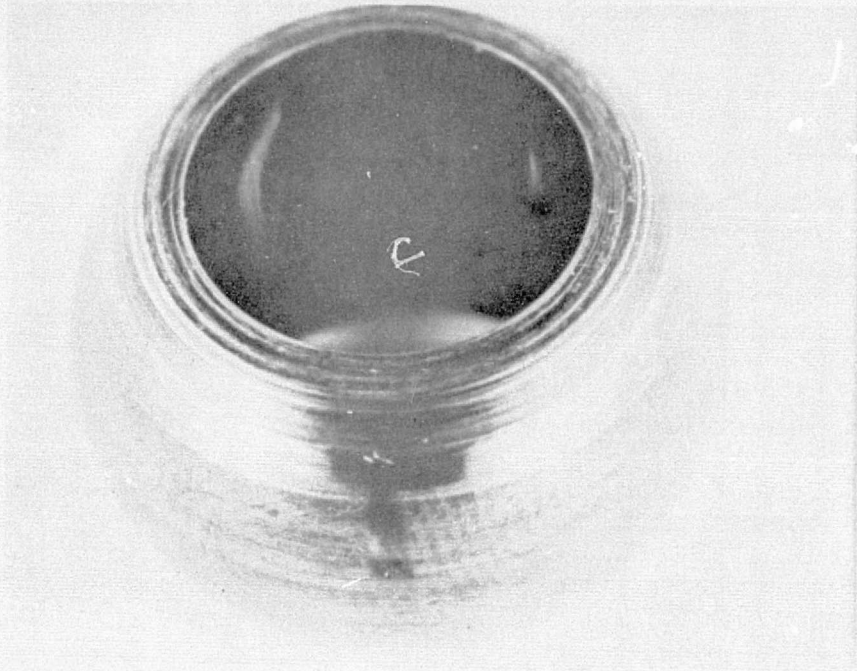
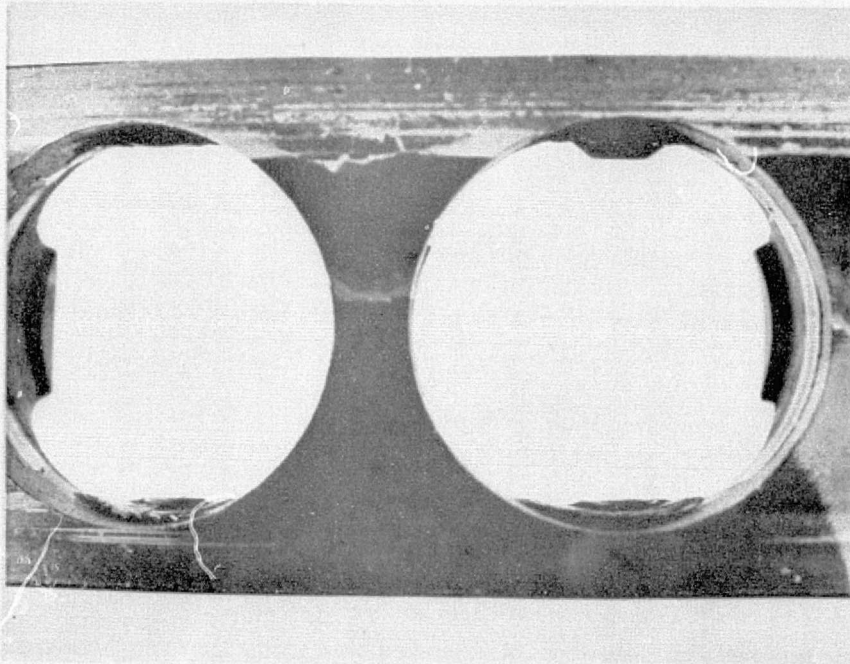
Figure 23 shows a Design C ball as removed from the failed bearing at 28.9 hours. Figure 24 shows a section of cage with severely damaged alinement restraints, after test; balls in the section of cage shown were unbroken but severely scrubbed.

FIGURE 23 - Unbroken Design C Ball Removed from Bearing at Completion

of Test. Ball Shows Severe Contact with Cage Pocket Restraints.
