NASA TECHNICAL MEMORANDUM

NASA TM X- 71748

A LIFE STUDY OF AUSFORGED, STANDARD FORGED AND STANDARD MACHINED AISI M-50 SPUR GEARS

by D. P. Townsend and E. V. Zaretsky
Lewis Research Center
Cleveland, Ohio 44135

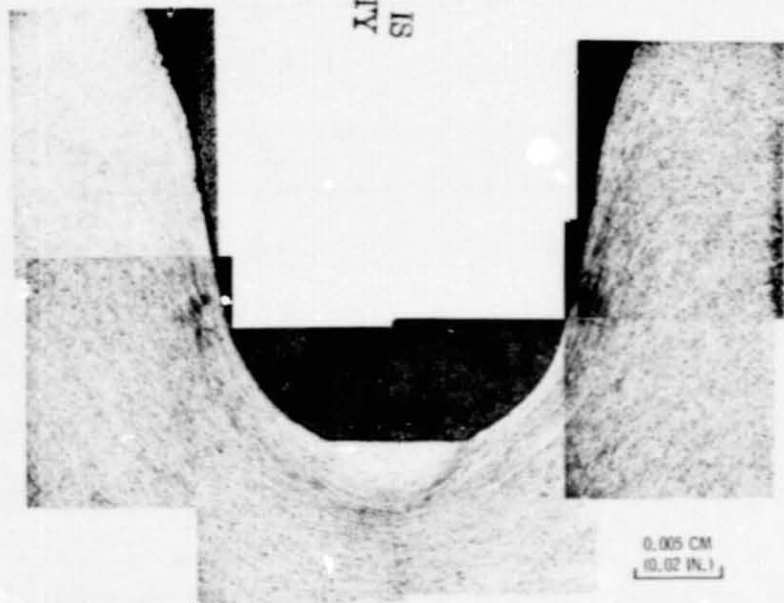
An important observation relevant to the above discussion is illustrated in the grain flow pattern of the standard forged and ausforged gears as shown in Fig. 4(a) and 4(b). The standard forged tooth is very near the final net shape and dimension, while the ausforged tooth still requires considerable machining to achieve the final tooth form, thereby resulting in the elimination of a major portion of the preferential and beneficial grain flow pattern. This would tend to make the ausforged gear tooth less resistant to bending fractures.

Figure 4(a). - Photomicrograph of macro grain flow pattern in standard forged gear: Etchant, 3 percent nital.

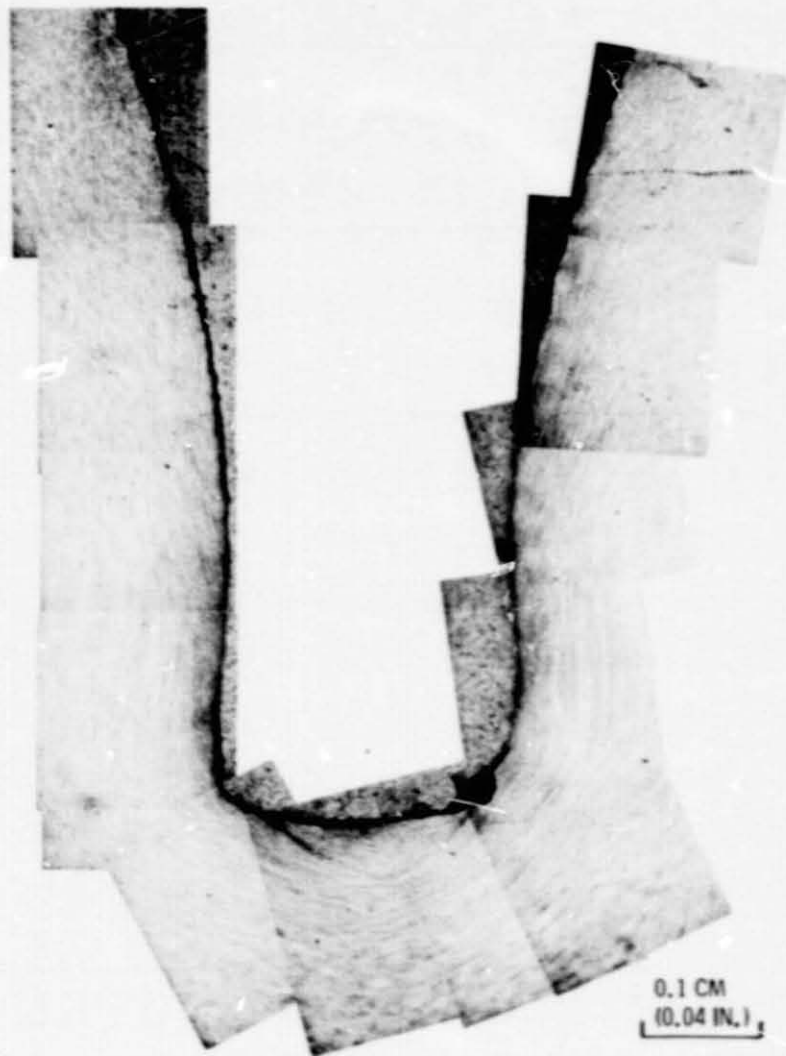
Figure 4(b). - Photomicrograph of macro grain flow pattern in ausforged gear. Etchant, 3 percent nital.

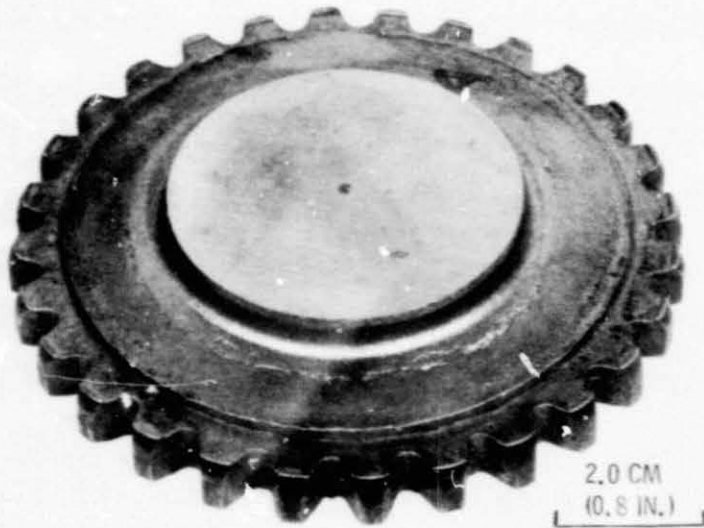
After several forging trials involving both tooling and procedural changes
the gear shown in Fig. 5(a) was produced. The teeth however were only ap-
proximately 60 percent formed. The tooth fill condition was improved by
changes in the die configuration and by slightly increasing the ausforging tem-
perature to 1103 K (1525° F) in order to achieve improved metal flow char-
acteristics.

Figure 5(a). - Ausforged gear after initial tooling and process modifica-
tions. Tooth fill is approximately 60 percent.

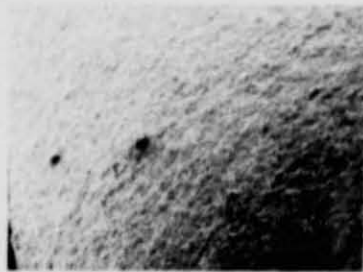
(a) STANDARD MACHINED.

A typical fatigue spall of the standard machined AISI M-50 is shown in Fig. 8(a). Metallurgical examination indicated that the fatigue spalls were of subsurface origin and initiated at or near the pitch diameter in the region of maximum Hertz stress. A typical gear tooth fracture and cross section of the standard machined AISI M-50 gear is shown in Fig. 9(a). The failure originated in the root area and was not related to any prior surface fatigue spall caused by normal tooth contact as shown in the Scanning Electron Microscope (SEM) photo, Fig. 10(a). The fracture surface in Fig. 10(a) shows the dimpled fracture pattern which is typical of a tensile failure; thus, supporting the conclusion that the tooth failed in a pure bending overload mode. The failures are essentially classical root crack failures [22]. Similar results were obtained with standard machined AISI M-50 gears with tip relief in [13] at a higher tooth loading.

Figure 8. - Typical fatigue spall of VIM-VAR AISI M-50 gear teeth. Maximum Hertz stress, 17.1×10^8 newtons per square meter (248 000 psi); maximum bending stress at tooth root, 2.67×10^8 newtons per square meter (38 700 psi); speed, 10 000 rpm; temperature, 350 K (170^0 F); lubricant, super-refined naphthenic mineral oil.

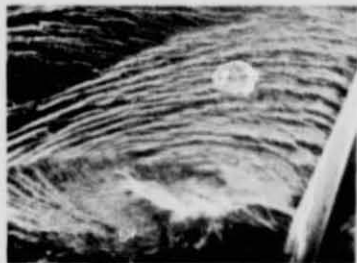
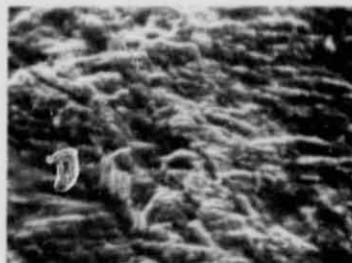
Figure 10. - Scanning electron photomicrograph of fracture surface of the VIM-VAR AISI M-50 gear tooth at different magnifications.
