NASA TN D-7619

EVALUATION OF TANTALUM-ALLOY-CLAD URANIUM MONONITRIDE FUEL SPECIMENS FROM 7500-HOUR, 1040° C PUMPED-LITHIUM-LOOP TEST

by Gordon K. Watson

Lewis Research Center
Cleveland, Ohio 44135

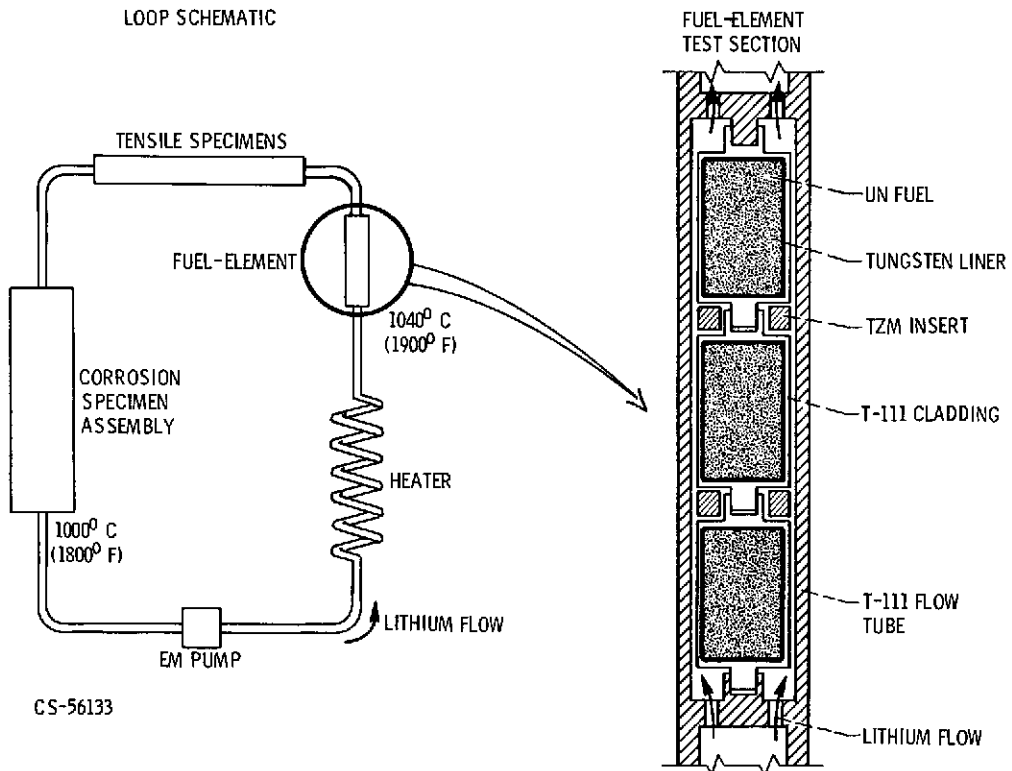
A schematic drawing of the lithium loop and a cross section of the fuel-element test section are shown in figure 1. Also included in the loop was a tensile-test-specimen assembly (containing advanced tantalum and tungsten alloys) and a corrosion-specimen assembly (containing T-111 and advanced tantalum alloys). The entire loop, with the exception of a columbium - 1-percent-zirconium surge tank (not shown in fig. 1) was fabricated from T-111. Lithium, at the rate of about 1.8 kilograms per minute (4.0 lb/min), was circulated through the loop by an electromagnetic (EM) pump. As the lithium passed through a resistance-heated coil of T-111 tubing, it was heated to 1040^O C (1900^O F). From there, the lithium flowed through the fuel-element test section at a flow velocity of 1.5 meters per second (5 ft/sec), through the heat-rejection part of the loop, where the lithium was cooled to about 1000^O C (1830^O F), and finally back to the pump. The loop was contained in a 61-centimeter- (24-in.-) diameter vacuum chamber that maintained a vacuum during loop operation of 1.3×10^{-6} newton per square meter (10^{-8} torr) or better.

The T-111 clad UN specimens were arranged in series in the fuel-element test section as shown in figure 1. Specimen position was maintained by two TZM spacers (molybdenum-0.5titanium-0.08zirconium-0.03carbon) and by the interlocking design of the specimens. The TZM spacers were included in the test to provide some information on the compatibility of TZM in a flowing lithium - T-111 system because some of the components in the proposed reactor were to be fabricated from TZM. Post-test evaluation of the TZM spacers is presented in reference 13. The lithium flow in this section of the loop was in the annulus between the fuel specimens and the containment tube, as can be seen in figure 1.

Figure 1. - Schematic drawing of 1040° C (1900° F) lithium loop and fuel-element test section.

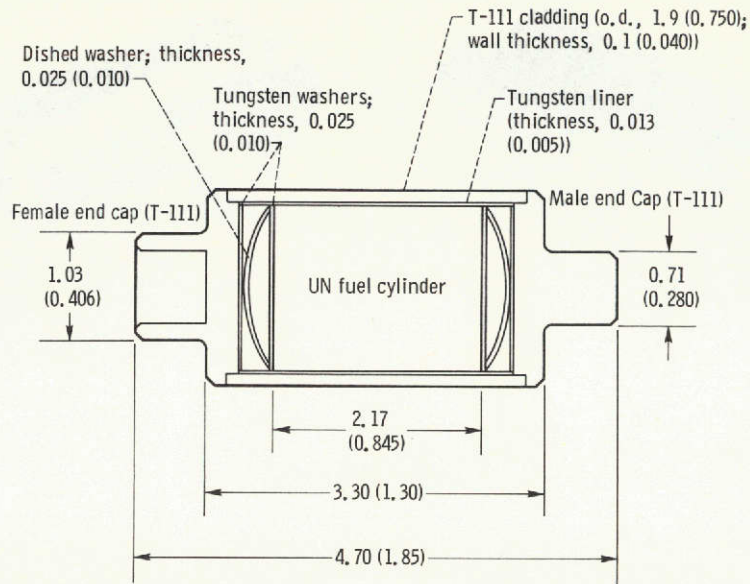
As shown in figure 2, the UN fuel cylinders were positioned axially by dished washers sandwiched between flat, 0.025-centimeter- (0.010-in.-) thick tungsten disks. The main purpose of the flat tungsten disks on each side of the dished washers was to prevent contact of the UN fuel with the T-111 end caps. The gap between the UN fuel and the end caps served to minimize heat input to the UN during welding of the male end cap to the cladding. The gap also minimized the effects of thermal expansion differences between the fuel and the cladding. Tungsten sheet (0.025 cm (0.010 in.) thick) was used for the dished washers in the first set of specimens. Some of these relatively brittle washers cracked during shipment of the specimens to the contractor for testing. Although it was felt that the cracked washers would not adversely affect the experiment, the dished washers for the second set of specimens were fabricated from T-111, a more ductile material, and no further cracking problems were encountered. The flat tungsten disks served an additional function in the second set of specimens by also preventing contact of the UN fuel and the dished T-111 washers. The components for a typical fuel-element specimen (LT-6), prior to assembly, are shown in figure 3.

Figure 2. – Design of fuel-element specimens used in 1040° C (1900° F) lithium-loop test. (Dimensions in centimeters (in.).)

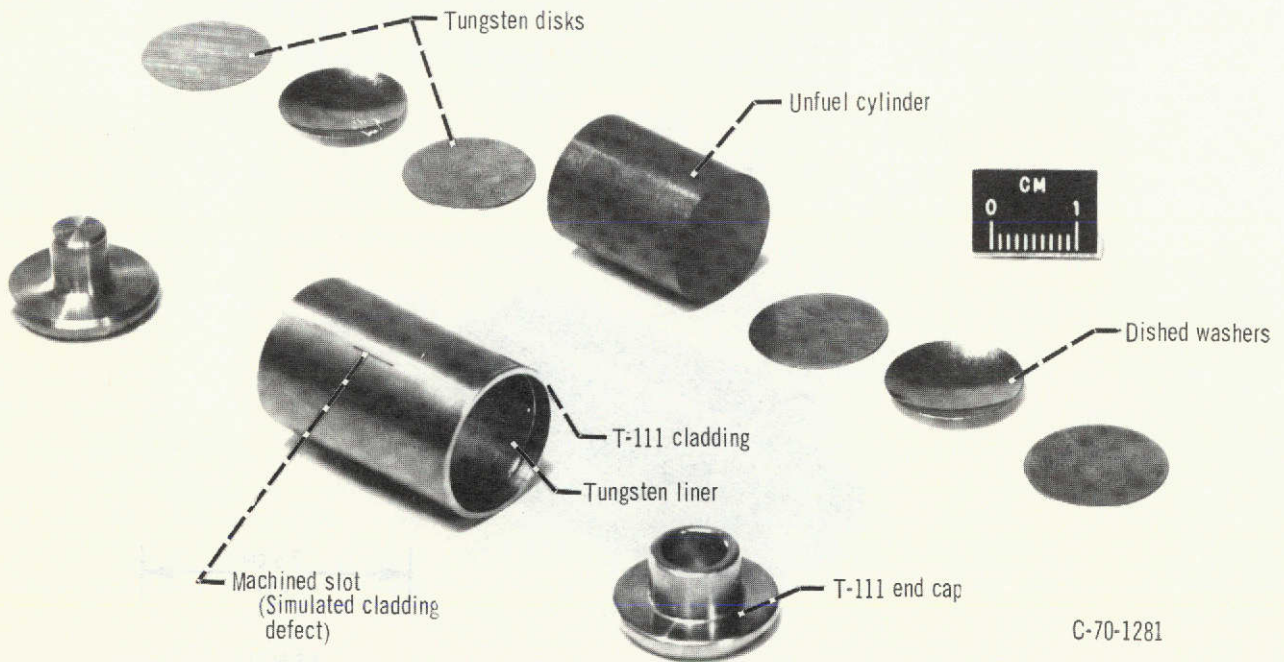
Figure 3. - Components for typical fuel-element specimen (LT-6) prior to assembly.

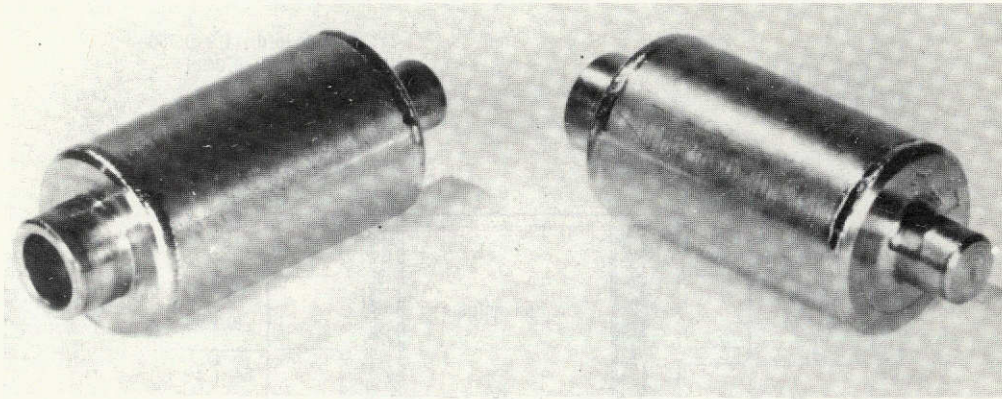
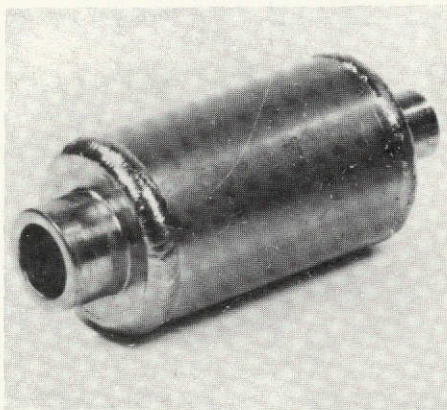
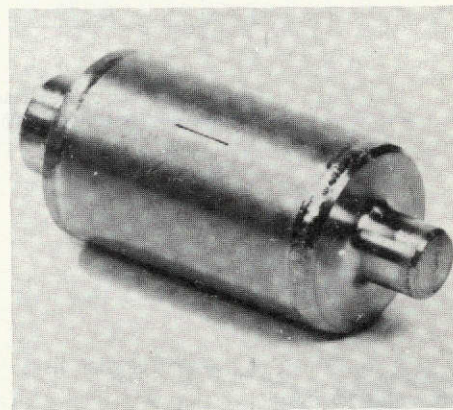
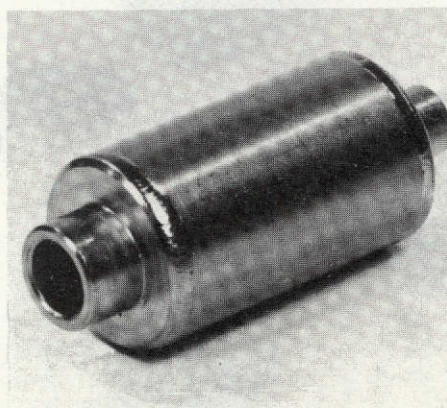
All five of the fuel-element specimens tested in the lithium loop appeared to be in excellent condition after removal from the loop, as can be seen in figure 4. The specimens were clean and bright and showed no evidence of any corrosion of the T-111 claddings. Excessive weld heat input during the fabrication of specimens LT-5 and LT-6 resulted in rather large weld beads, which were filed down to minimize possible flow restrictions in the fuel-element test section. Thus, these welds (see fig. 4(b)) look different from the welds on the other specimens. Except for the simulated cladding crack in specimen LT-6, no leaks or cracks could be found in the fuel-element specimens with a helium mass spectrometer leak detector. No dimensional changes as a result of the lithium exposure were observed.

Figure 4. - Fuel-element specimens after exposure in 1040° C. (1900° F) lithium loop.

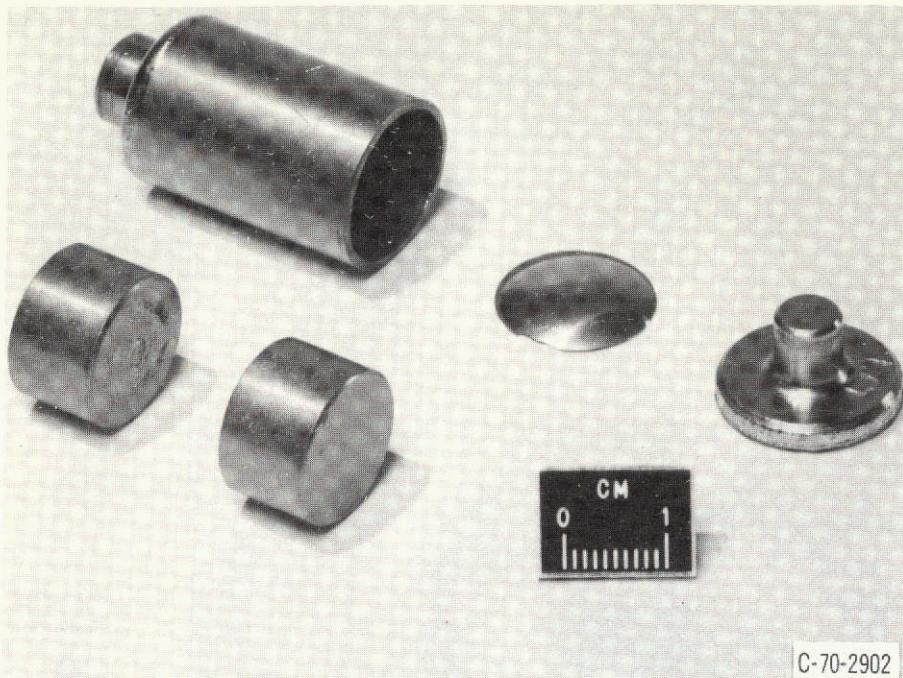
All the specimen components were clean and bright except for the UN fuel cylinder from LT-6, which showed some erosion and discoloration at the simulated cladding defect. Typical components from a specimen with no defect (LT-1) are shown after disassembly in figure 5. Only one dished tungsten washer is shown because the other washer was broken during shipment. Note that one of the tungsten disks is stuck to the dished washer. The other disks are not shown. The components from a specimen with a defect (LT-6) are shown in figure 6 after 5000 hours in flowing lithium. (Prior to assembly, one of the dished T-111 washers was dimpled to provide additional axial clearance for the UN fuel cylinder.) The marks on the outer surface of the T-111 cladding were caused by slippage in the vise during removal of the end cap. The discolored area on the UN cylinder coincided exactly with the intentional defect in the fuel-element cladding. A matching discolored area was observed on the inside surface of the tungsten liner also. The eroded area of the UN fuel cylinder from specimen LT-6 is shown in more detail in figure 7. Note how the discolored area fans out from the defect slot in the direction of the lithium flow. In this side-lighted photograph, the erosion depth is very apparent. The weight loss from the 61-gram UN cylinder, however, was only 0.0162 gram (about 0.03 percent of the total UN weight), which is quite low considering the large gap width and the long exposure time (5000 hr). The weight loss from the UN

Figure 5. - Fuel-element specimen LT-1 disassembled after 2500 hours in 1040° C (1900° F) lithium loop.

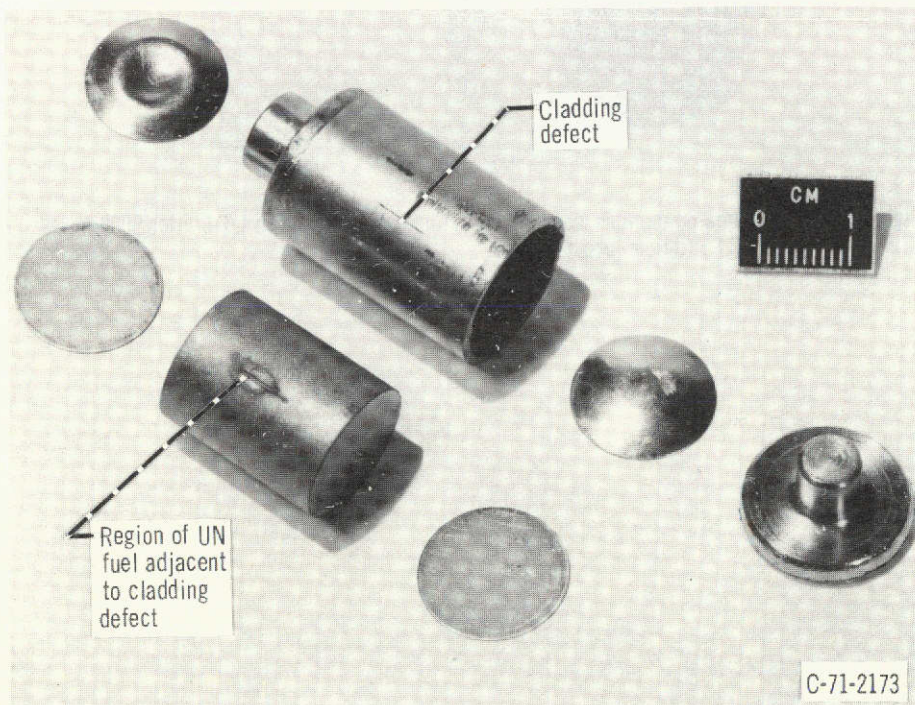
Figure 6. - Fuel-element specimen LT-6 disassembled after 5000 hours in 1040° C (1900° F) lithium loop. Note cladding defect and discolored area on uranium mononitride fuel cylinder.

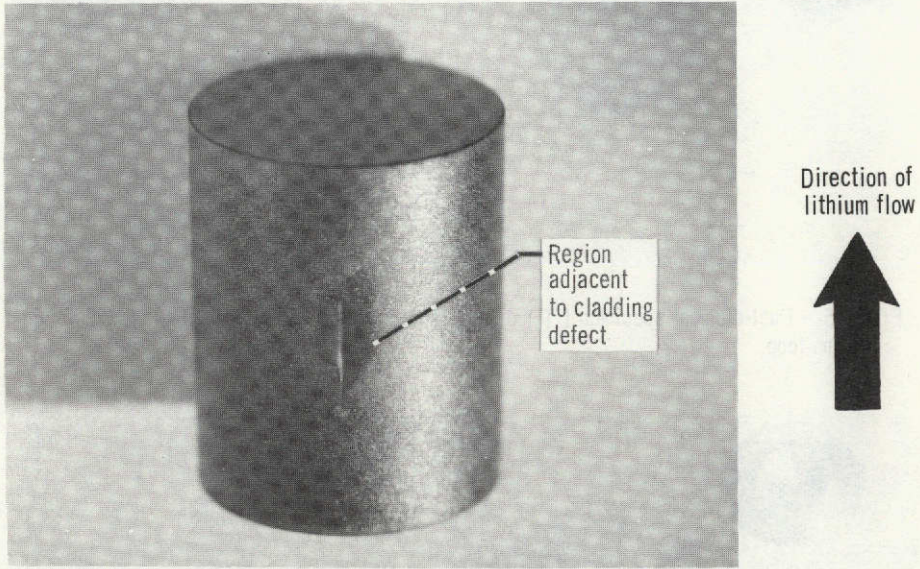
cylinder was somewhat larger than the weight loss from the entire fuel-element specimen (0.0133 g). This difference might have been the result of some reaction between the UN and the cladding in the defect area (see the section Metallography) or of some trace amounts of lithium remaining in the fuel-element specimen having a defect when it was weighed.

Figure 7. - Eroded area on uranium mononitride cylinder from specimen LT-6 after 5000 hours in 1040° C (1900° F) lithium loop.

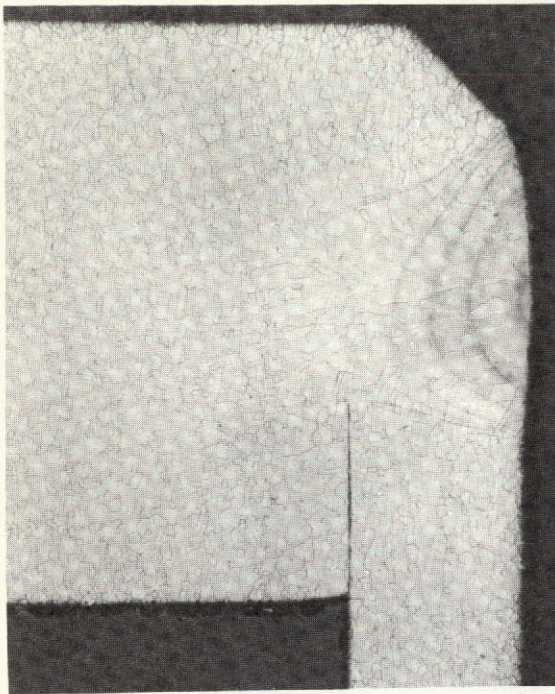
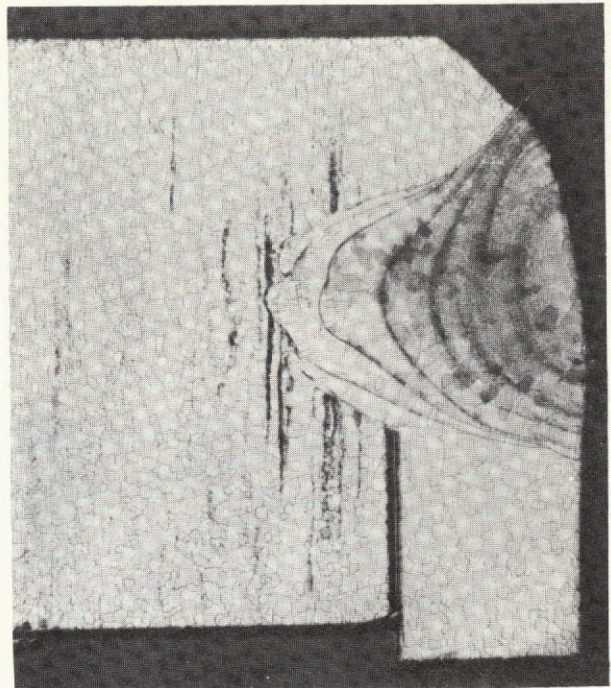
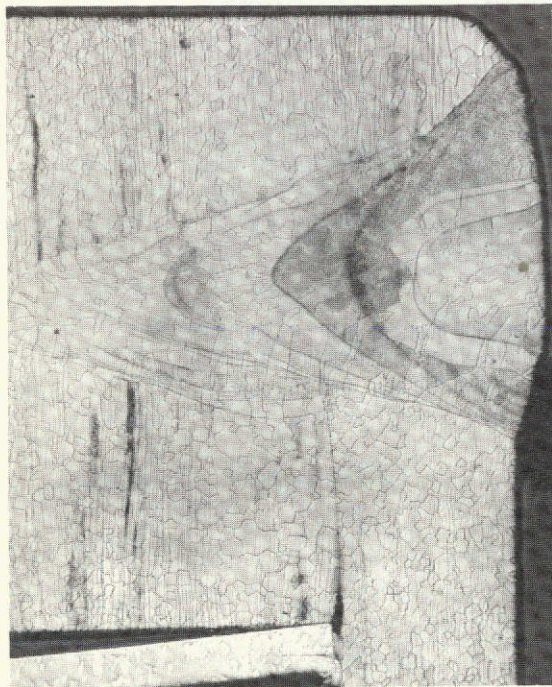
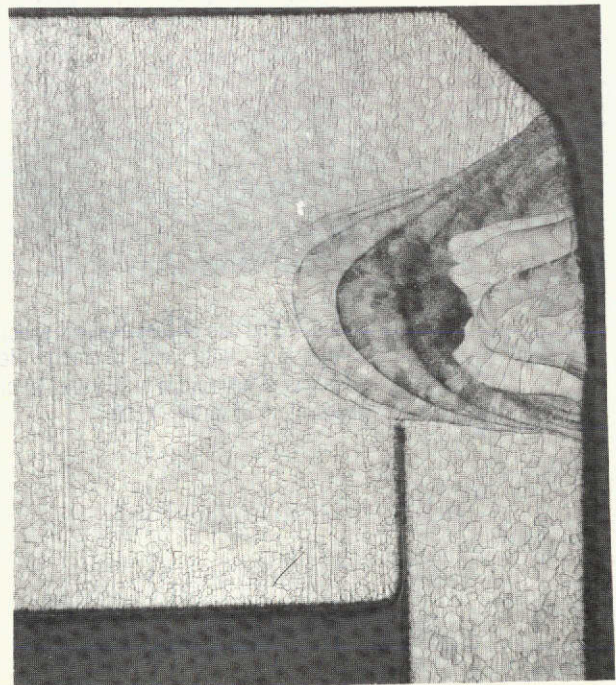
T-111 cladding. - Welds between the end cap and the cladding from specimens typical of each exposure condition are shown in figure 8. The difference in joint penetration during welding between the first set of specimens fabricated (LT-1 to LT-4) and the second set of specimens fabricated (LT-5 to LT-7) can be seen clearly in this figure. The weld heat input for the second set of specimens, typified by specimen LT-6 (fig. 8(c)), was much greater than that for the first set of specimens and resulted in a larger weld fusion zone and greater joint penetration. The larger welds, however, did not cause any problems during fabrication or during lithium exposure. Comparison of the microstructure of the untested specimen with the microstructures of the lithium-exposed specimens shows that the T-111 end caps and welds were in excellent condition and there was no evidence of any corrosion or chemical compatibility problems. The only noticeable change in microstructure was the formation of dark bands of precipitates in the T-111. There was no apparent trend for the amount of precipitates to increase with increasing exposure time. These precipitates have not been identified, but they are probably the result of localized areas of inhomogeneities in the T-111. At a higher magnification (see fig. 9), grain-boundary precipitates also can be seen in the T-111 microstructures of the tested specimens. It was shown in the work of reference 19 that precipitates of this type are commonly formed during long-term thermal aging of T-111 at about 1040° C (1900° F) regardless of aging environment (lithium or vacuum). Thus, it is reasonable to assume that the precipitates observed in this present study are also the result of thermal aging and not the result of the lithium exposure.

Figure 8. - End-cap weld area of T-111 fuel-element specimens in untested condition and after various exposures in 1040° C (1900° F) lithium loop. Etchant: 30 grams of ammonium bifluoride, 50 cubic centimeters of nitric acid, and 20 cubic centimeters of water. X25.

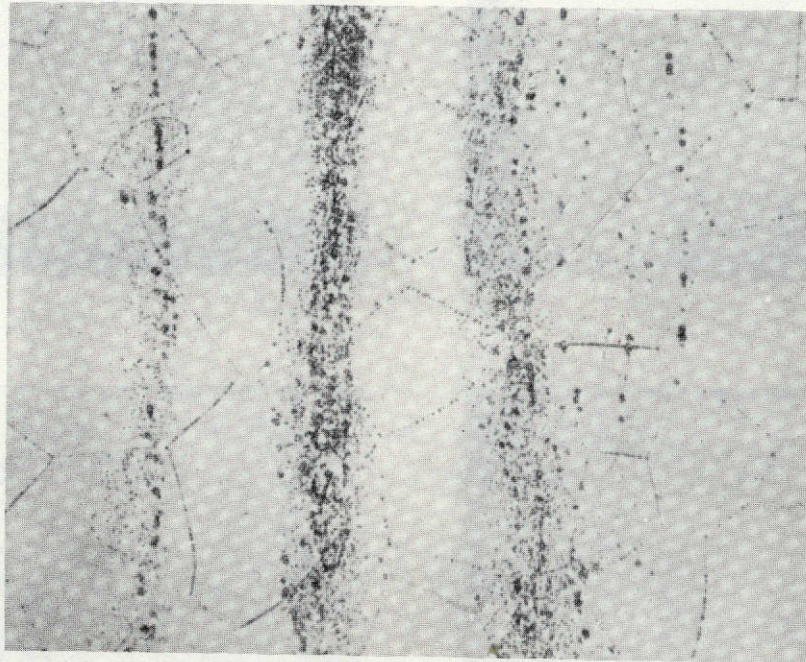
Figure 9. - End cap of fuel-element specimen LT-3 after 2500 hours in 1040° C (1900° F) lithium loop. Note bands of precipitates and precipitates in grain boundaries. Etchant: 30 grams of ammonium bifluoride, 50 cubic centimeters of nitric acid, and 20 cubic centimeters of water. X500.

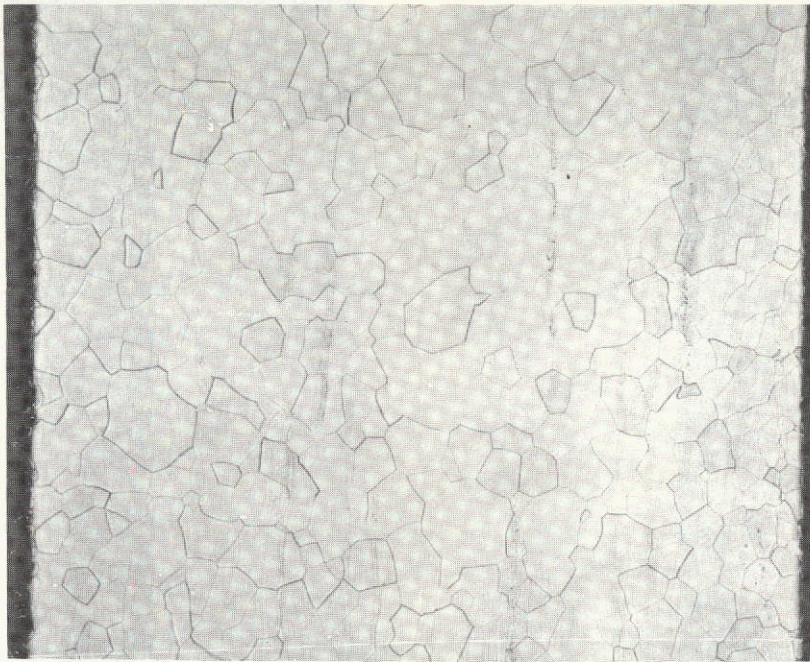
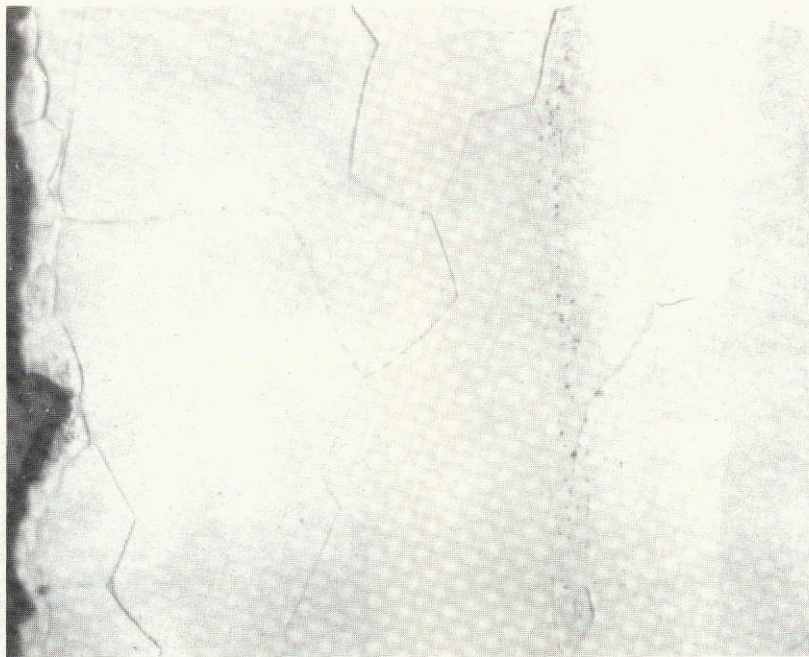
Examination of the T-111 claddings from all the lithium-exposed specimens showed no evidence of any lithium corrosion. No apparent contamination of the T-111 by the UN was observed except for the specimen having a defect (LT-6). The cladding microstructure from specimen LT-2 exposed for 7500 hours in the loop is shown in figure 10. As can be seen, the cladding is in excellent condition. A thin layer (about 1×10^{-3} cm (4×10^{-4} in.) thick) of a second phase, however, is visible at high magnification on the inside surface of the T-111 cladding (fig. 10(b)). This layer is thought to be a tungsten-rich layer formed as a result of diffusion from the tungsten liner. A diffusion layer of this type has essentially no effect on the strength or ductility of the T-111 cladding, as shown in reference 20.

Figure 10. - Longitudinal section of T-111 cladding from fuel-element specimen LT-2
after 7500 hours in 1040° C (1900° F) lithium loop. Note tungsten-rich layer on
inside surface of cladding. Etchant: 30 grams of ammonium bifluoride, 50 cubic
centimeters of nitric acid, and 20 cubic centimeters of water.

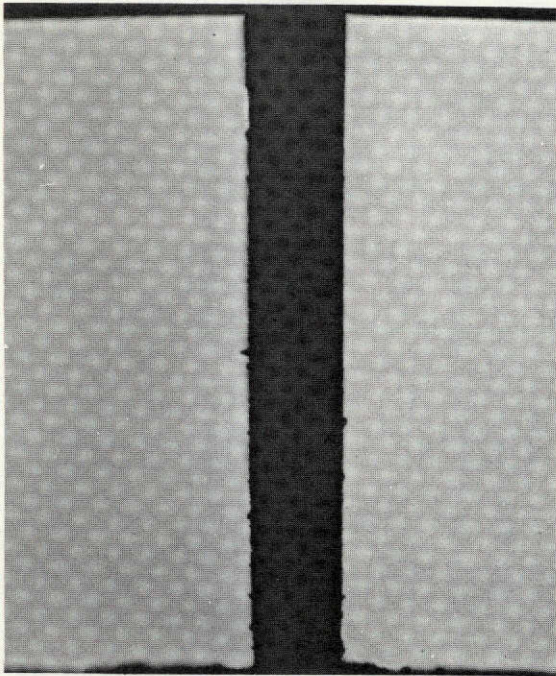
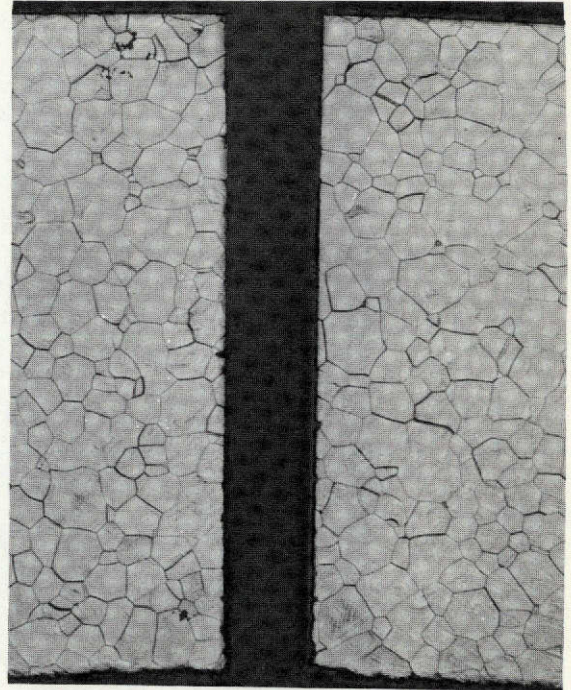
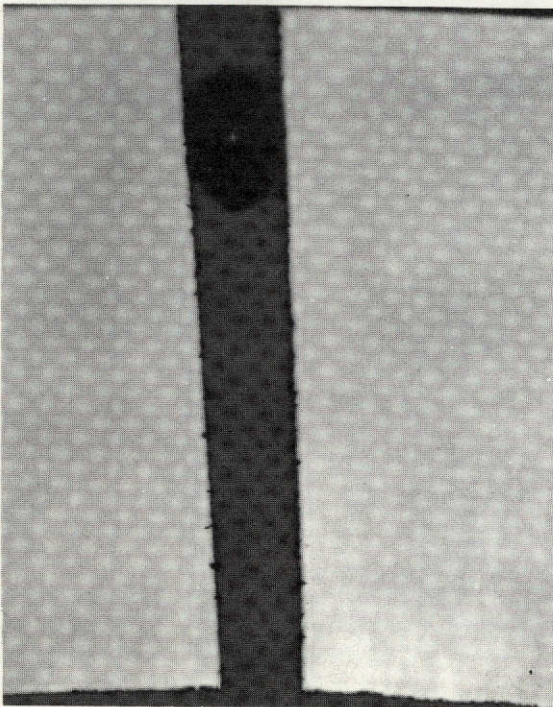
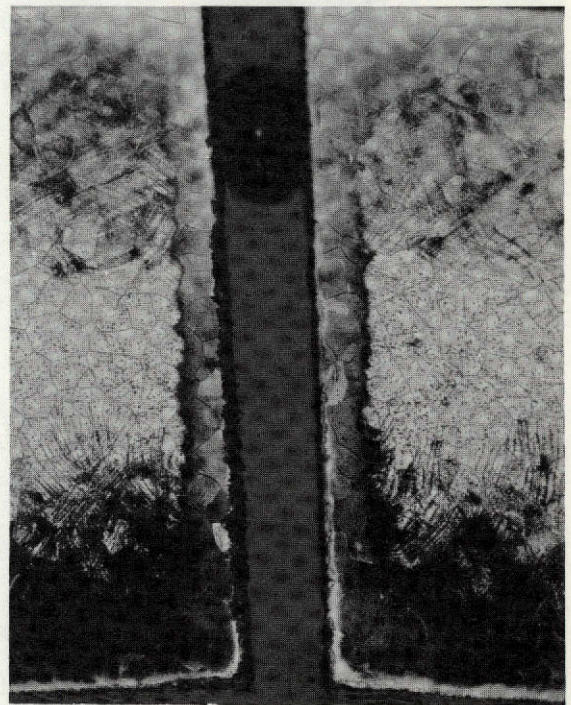
The T-111 microstructure around the defect slot in specimen LT-6 is shown in figure 11 along with the similar defect region in the untested control specimen LT-7. In the unetched condition (figs. 11(a) and (c)), both samples appear to be uncontaminated.

In the etched condition, however, a large number of precipitates can be seen in the lithium-exposed sample (fig. 11(d)), while no precipitates can be seen in the untested control sample (fig. 11(b)). Thus, the observed precipitates are considered to be the result of the UN fuel being directly exposed to the flowing lithium.

A small sample of the T-111 cladding surrounding the defect slot in specimen LT-6 was analyzed for nitrogen in an attempt to identify the precipitate around the defect. Whereas the average nitrogen content of the cladding was about 25 parts per million by weight, the nitrogen content of the defect area sample was about 400 parts per million by weight. Right at the defect the nitrogen content of the cladding was probably much higher, because the nitrogen content at the defect would be diluted by the uncontaminated T-111 around the reaction zone.

The nitrogen pickup by the T-111 at the defect region was probably the result of the erosion of the UN fuel cylinder by the flowing lithium. The exact mechanism for the nitrogen pickup in the T-111, however, is not known. One possible explanation is that small particles of UN eroded from the fuel cylinder contacted the T-111 and reacted. The resulting nitrogen could have diffused into the T-111, and the free uranium could have been carried away by the lithium flow. (The reactions between UN and T-111 in direct contact and the resulting contamination of the T-111 were demonstrated in capsule tests in the study of ref. 3.)

Figure 11. - Microstructures of defect region in T-111 cladding of fuel-element specimens LT-7, untested, and LT-6, exposed 5000 hours in 1040° C (1900° F) lithium loop. Etchant: 30 grams of ammonium bifluoride, 50 cubic centimeters of nitric acid, and 20 cubic centimeters of water. X100.

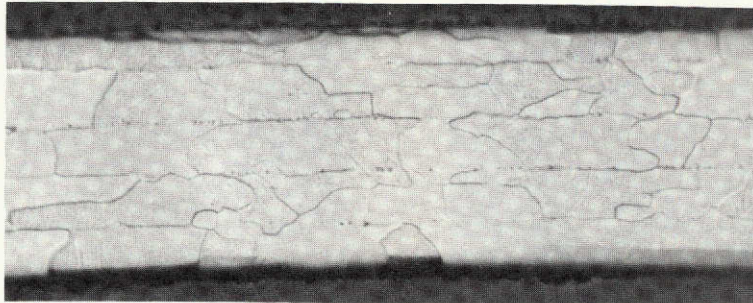
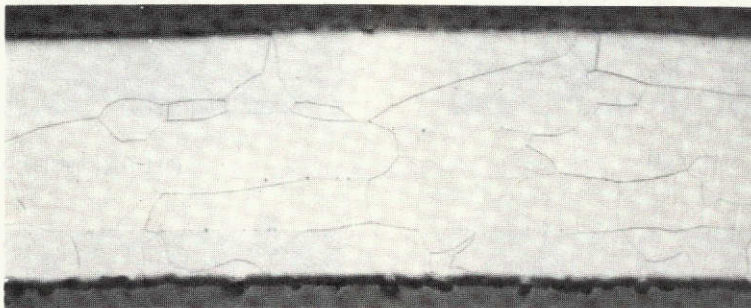
Tungsten liners. - None of the tungsten liners showed any evidence of any chemical compatibility problems with the UN fuel. As can be seen in figure 12, the only noticeable change in the microstructures of the tungsten liners as a result of the long thermal exposure was some grain growth and the elimination of the visible bond lines between the layers of tungsten foil.

Figure 12. - Comparison of cross section of tungsten liners in untested condi-
tion and after 7500 hours in 1040° C (1900° F) lithium loop. Etchant: 3
parts lactic acid, 2 parts nitric acid, and 1 part hydrofluoric acid. X250.

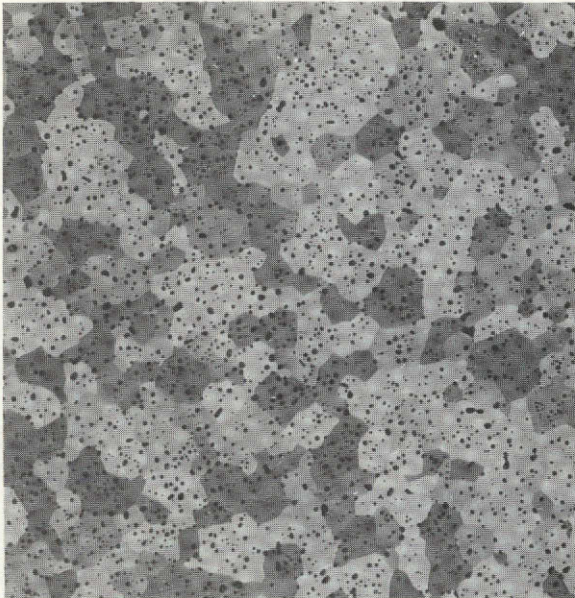
(a) LT-4; untested; X100.

Uranium mononitride fuel cylinders. - A comparison of the UN microstructures before and after testing showed no change in general appearance as a result of the exposure in the pumped-lithium loop. The UN used in the first set of specimens is shown in figure 13 in the untested condition and after 7500 hours in the loop. The UN from the second set of specimens is shown in figure 14 in the untested condition and after 5000 hours in the loop. As can be seen in both figures, long-time exposure in the loop at 1040° C (1900° F) had no apparent effect on the density, grain size, and pore structure of the UN fuel cylinders. The white spots that appear in the pores in two of the photomicrographs (i. e. , figs. 13(b) and 14(d)) are probably the result of reflected light from the bottom of the pores. The densities and microstructures of both lots of UN were quite similar except that the grain size (ASTM No. 6) of the UN used in the first set of specimens (fig. 13) was slightly larger than the grain size (ASTM No. 7) of the UN used in the second set of specimens (fig. 14). It was shown in the work of reference 14 that die-pressed UN would have to be sintered at a higher temperature than isostatically pressed UN in order to achieve similar densities. Thus, it is assumed that the die-

Figure 13. - Comparison of uranium mononitride fuel microstructures in untested condition and after 7500 hours in 1040° C (1900° F) lithium loop. Etchant: 60 cubic centimeters of acid, 24 cubic centimeters of nitric acid, and 2 cubic centimeters of hydrofluoric acid.

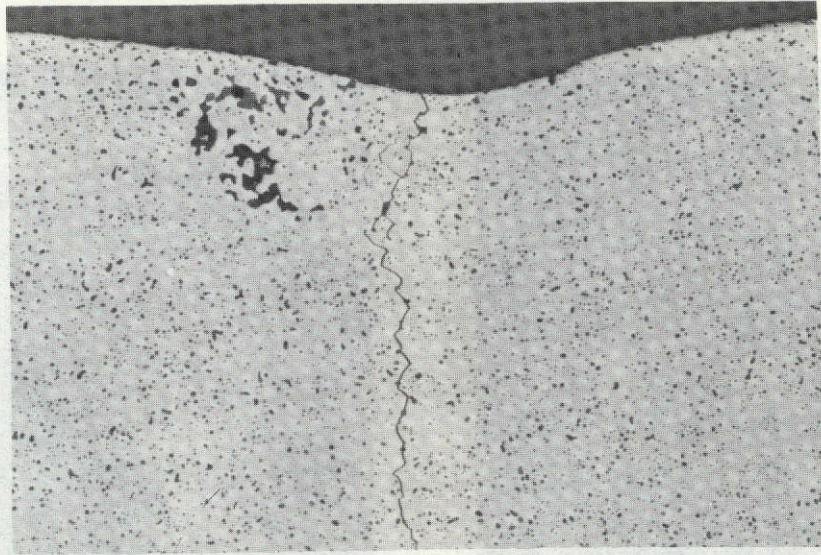
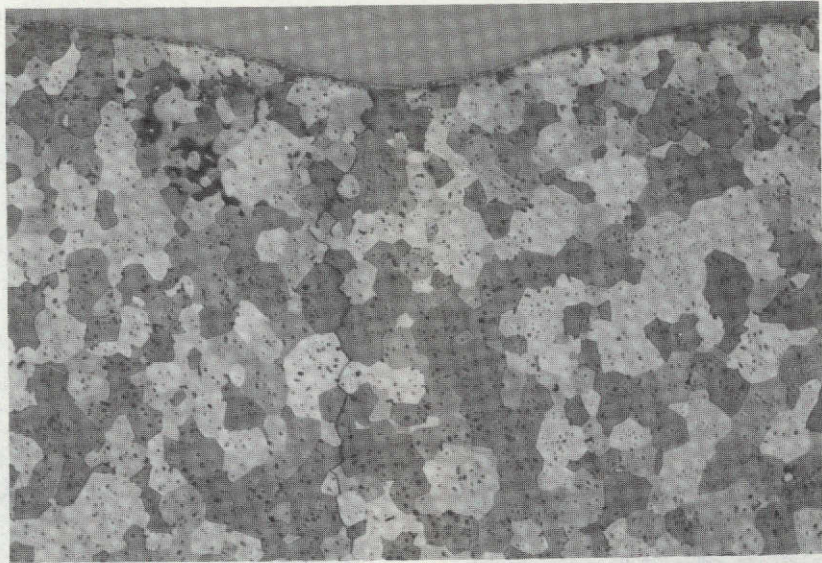
The UN fuel cylinder from specimen LT-6, with an intentional defect, was sectioned through the eroded area with a water-cooled silicon carbide abrasive saw. The cut section then was examined metallographically to determine what effect direct exposure to flowing lithium had on the UN. The cross section of the UN cylinder adjacent to the simulated cladding defect is shown in figure 15 in both the unetched and etched conditions. The erosion of UN by the lithium is very apparent in this figure. There is no evidence, however, of any chemical compatibility problem between the UN and the flowing lithium. It appears in figure 15 that the UN lost from the surface of the fuel cylinder was the result of simple erosion. It is possible that some surface reactions occurred between the UN and the lithium, but it is not apparent from the metallography. The crack in the UN fuel cylinder probably occurred during sectioning of the UN cylinder for examination and not during the lithium exposure. The low-density region to the left of the eroded area was probably present in the UN cylinder prior to testing. A similar low-density area can be seen in the upper left corner of the photomicrograph of the untested UN cylinder from the same lot of material (fig. 14(a)).

Figure 15. - Uranium mononitride fuel microstructures in immediate area of cladding defect in fuel-element specimen LT-6 after 5000 hours in 1040° C (1900° F) lithium loop. Etchant: 60 cubic centimeters of lactic acid, 24 cubic centimeters of nitric acid, and 2 cubic centimeters of hydrofluoric acid. X100.

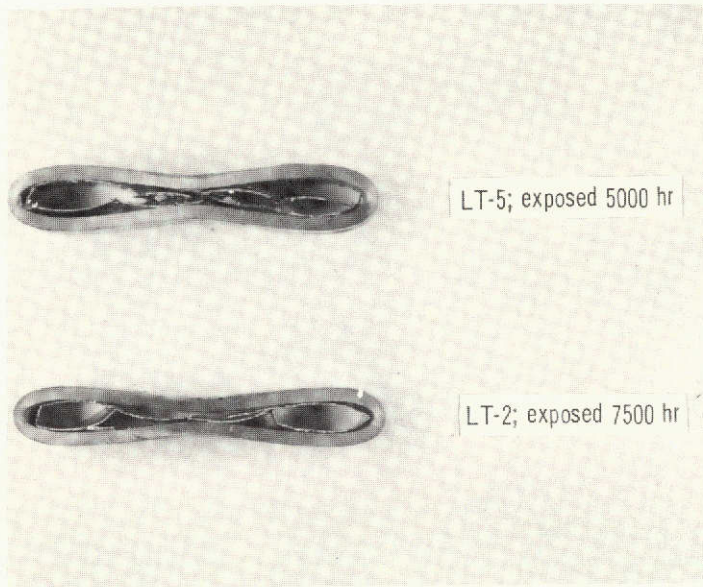
Figure 16. - Results of tube flattening tests conducted on T-111 claddings from fuel-element specimens LT-5 and LT-2. Test rings prepared and tested in argon atmosphere; both rings flattened completely without cracking.
