FINAL DESIGN REPORT

BRAYTON HEAT EXCHANGER UNIT DEVELOPMENT PROGRAM (ALTERNATE DESIGN)

AIRESEARCH MANUFACTURING COMPANY
Los Angeles, California

August 2, 1973

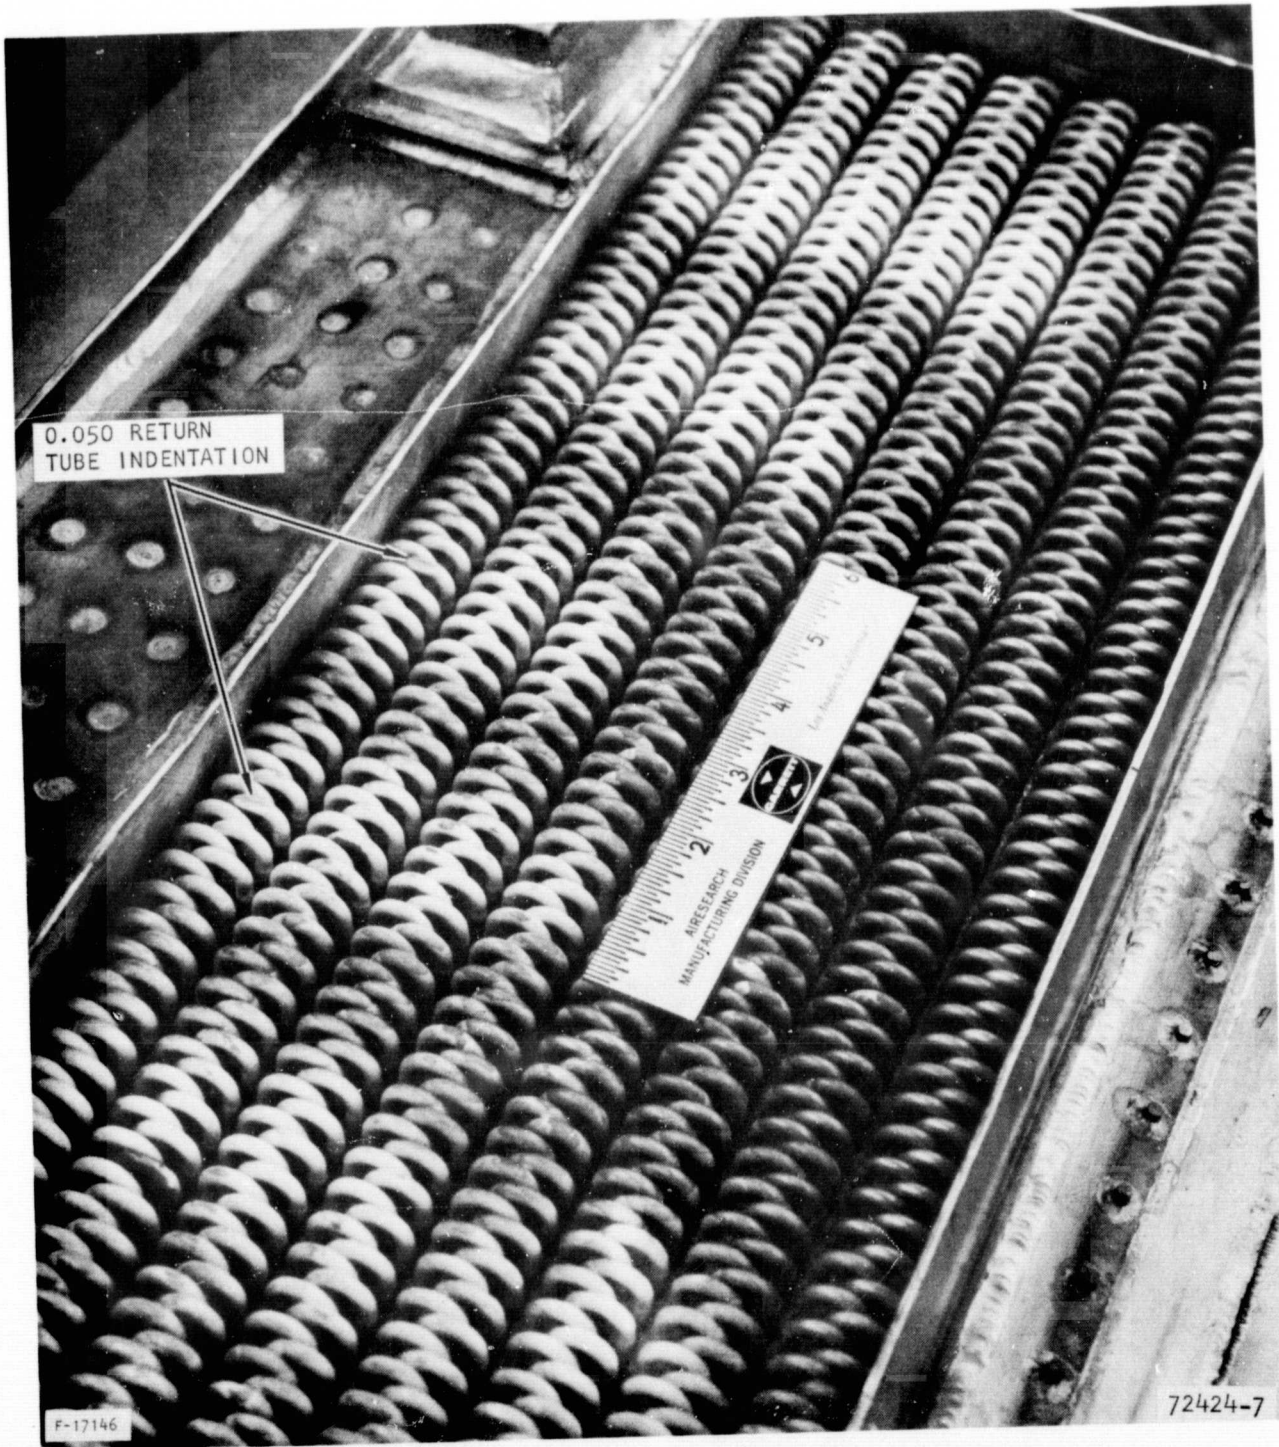
The tube-to-header brazing joint leaks in the heat sink heat exchanger occurred due to welding the transition section to the heat sink heat exchanger. In addition to the heat effect during the attachment of the transition section to the heat sink heat exchanger, it was found that gussets located inside the manufacturing leak test pans had been bearing on the downstream (gas) liquid circuit manifold and some return bends. The gussets caused one 0.050-in. indentation (Figures 4-16 and 4-17) in the downstream (gas) liquid manifold and 0.015- to 0.005-in. indentations at seven other locations in both

Figure 4-16. Indentations in the Liquid Circuit Manifolds

of the liquid circuit manifolds. The leak test pan gussets on the side opposite the liquid circuit manifolds caused a 0.050-in. indentation in two return bends and 0.015- to 0.005-in. indentations in eight other return bends.

An ASTM 1.5S solder repair cycle on the heat exchanger assembly was used to repair the tube-to-header brazing joint leaks. The procedure for repair was basically the same as for the repair of the one tube-to-header brazing joint leak found previously on the heat sink heat exchanger assembly. The welded heat exchanger assembly was brazed in an inclined position because of space restraints inside the atmosphere furnace. The ASTM 1.5S (600°F) solder was placed adjacent to the ends of the finned tubes in a horseshoe type shape.

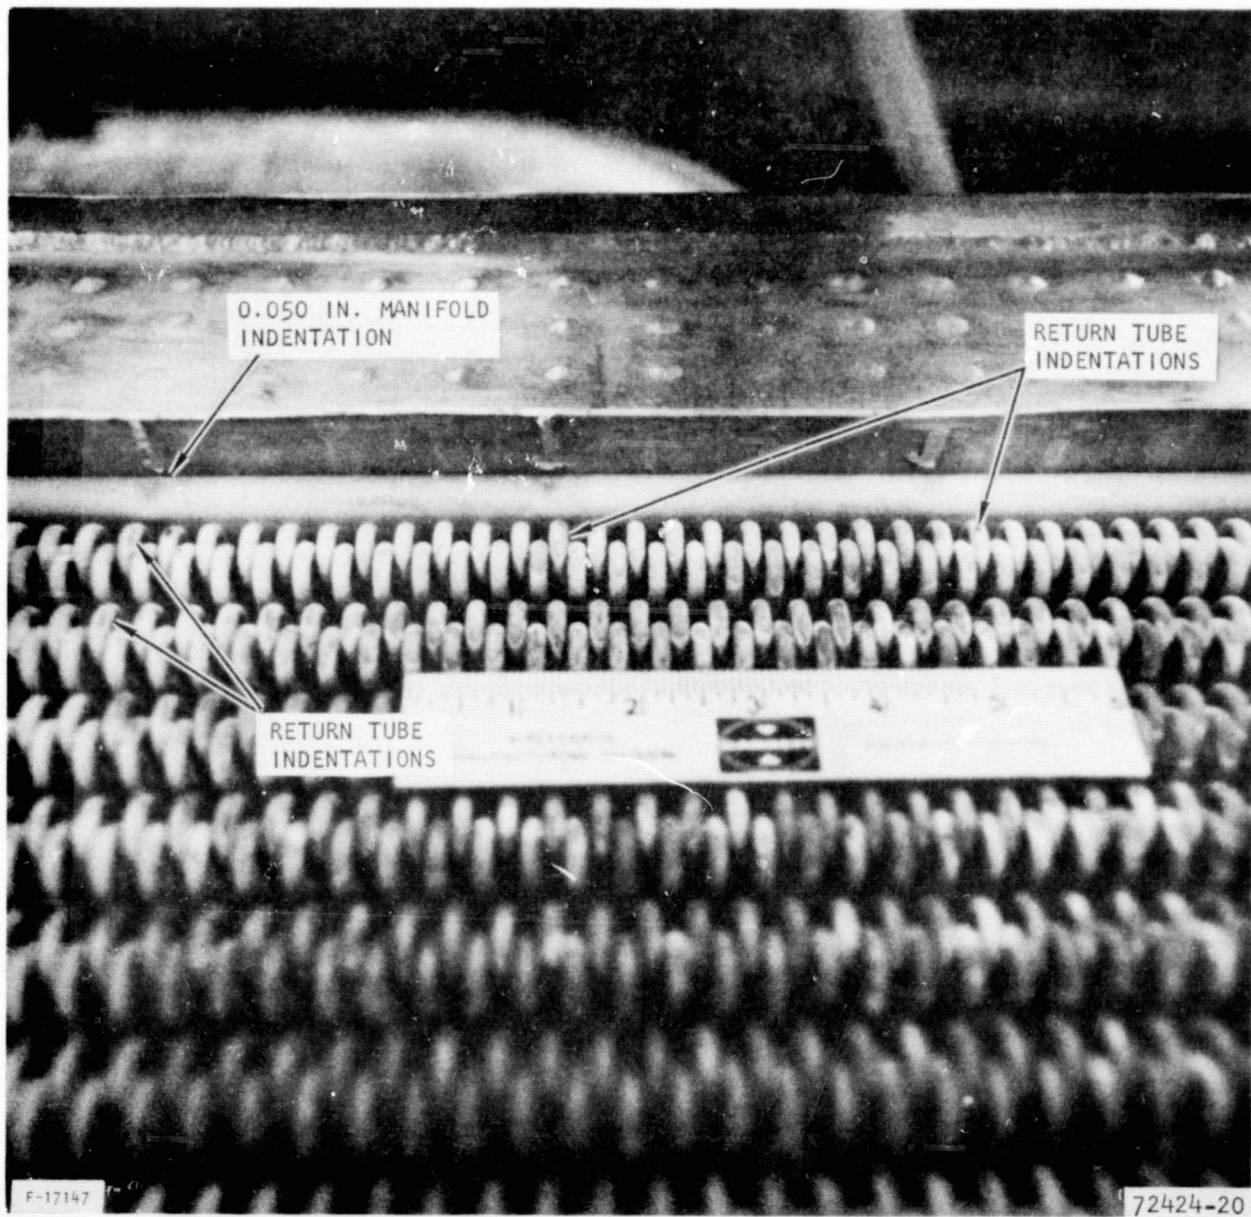
Figure 4-17. Closeup of Indented Return Bends
on the Heat Sink Heat Exchanger

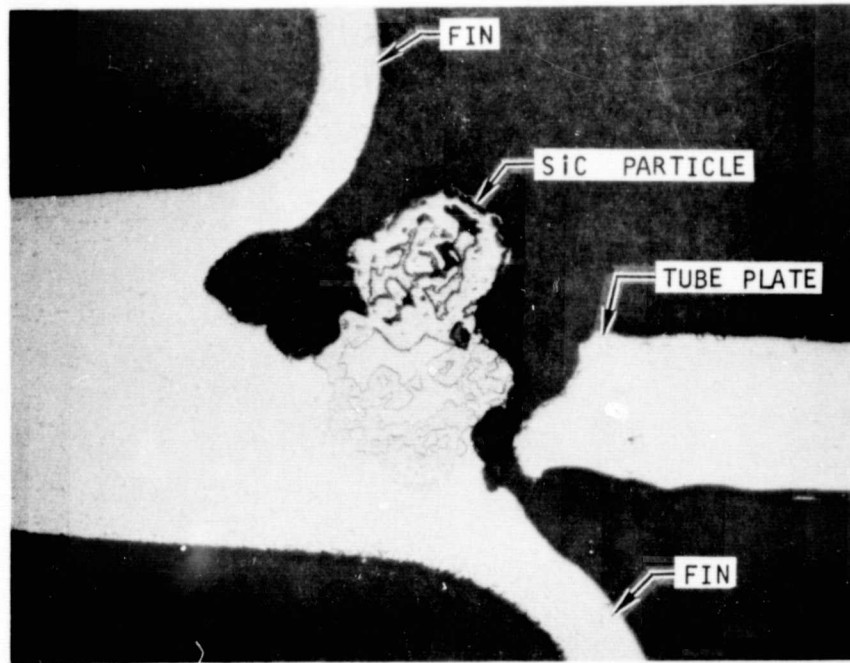
a. Location: 9th High Pressure Passage

The core module was sectioned to determine the cause of the leakage. Figure B-1 illustrates a typical leak area just inside the offset fin in the high-pressure passage of the core. This type of leak was typical at both the inlet and outlet ends. Photomicrographs of the tube plate erosion are seen in Figure B-2. The photomicrographs show the silicon carbide (SiC) particle alloyed with the tube plate and the brazing alloy. An interpass leak area is visible adjacent to the SiC particle. Further testing with Hastelloy X coupons brazed with Palniro 1 and Palniro RE confirmed alloying of the gold and the silicon, which formed a chemically modified Palniro 1 brazing alloy that was aggressive and eroded the Hastelloy X tube sheet. Photomicrographs showed that the microstructure of the test coupons was the same as the sample taken from the core module. This also was substantiated by an electron microprobe analysis. This interaction between the gold braze alloy, Hastelloy X, and SiC was unobserved until the metallurgical analysis revealed the cause of the interpass leakage.

The presence of silicon and carbon elements adjacent to the particle indicated that the foreign body was a piece of silicon carbide. This silicon carbide had reacted with the gold base brazing alloy to form a gold-silicon

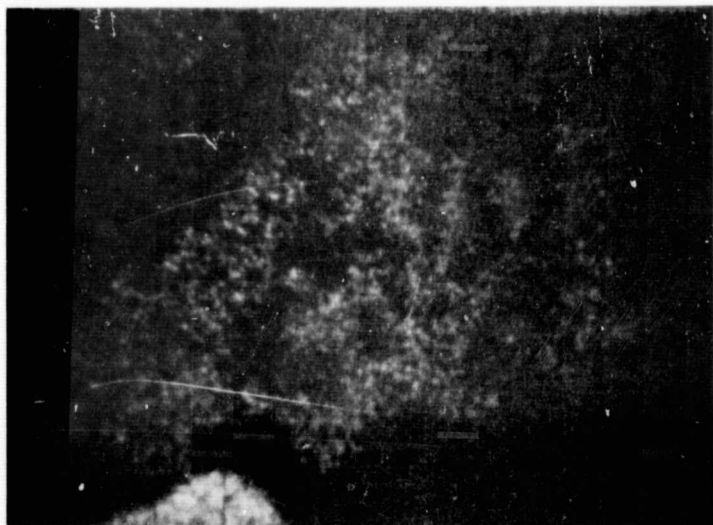
Figure B-3.   X400

The samples submitted for microprobe analysis identified the elements present in the neighborhood of the particle. Spot scans illustrated that the major constituents were gold, palladium, nickel, iron, chromium, molybdenum, (originating from the Palniro 1 brazing alloy or the Hastelloy X material), silicon, and carbon. Radiographic images were made that showed the metallurgical phases present were a primary gold constituent in a gold-silicon eutectic (see Figures B-3, B-4, and B-5).

Photomicrograph Showing
Area Examined by Micro-
probe Analysis

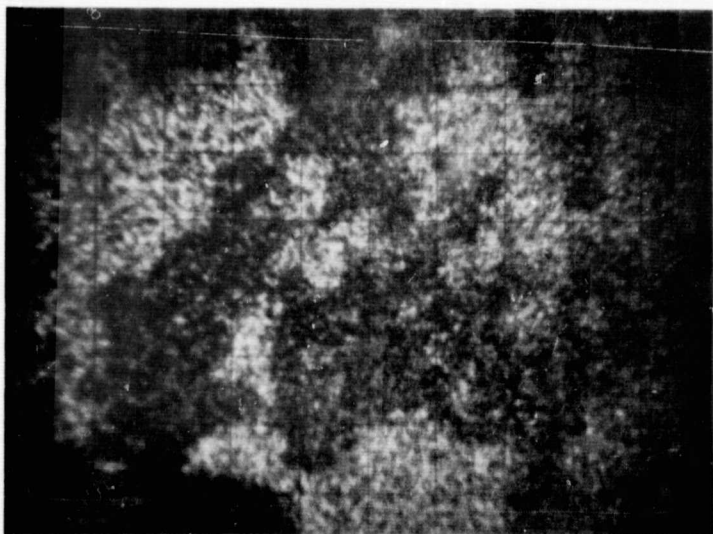
X400
Figure B-4.

X-Ray Image Showing Loca-
tion of Silicon (White
Spots)

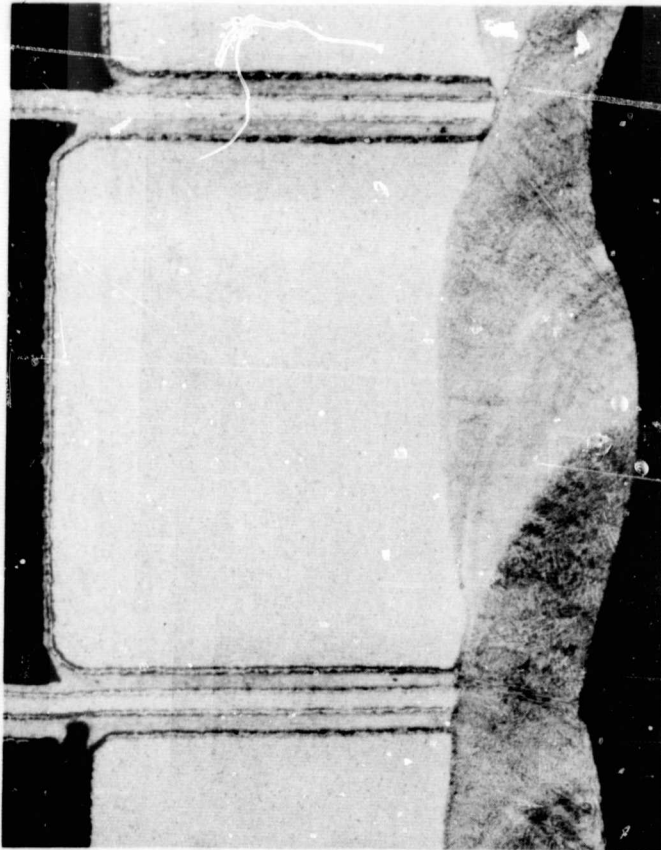
(b) SEAL PLATE TO HEADER BAR BRAZE JOINT SHOWING

UNBRAZED AREA AT A RECESSED HEADER BAR
