## Nuclear Materials and Energy

# High heat flux testing of first wall mock-ups with and without neutron irradiation

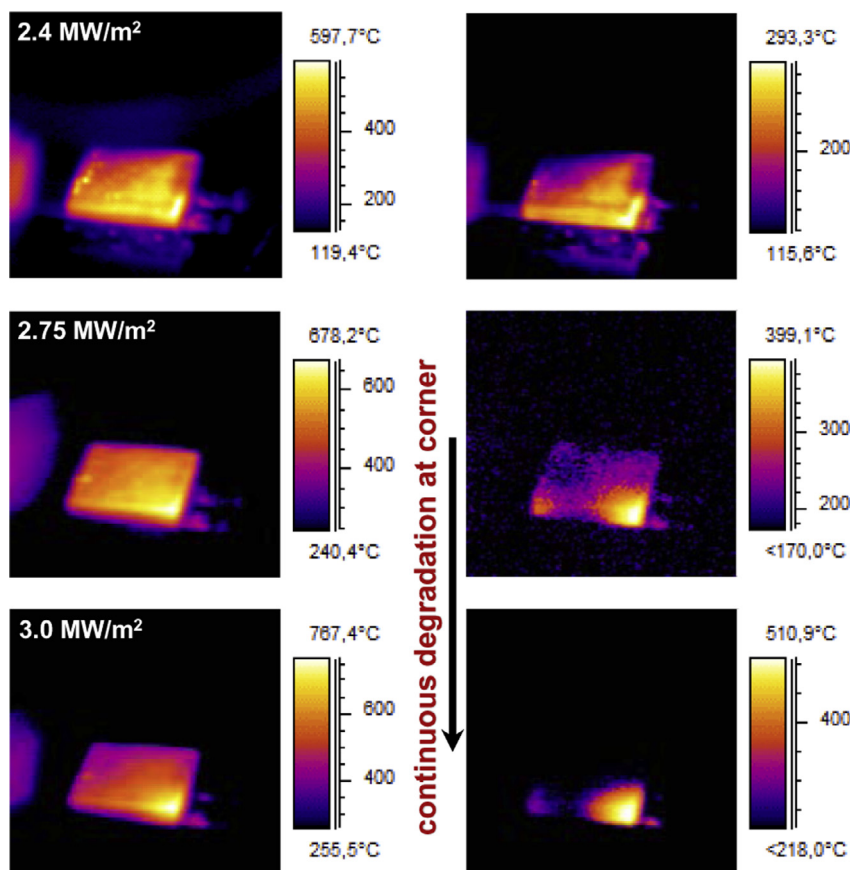
During HHF-testing of the non-irradiated European mock-up, both tiles, although loaded individually, started overheating at one outer corner of the loaded area (Fig. 3) during cycling at 2.75 MW/m$^2$. However, even up to 200 cycles at 3 MW/m$^2$ the tiles

**Fig. 3.** IR-images of the non-irradiated European mock-up, tile A, at the end of the screening at the particular power density after cycling (left) and after 5 s cool down (right).

are still attached and the tests were stopped due to exceeding the allowed surface temperature in JUDITH-1 in the overheated area (Table 3).

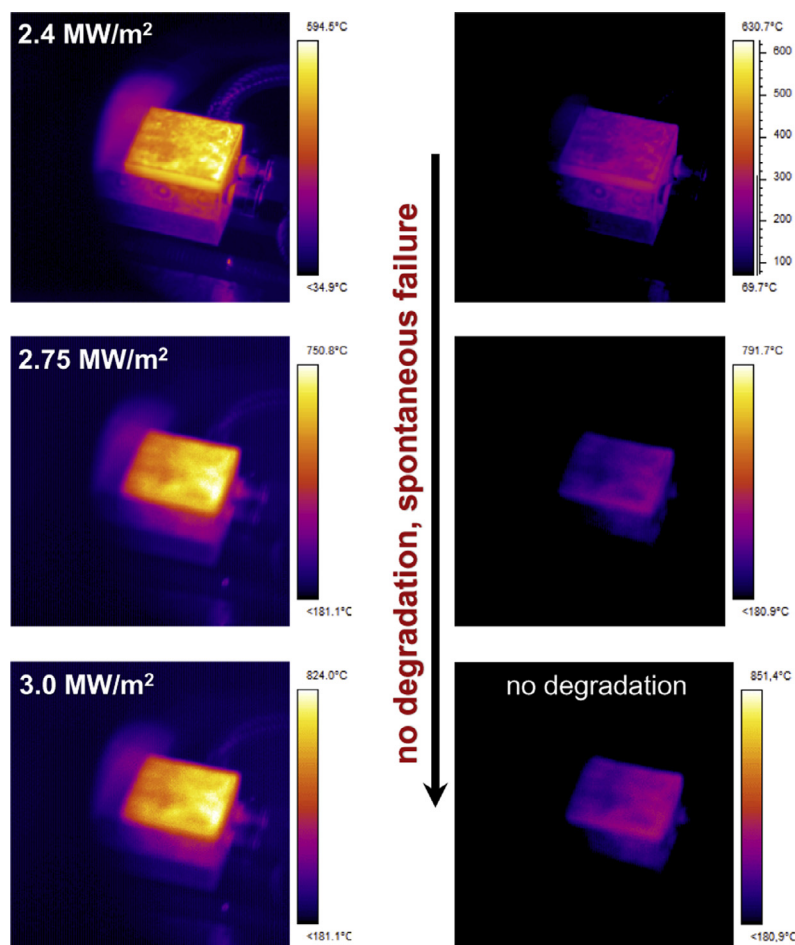
In contrast, the irradiated European mock-up failed abruptly at the edge between the two Be tiles. For tile A this occurred after 11 cycles at 3.0 MW/m$^2$ without showing any sign of degradation before failure (Fig. 4). For tile B a malfunction of the facility's deflection system occurring during cycling at 1.8 MW/m$^2$ caused local melting of the surface. Based thereon, the tests on tile B were stopped after screening at 2.75 MW/m$^2$ due to exceeding the facility's temperature threshold at the affected molten area (Table 3). However, despite this local overheating, the cool down performance of tile B did not show any degradation of the heat removal capability up to this loading step.

**Fig. 4.** IR-images of the irradiated European mock-up, tile A, at the end of the screening at the particular power density after cycling (left) and after 5 s cool down (right).

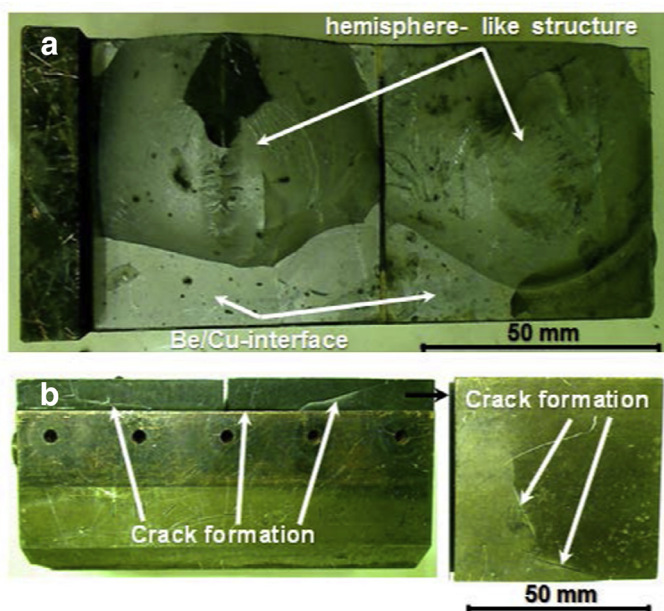
Similar to the irradiated European mock-up, the Russian mock-up failed abruptly on both tiles (Table 3). Thereby, the sustained loading conditions are a maximum of 25 cycles at 2.4 MW/m$^2$. In both cases a full detachment of the Be-tile occurred. Thereby,

the crack first runs along the Be/Cu interface while it then proceeds into the Be-tile creating a hemisphere like structure (Fig. 5a). Although the irradiated European mock-up did not detach completely, in a side view (Fig. 5b) similarly partial detachment at the Be/Cu interface and crack formation into Be was found for both tiles. A possible reason for the change in failure mode after neutron irradiation is the neutron induced embrittlement and reduced ductility of beryllium [3,10].

**Fig. 5.** Macroscopic image of the loaded irradiated mock-ups; (a) Russian mock-up with detached tiles; (b) European mock-up showing crack formation at the Be/Cu interface and in Be.

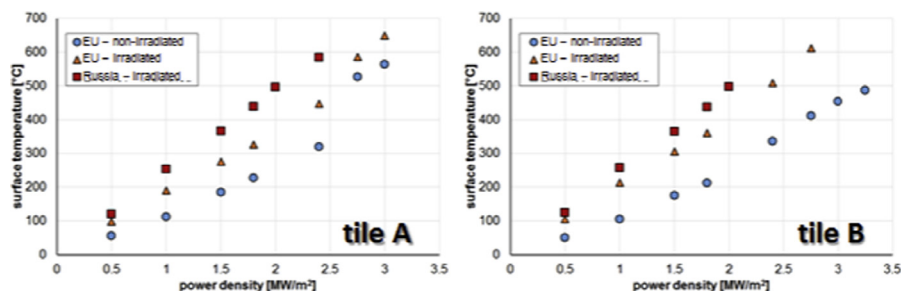
The comparison of the reference and irradiated European mock-up shows that the measured surface temperatures after neutron irradiation are significantly higher (Fig. 6). Thereby, it needs to be noted that due to the lack of a calibration tile and no measured temperature by the two color pyrometer (range: 550–1600 °C) the surface emissivity was set for the Russian mock-up and the non-irradiated European mock-up, based on former experience, to an emissivity of 0.3. A change of the emissivity for the non-irradiated European mock-up between cycling of tile A at 2.4 MW/m$^2$ and 2.75 MW/m$^2$, attributed to slight air ingress during testing and a

machine shut down for a longer period leading to the formation of a surface oxidation layer, has been identified as the most probable reason for the measured temperature increase shown in Fig. 6. For the irradiated European mock-up a calibration via two-color pyrometer was possible resulting in an emissivity of 0.39. On the one hand the higher temperatures after irradiation might be attributed to the degradation of the thermo-physical properties of the materials, which experimentally only occurs for low irradiation temperature and high dose [3] and therefore would correspond to the applied irradiation conditions at 60 °C. On the other hand, due to the applied in-pile cyclic loading at $0.5 \, MW/m^2$ also a degradation at the joined interfaces could have occurred. Neither thermo-physical nor metallographic analyses could be performed to verify one or both hypotheses. The discrepancy in surface temperature between the irradiated European and Russian mock-up is to a large extent a result of the increased thickness of the Be-tile by 1 mm in combination with the used different surface emissivity values. The use of different Be-grades for the European and Russian mock-ups might also play a minor role. However, based on the limited number of tests and the failure mode shown in Fig. 5, from the results a superiority of one or the other joining technology cannot be deduced. Occurring differences in power handling capability might be attributed to the thickness and the material properties of the used Be-grades.

**Fig. 6.** Temperature evolution for all three investigated mock-ups during screening at the particular power density for tile A and B.
