NASA TECHNICAL MEMORANDUM

NASA TM X-1924

FLIGHT TEST OF A 40-FOOT-NOMINAL-DIAMETER DISK-GAP-BAND PARACHUTE DEPLOYED AT A MACH NUMBER OF 3.31 AND A DYNAMIC PRESSURE OF 10.6 POUNDS PER SQUARE FOOT

by Clinton V. Eckstrom

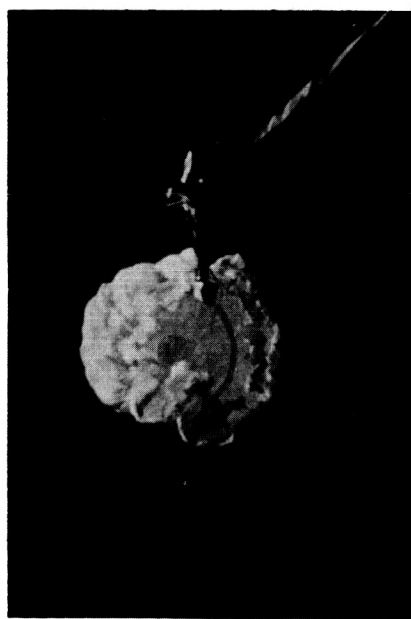
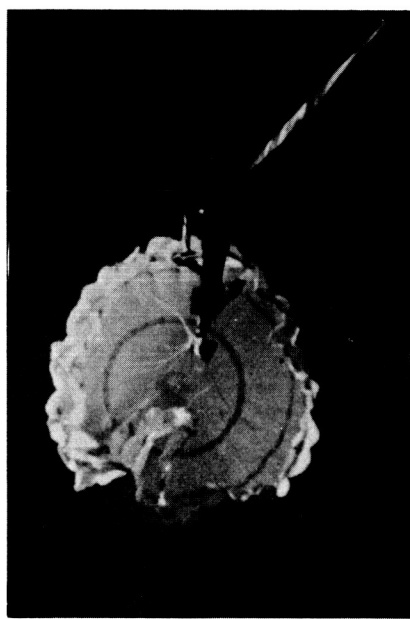
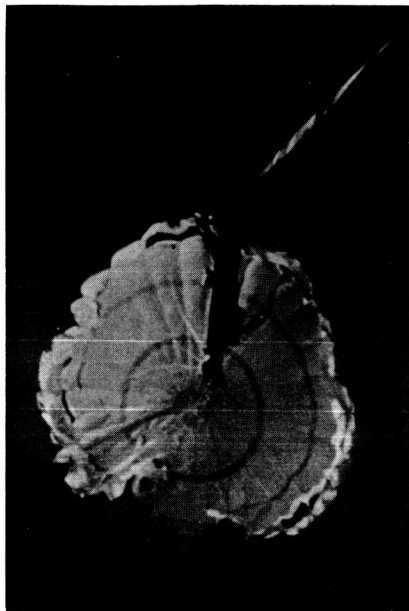
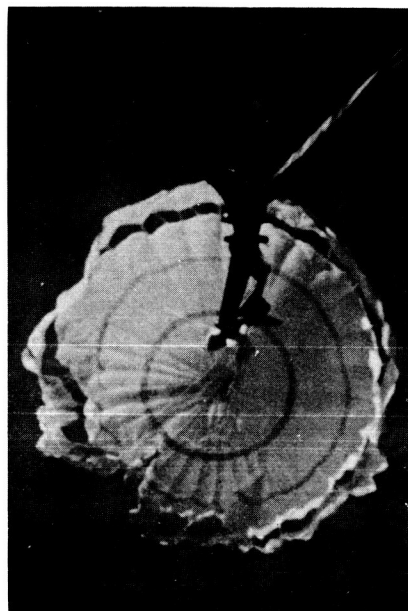
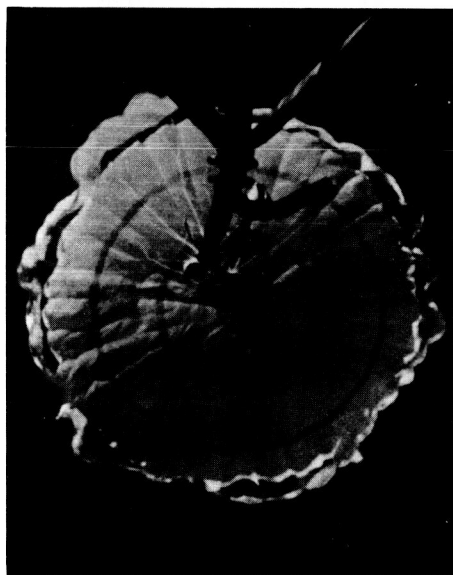
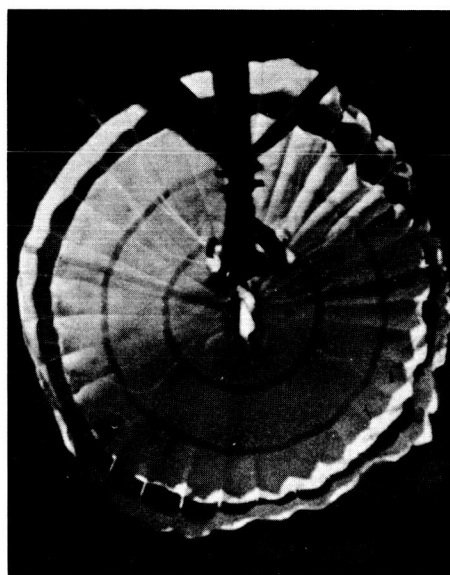
(a) Initial canopy inflation sequence.

Canopy inflation.- The first inflation of the canopy occurred in a normal manner, and the projected area increased smoothly from the time of line stretch to first full opening at $t' = 1.03$ seconds as shown in figure 17. Selected frames from the aft camera film taken during the initial inflation process are shown in figure 18(a).

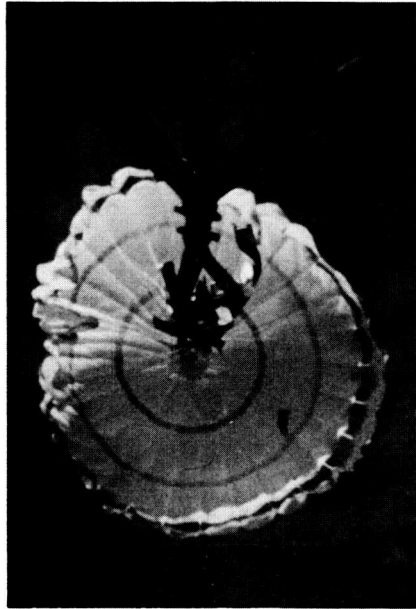
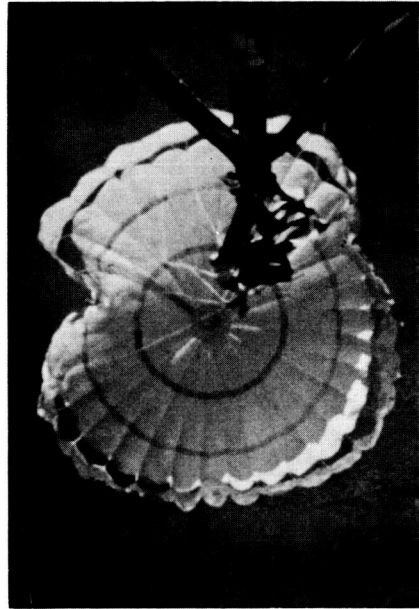
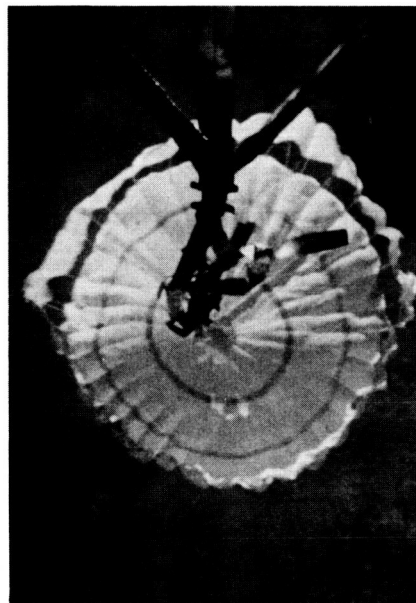
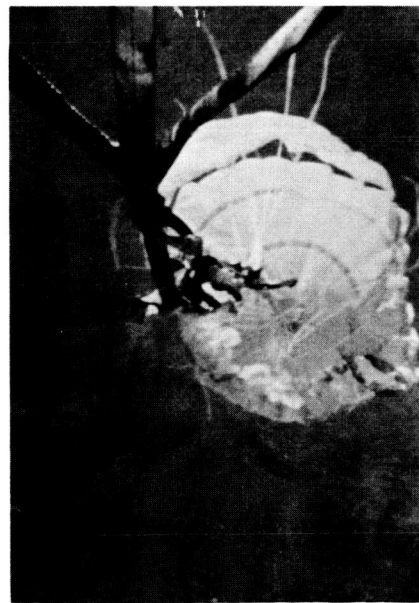
(b) Canopy collapse sequence.

Immediately after the first inflation, the canopy partially collapsed as evidenced by figures 17, 18(b), and 18(c). During the sequence shown in figure 18(c), the load transmitted to the tensiometer varied considerably as indicated in the caption of each photo. The canopy load variation sequence is presented to show that the canopy projected area does not vary significantly at this time even though the tensiometer force oscillates between maximum and near-zero values. The parachute operated in the partially open condition as shown by figures 18(b) and 18(c) for just over 1 second (from $t' = 1.03$ to $t' = 2.10$ seconds) before a tear in the canopy can be seen in the frame corresponding to $t' = 2.10$ seconds as shown in figure 18(d). Additional tears in the canopy were observed on the film to have occurred at $t' = 3.28$ and $t' = 4.29$ seconds as also shown in figure 18(d). The parachute canopy did not again attain full inflation during the 60 seconds of film coverage. The partial canopy collapse after the first full inflation was expected based on results of previous flight tests for disk-gap-band parachutes. (See refs. 3, 4, and 9.) It was anticipated, however, that use of the energy absorber in the riser system would limit the opening load and the effects of suspension-line elasticity and, as a result, possibly reduce the severity of the canopy collapse and subsequent shape variations. The opening load was limited and for the 1 second of useful data available for comparison, it

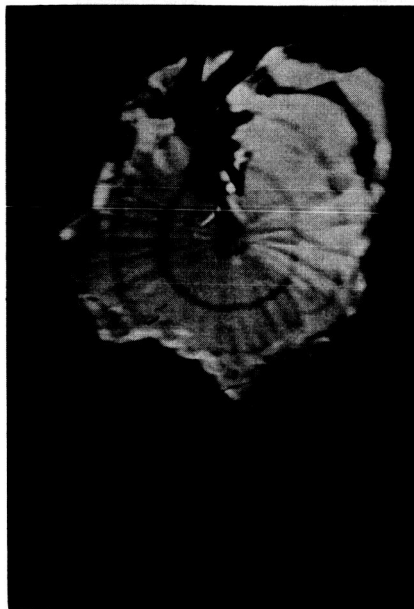
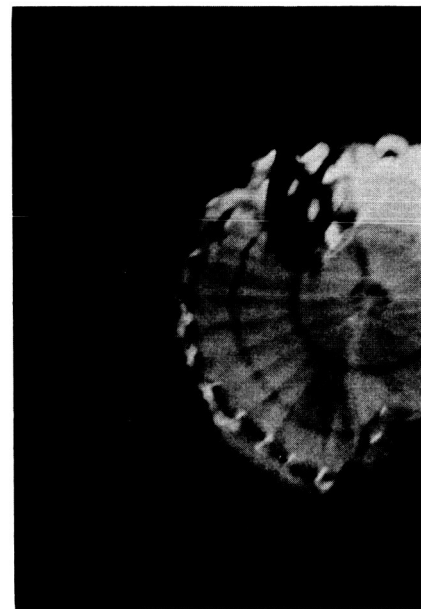
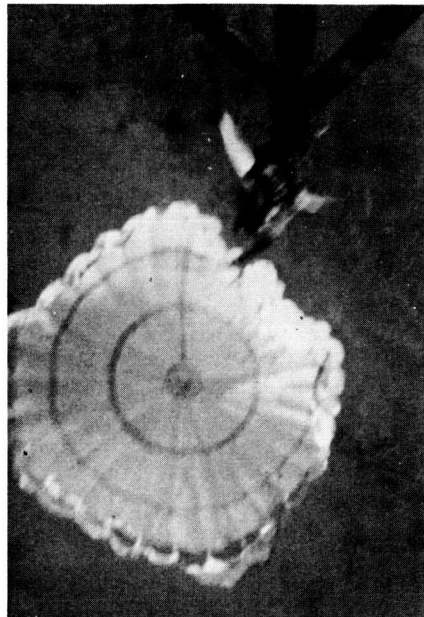
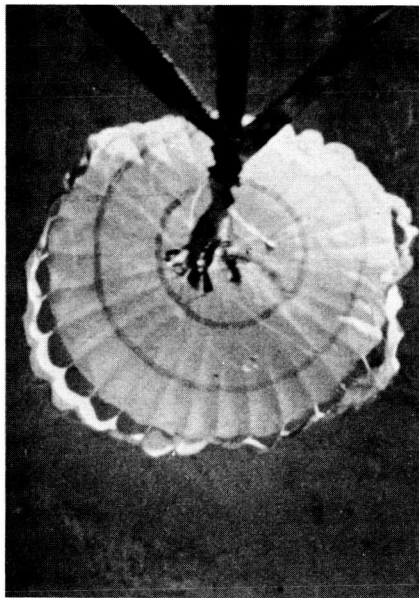
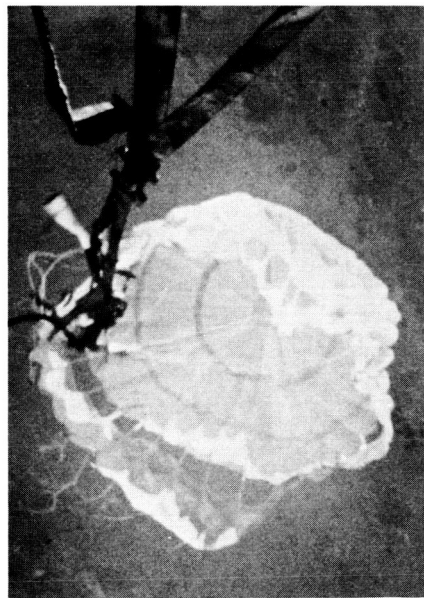
(c) Canopy load variation sequence.

t' = 1.49 seconds
Tensiometer force,
618 lb (2 745 newtons)

t' = 1.60 seconds
Tensiometer force,
3 950 lb (17 550 newtons)

t' = 1.64 seconds
Tensiometer force,
323 lb (1 436 newtons)

t' = 1.71 seconds
Tensiometer force,
2 987 lb (13 295 newtons)

t' = 1.76 seconds
Tensiometer force,
390 lb (1 732 newtons)

t' = 1.84 seconds
Tensiometer force,
3 282 lb (14 595 newtons)

t' = 1.95 seconds
Tensiometer force,
3 762 lb (16 710 newtons)

t' = 2.00 seconds
Tensiometer force,
446 lb (1 981 newtons)

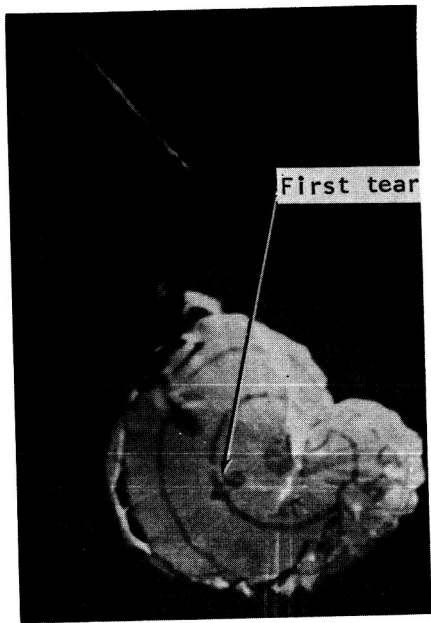
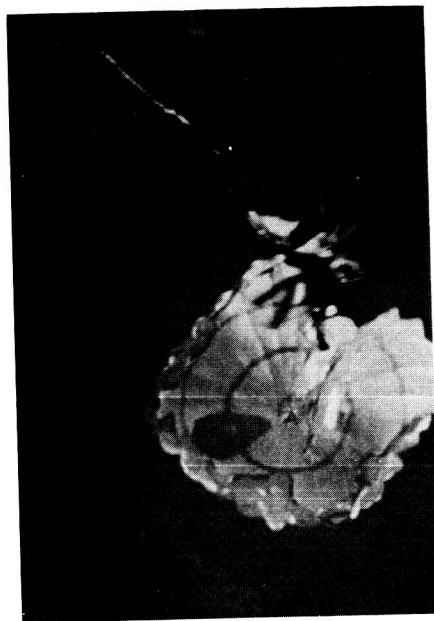
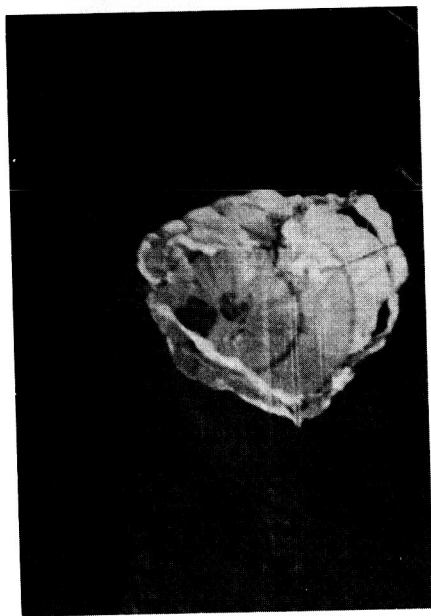
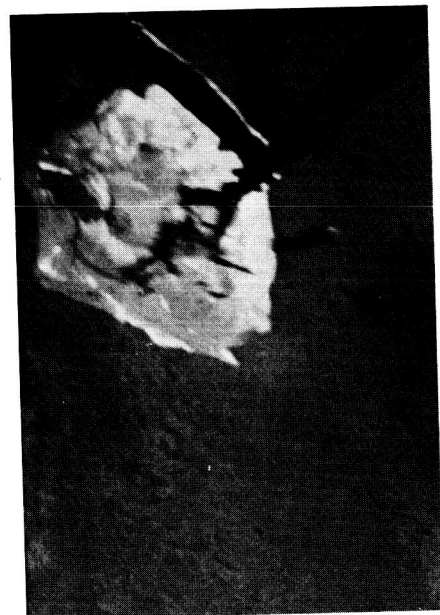
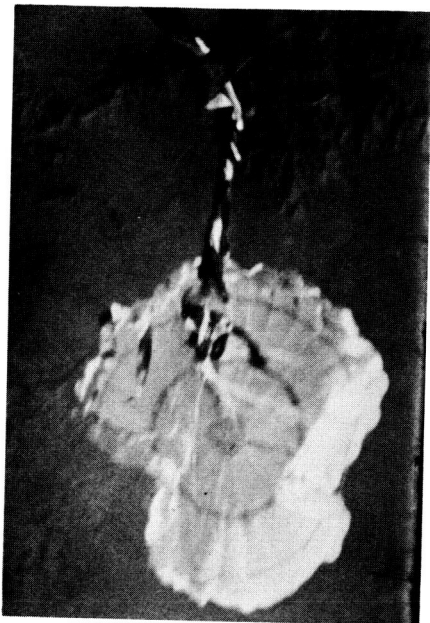
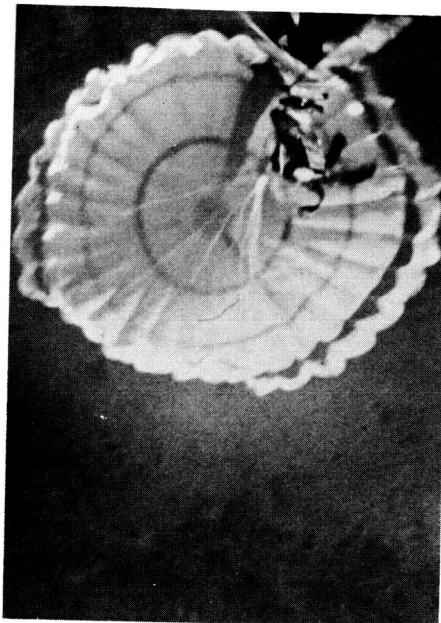
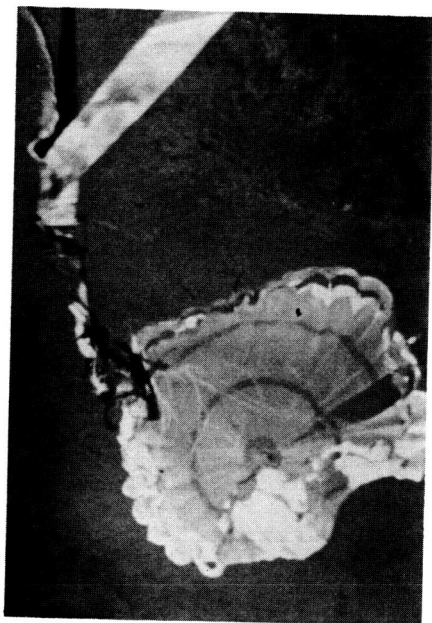
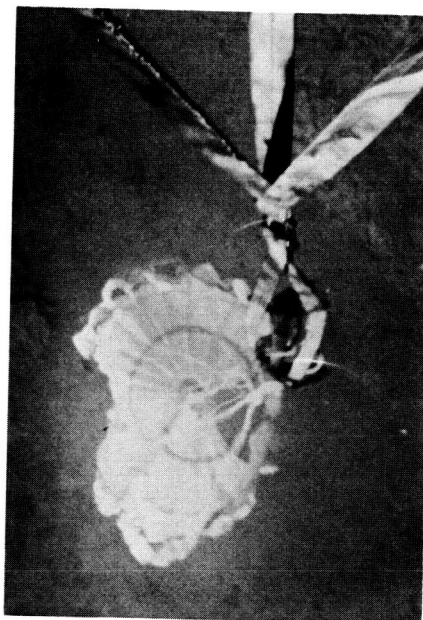
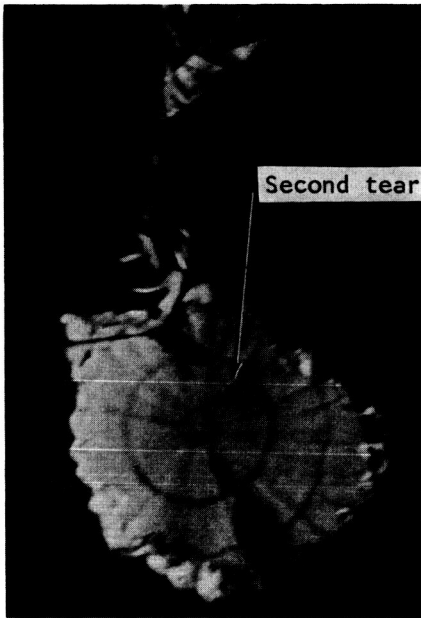
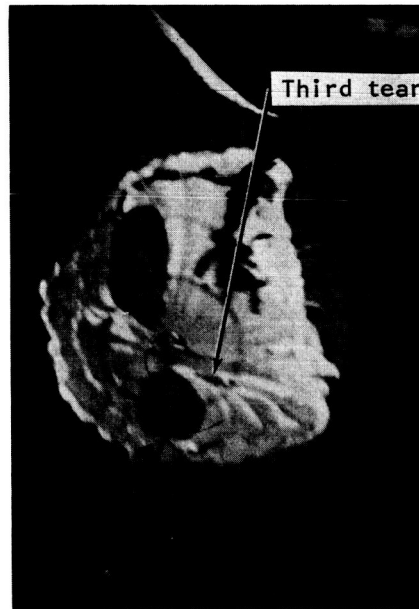
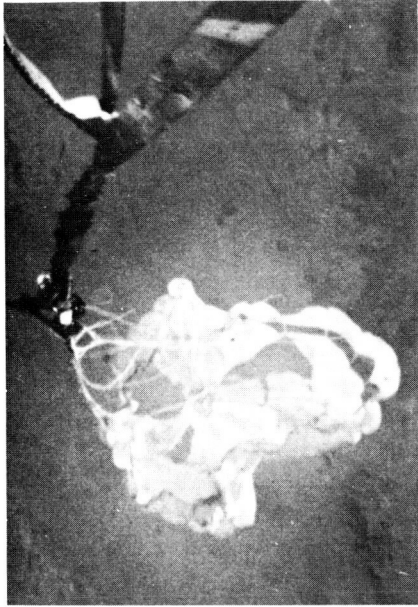
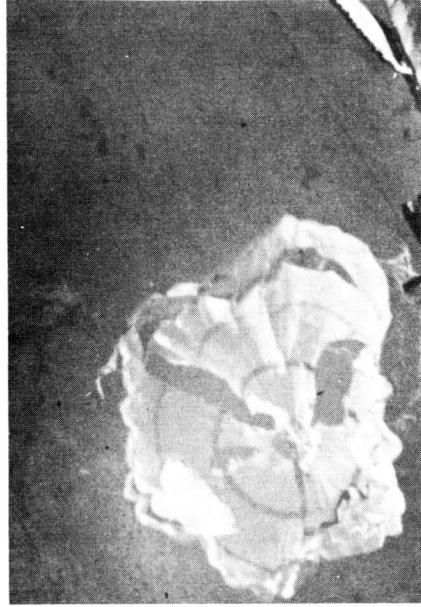
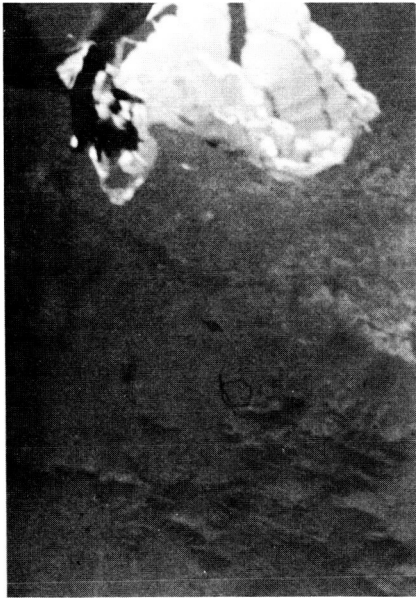
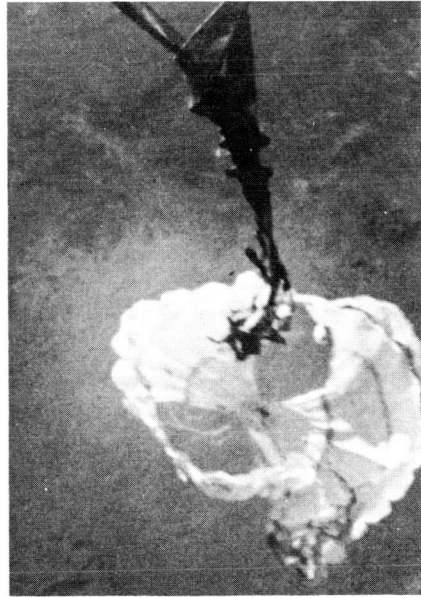
(d) Canopy damage sequence.

Parachute damage.- The extent of damage sustained by the parachute immediately after deployment was shown previously in figure 18. A postflight inspection of the recovered parachute located the specific damaged area shown in figure 24. It appears that further damage beyond that seen in figure 18 did not occur. The major damage was

2. The parachute canopy inflation process began immediately, the first inflation occurring at 1.03 seconds. The parachute canopy then assumed a varying partially inflated shape. At 2.10 seconds and again at 3.28 and 4.29 seconds, the canopy was severely damaged by tears which occurred in the disk portion of gores 8, 12, and 22.

6. The canopy sustained extensive damage in the disk area beginning about 1 second after the first full inflation of the parachute. This damage is attributed primarily to aerodynamic heating which severely weakened the canopy material. This condition was undoubtedly aggravated by the fact that three mechanical scratch gages were located in the canopy area near where the aerodynamic heating problem was most severe.

First tear

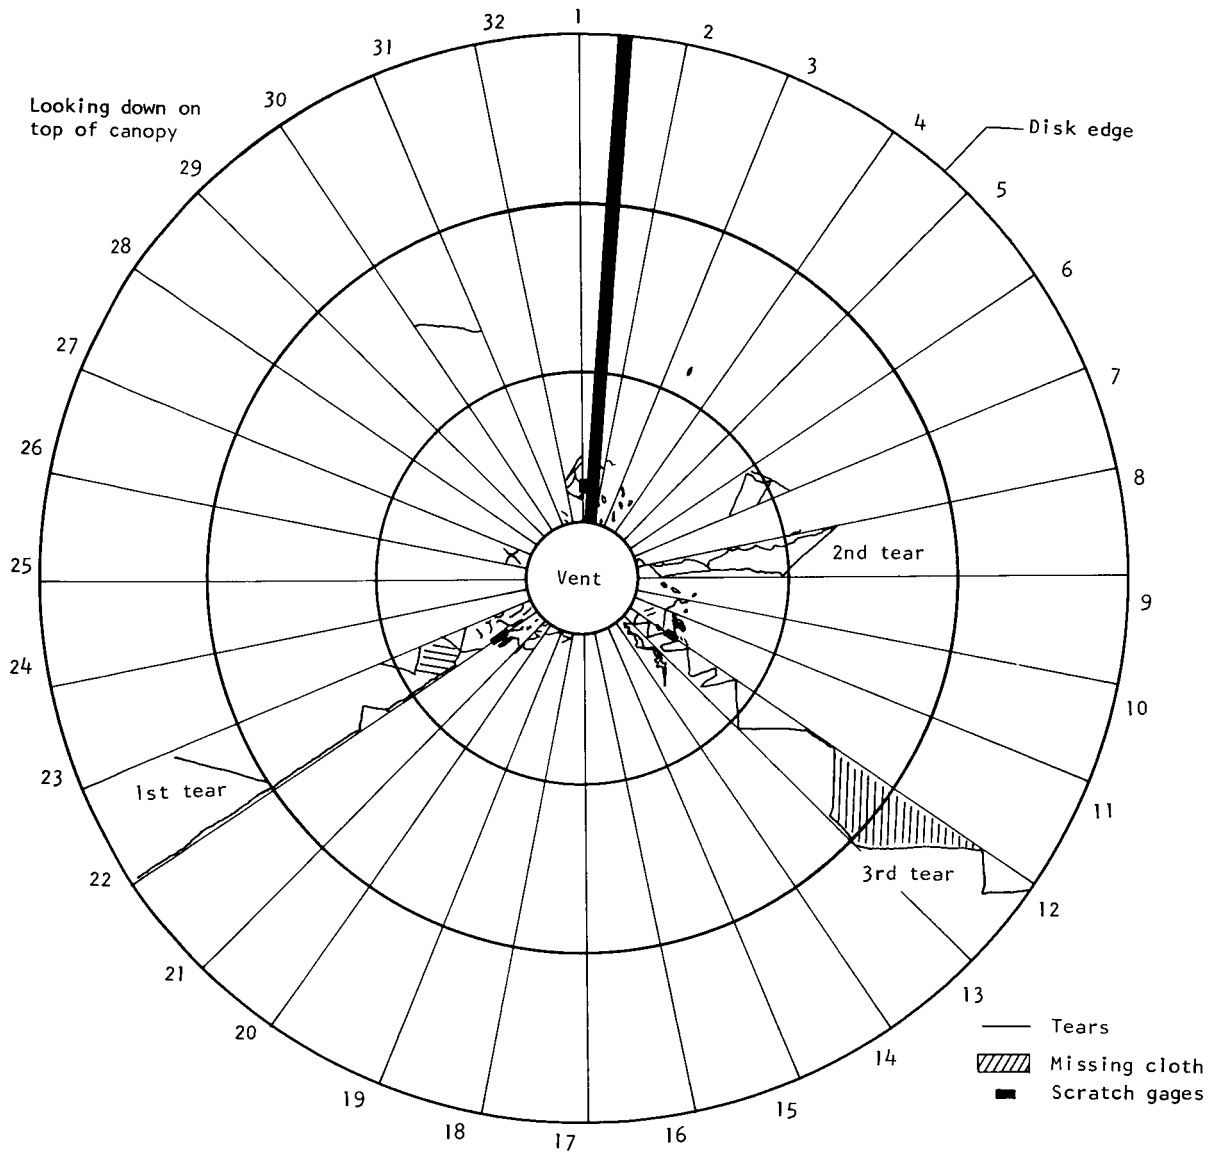
sustained by the disk area of gores 8, 12, and 22. The postflight examination also revealed that the parachute material had stiffened in an area around the canopy vent as shown in figure 25. It is believed that this area of stiffened material resulted when the canopy cloth cooled after it was exposed to aerodynamic heating; this heating occurred after parachute deployment during the high Mach number part of the flight test. Although it was known prior to flight that aerodynamic heating could be a problem, one of the test objectives was to determine whether the exposure would be detrimental since the para-chute was subjected to the high rate of heat input for a very short period of time. On a previous deployment at a Mach number of 2.72 (ref. 4), no evidence of aerodynamic heating was found. A comparison of stagnation temperatures as a function of time for this flight test starting at a Mach number of 3.31 and of the previous flight test at a deployment Mach number of 2.72 showed that the heating environment was much more severe for this flight test.

Figure 24.- Sketch showing damaged areas of the canopy.

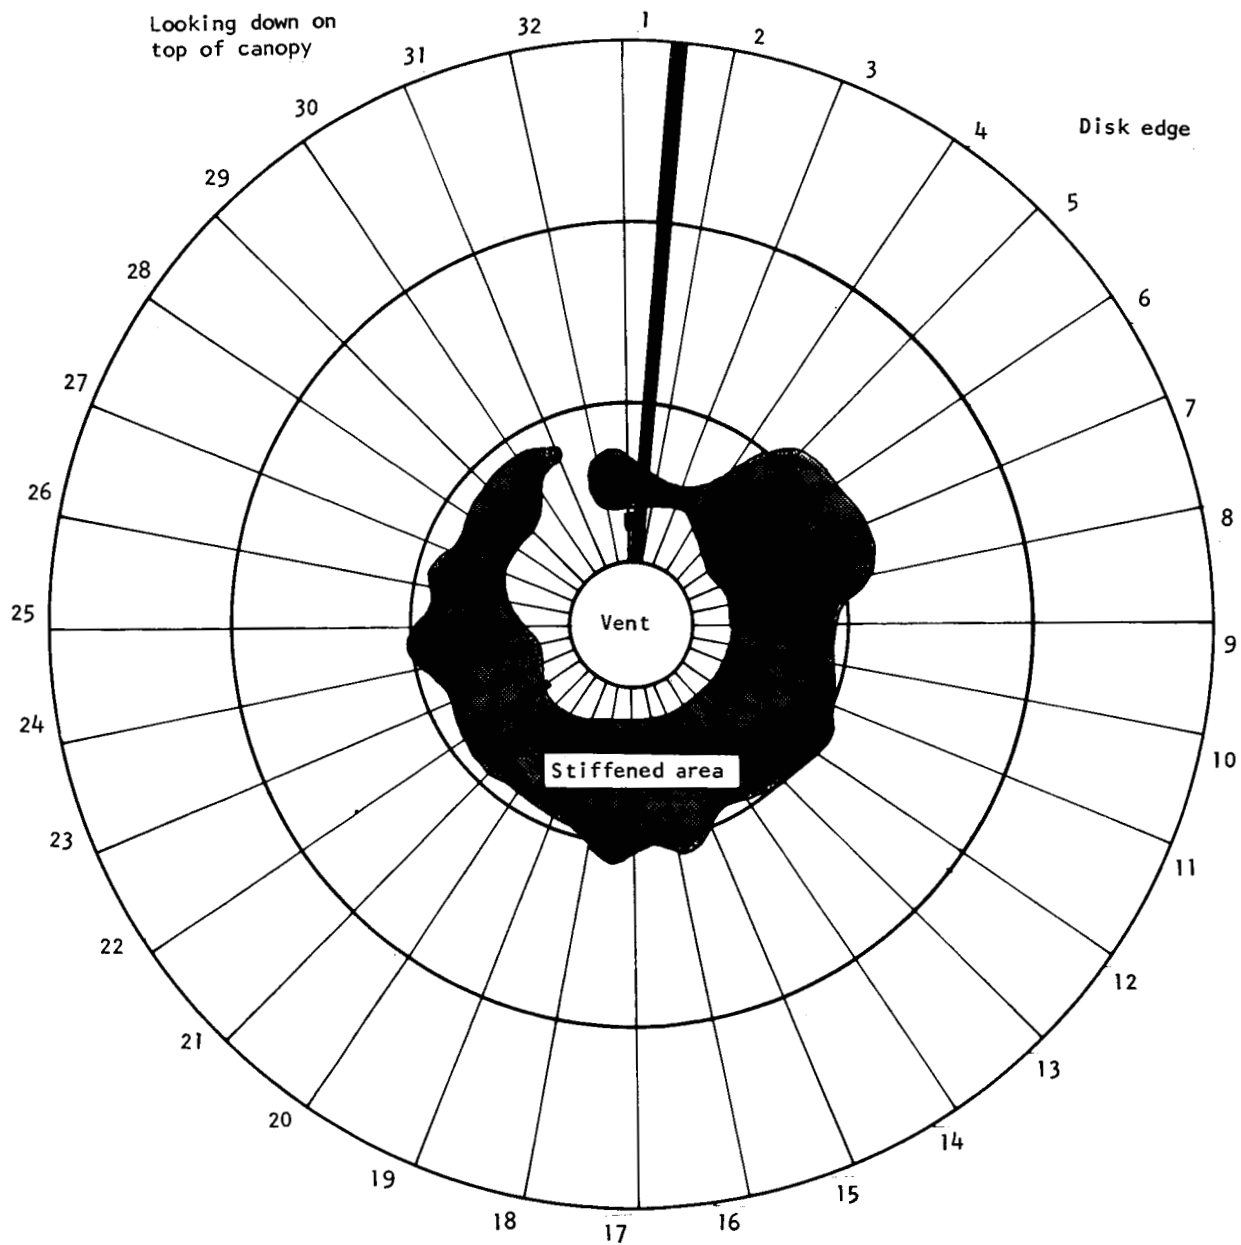
Figure 25.- Sketch showing stiffened area due to aerodynamic heating.
