[Kosse, Vladis](#) (2010) *Revealing design flaws at different stages of product development using anticipatory failure determination (AFD TM) technique*. In: Proceedings of the 6th Australasian Congress on Applied Mechanics, 12 - 15 December 2010, Perth, W.A.

Revealing Design Flaws at Different Stages of Product Development Using Anticipatory Failure Determination (AFD™) Technique

V. Kosse

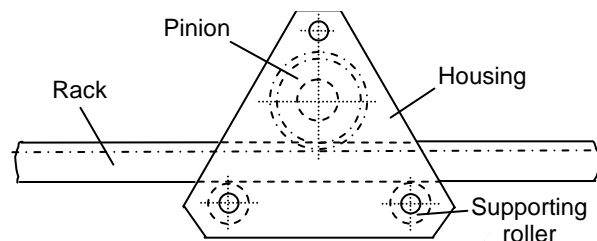
Figure 1: Rack and pinion mechanism

Step 7. Search for new solutions. There is no need to search for new solutions because the design flaw is obvious, and if the mechanism is built and installed it will be working under increased loads it was not designed for. This will cause accelerated wear of the rack and the pinion and premature failure.

This case study illustrates how the AFD™ tool can be effectively used to reveal a hidden design flaw in the mechanism, which may cause accelerated wear and premature failure.

Step 9. Development of means to prevent failures. One solution could be to put additional supporting rollers outside the flanges to minimise leverage action. An alternative solution could be to turn the mechanism 90°, so that the rack will travel in the vertical direction, and to put the chain on a sheave so that the rack will be suspended and its weight will not make any impact on forces in gear engagement. Moreover, the weight of the rack will work as a counterweight reducing forces applied to the rack and extending its operating life. These conceptual solutions are depicted in Fig. 3 below (the (a) option with additional supporting rollers, and (b) option with the vertical rack).
