1. Report No.		2.		3. Recipient's Accession No.	
4. Title and Subtitle Florida's East Coast Inlets Shoreline Effects and Recommended Action				5. Report Date December, 1987

6.	
7. Author(s) R. G. Dean M. P. O'Brien				8. Performing Organization Report No. UFL/COEL-87/017	
9. Performing Organization Name and Address Coastal and Oceanographic Engineering Department University of Florida 336 Weil Hall Gainesville, FL 32611				10. Project/Task/Work Unit No.

FLORIDA'S EAST COAST INLETS
SHORELINE EFFECTS AND RECOMMENDED ACTION

December, 1987

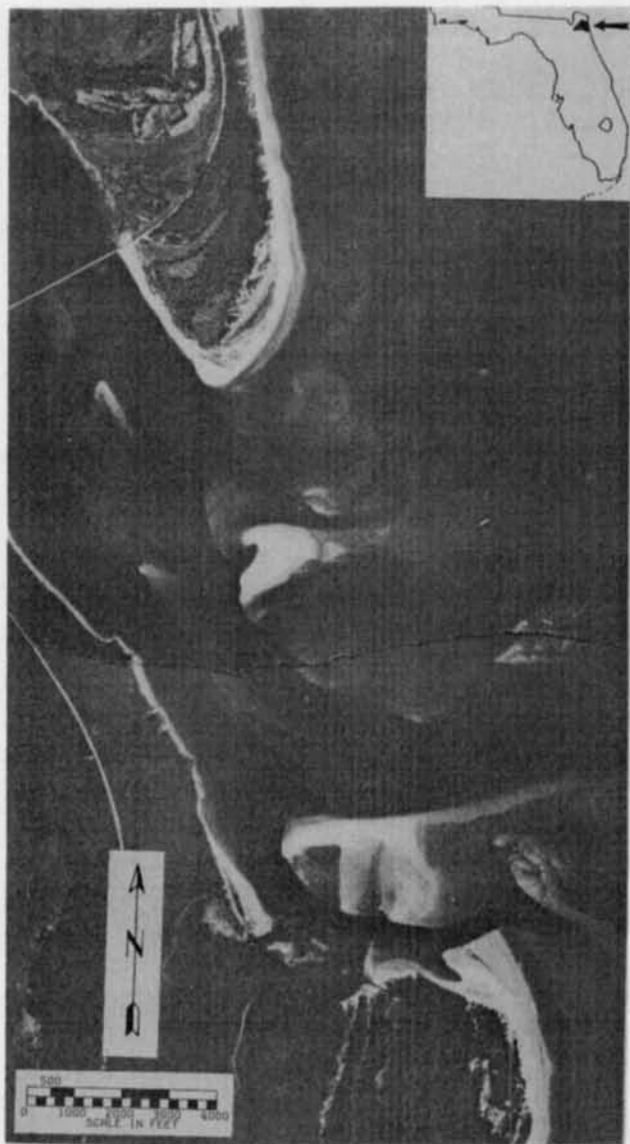
NASSAU SOUND

(Date of Photography: December 27, 1985)

- As this is a natural entrance, no action is recommended.

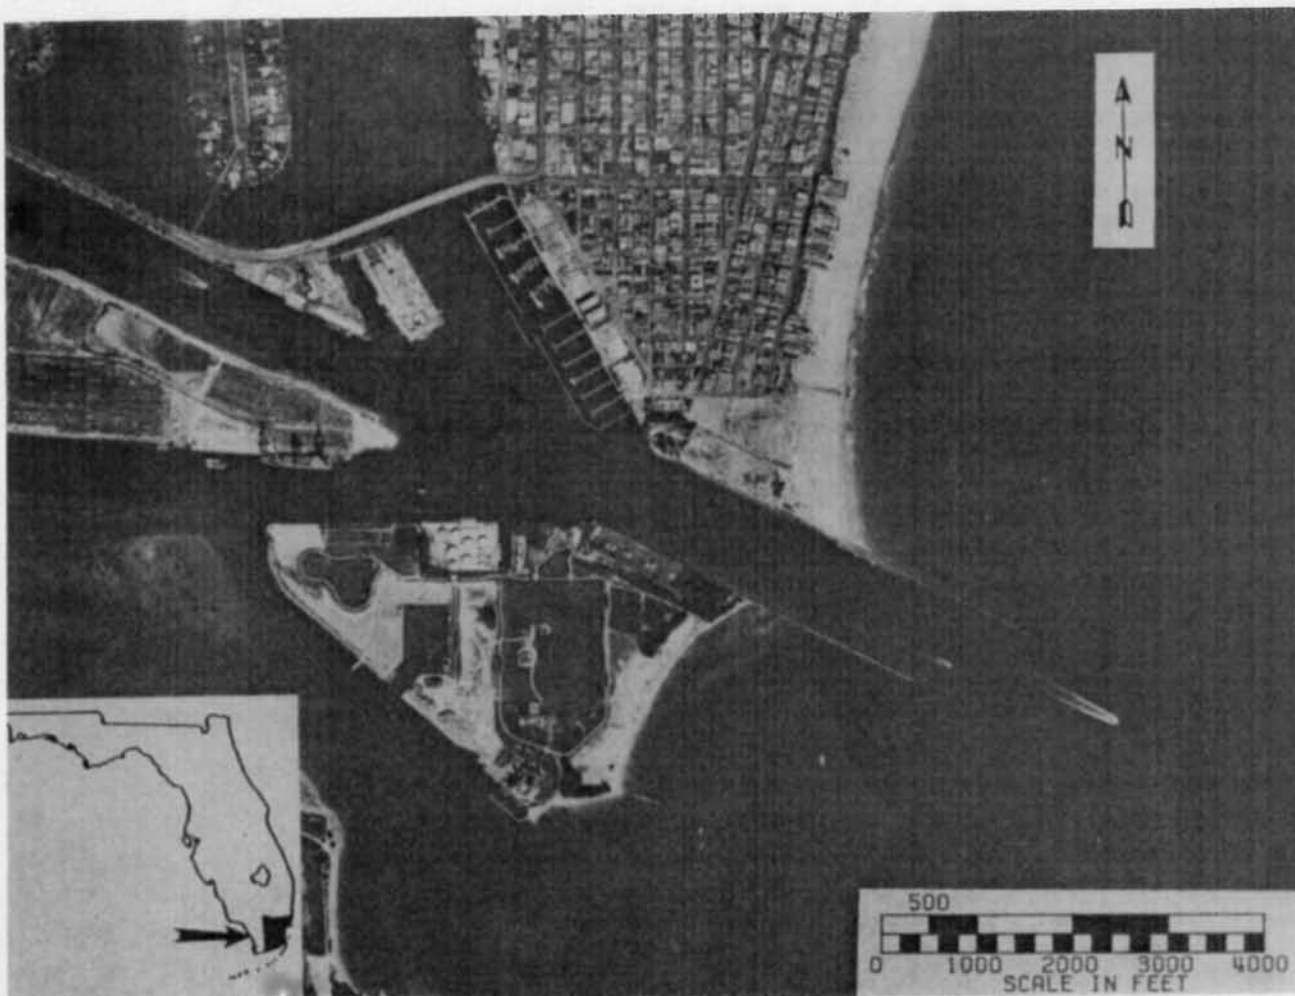
GOVERNMENT CUT (MIAMI HARBOR)

(Date of Photography: February 14, 1985)

- Place any material dredged from the channel on the south beach.
