FLORIDA'S WEST COAST INLETS  
SHORELINE EFFECTS AND RECOMMENDED ACTION

December, 1987

Coastal and Oceanographic Engineering Department  
University of Florida  
Gainesville, Florida 32611

7. Author(s) R. G. Dean M. P. O'Brien				8. Performing Organization Report No. UFL/COEL-87-018	
9. Performing Organization Name and Address Coastal and Oceanographic Engineering Department University of Florida 336 Weil Hall Gainesville, FL 32611				10. Project/Task/Work Unit No.

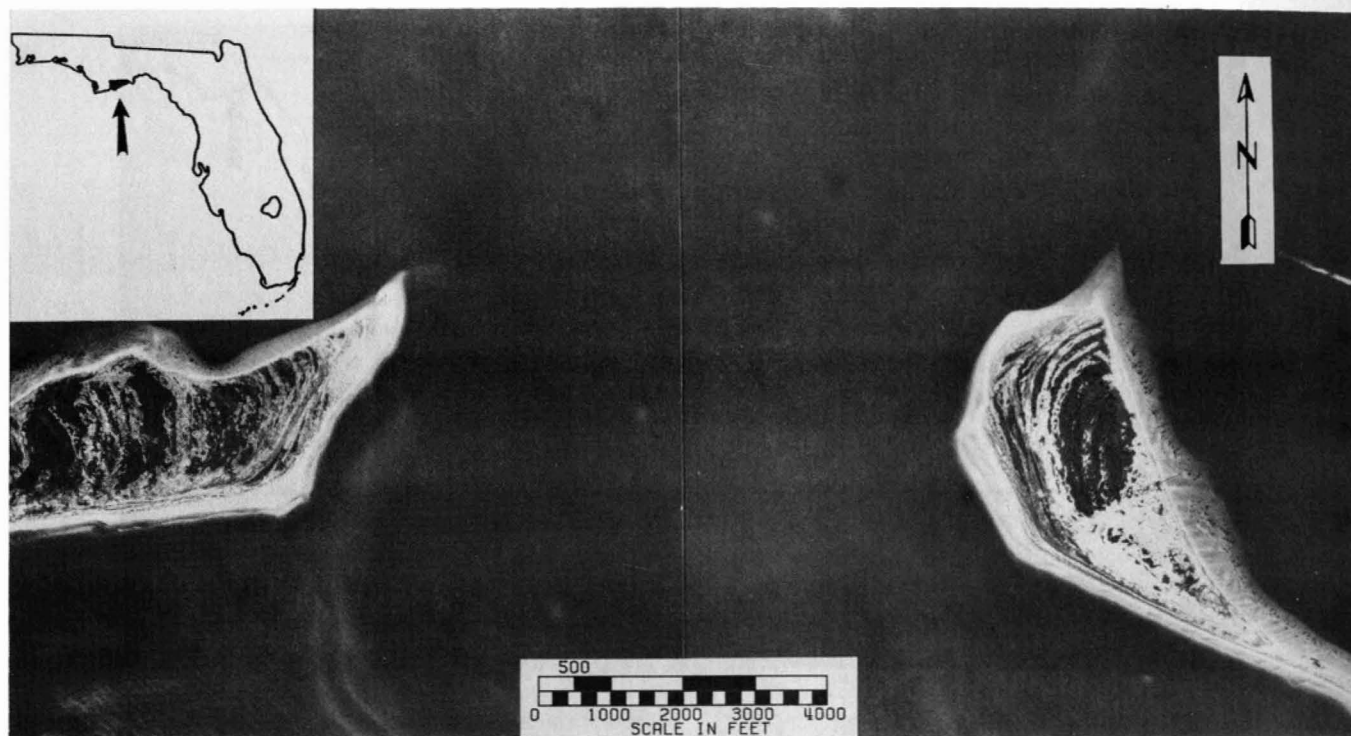
EAST PASS (CARRABELLE HARBOR)

Brief Historical Information

Recommended Action

- If this channel is dredged, place spoil on the east beach.

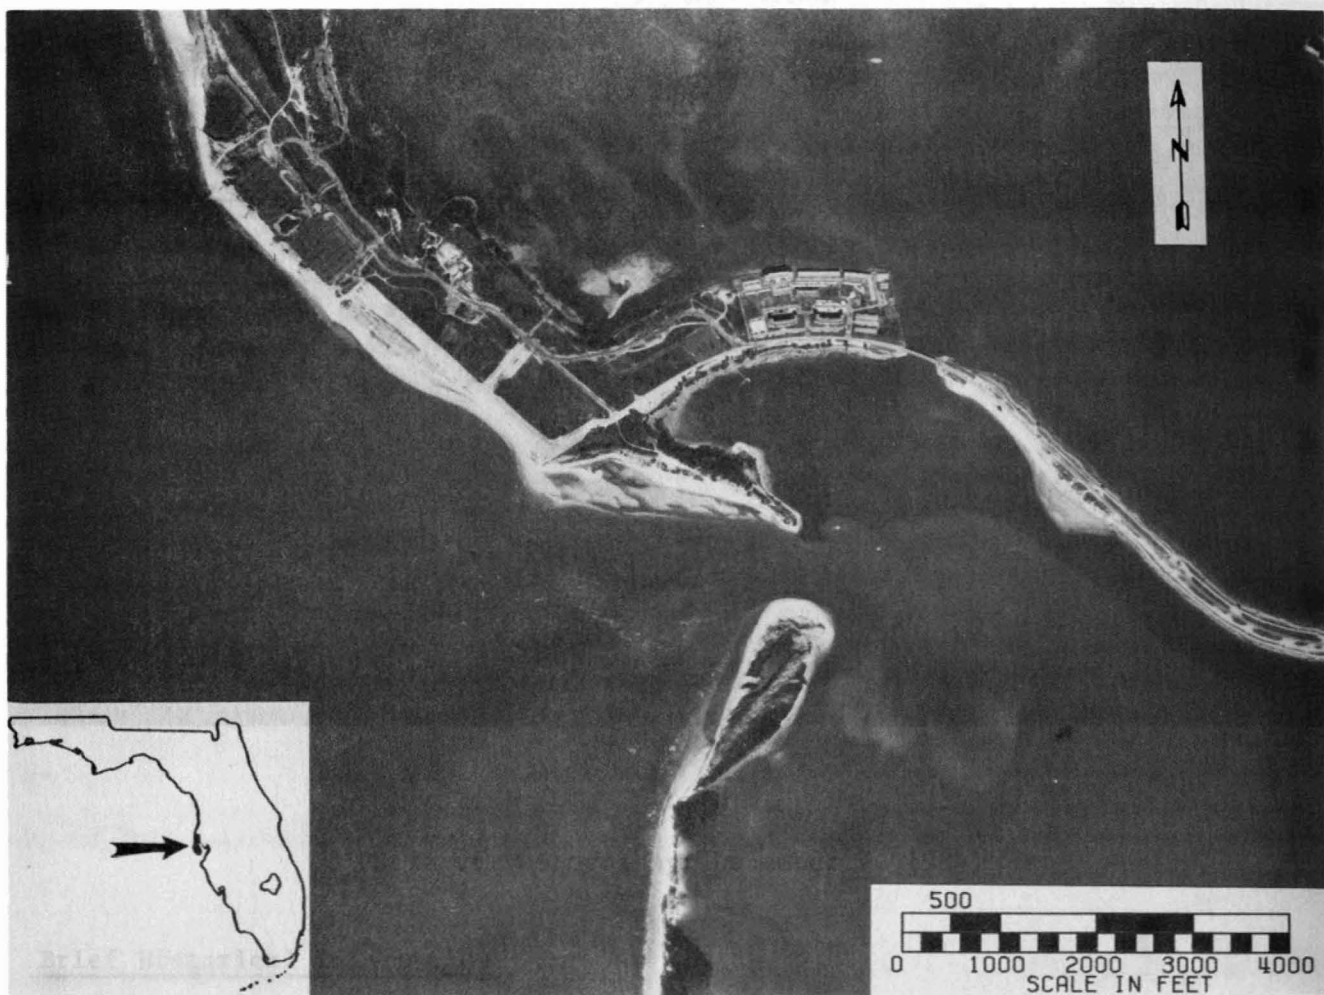
## HURRICANE PASS

- Pass breached by hurricane in 1921.
- Clearwater Causeway constructed between 1923-26.
- Honeymoon Causeway constructed between 1900-63.
- Dredging and filling began for Island Estates Development in 1958.
- In 1970, rip-rap placed on north side to stabilize south end of Honeymoon Island.
- Pass not maintained federally or locally; channel: 1,800 ft. wide by 6 ft. deep.

### Recommended Action

- Place all dredged material on the north beach.

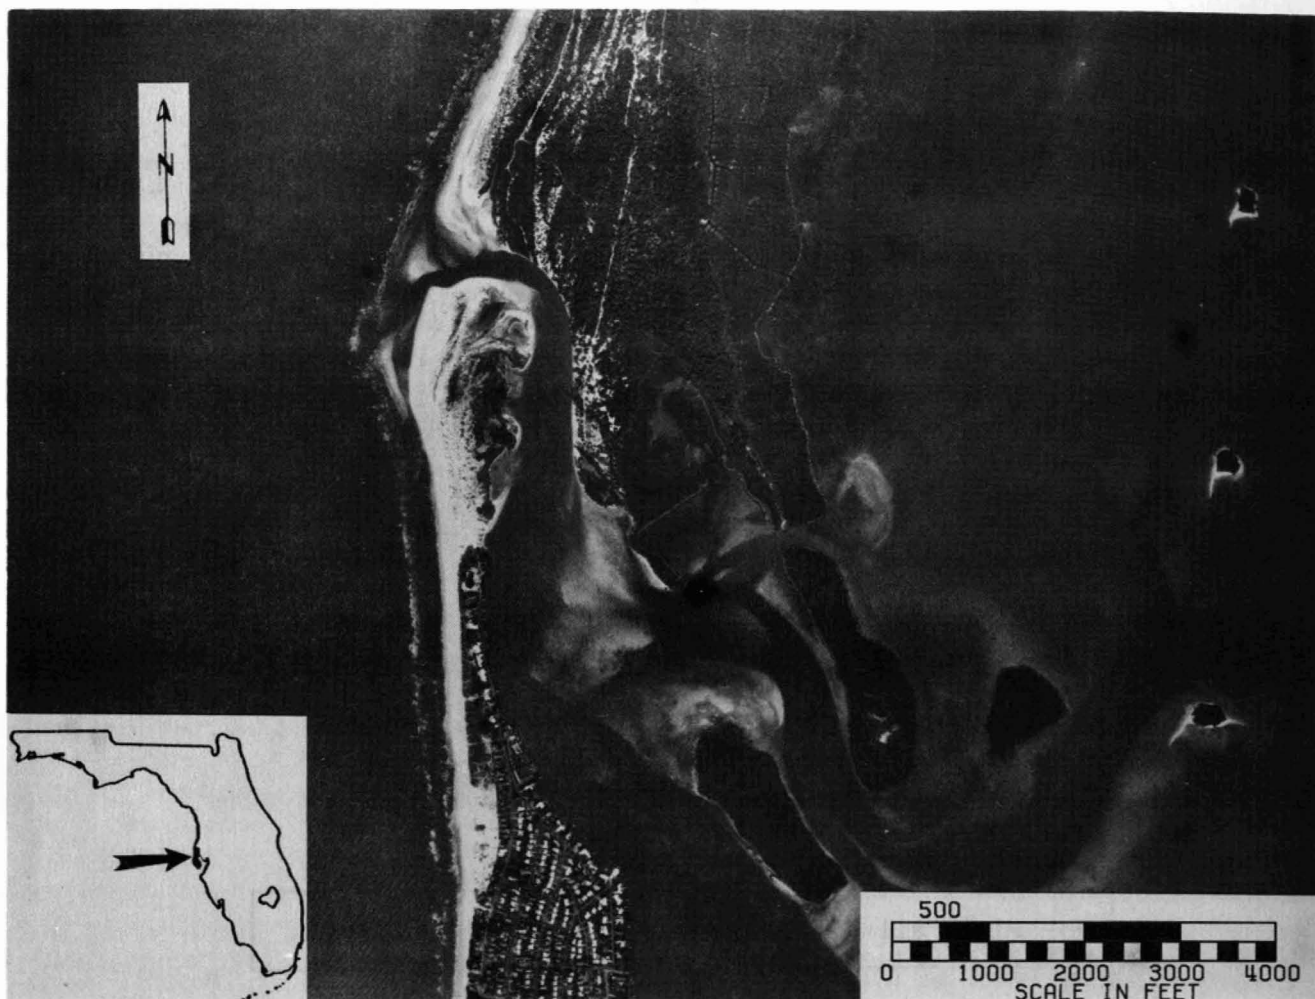
DUNEDIN PASS (BIG PASS)

- From 1883-1921, Big Pass was the predominant influence on Clearwater Bay-St. Joseph Sound area.
- Hurricane Pass formed by storm diverted flow from Big Pass in 1921.
- Clearwater Causeway constructed between 1925-26.
- Dredging for Island Estates Development started in 1958.
- Honeymoon Island Causeway constructed between 1960-63.
- Jetty construction at north end of Sand Key in 1974.
- Not Federally or locally maintained; channel dimensions: 1,800 ft. wide by 6 ft. deep.

Recommended Action

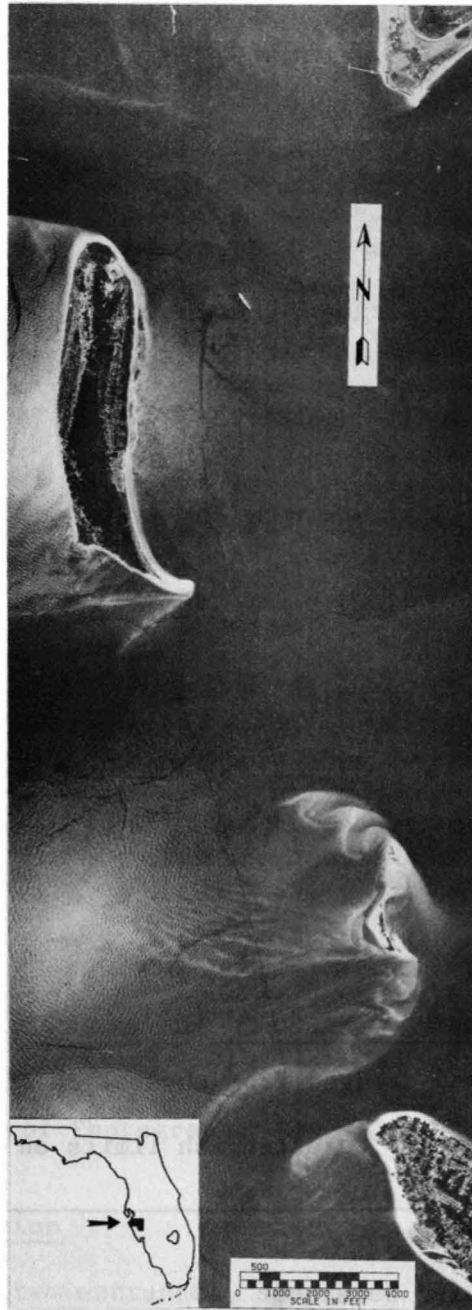
TAMPA BAY ENTRANCE

- Available surveys date from 1877.
- Federal navigation project.
- There are three channels: Egmont. Main shipping channel. Maintained by Corps of Engineers. Width 4,200 ft., depth 48 ft. Southwest. Width 4,900 ft., depth 21 ft. Not maintained. Passage Key. Width 1,500 ft., depth 17 ft. Not maintained.

### Recommended Action

- Place beach quality dredged material on adjacent eroding beaches according to documented need.

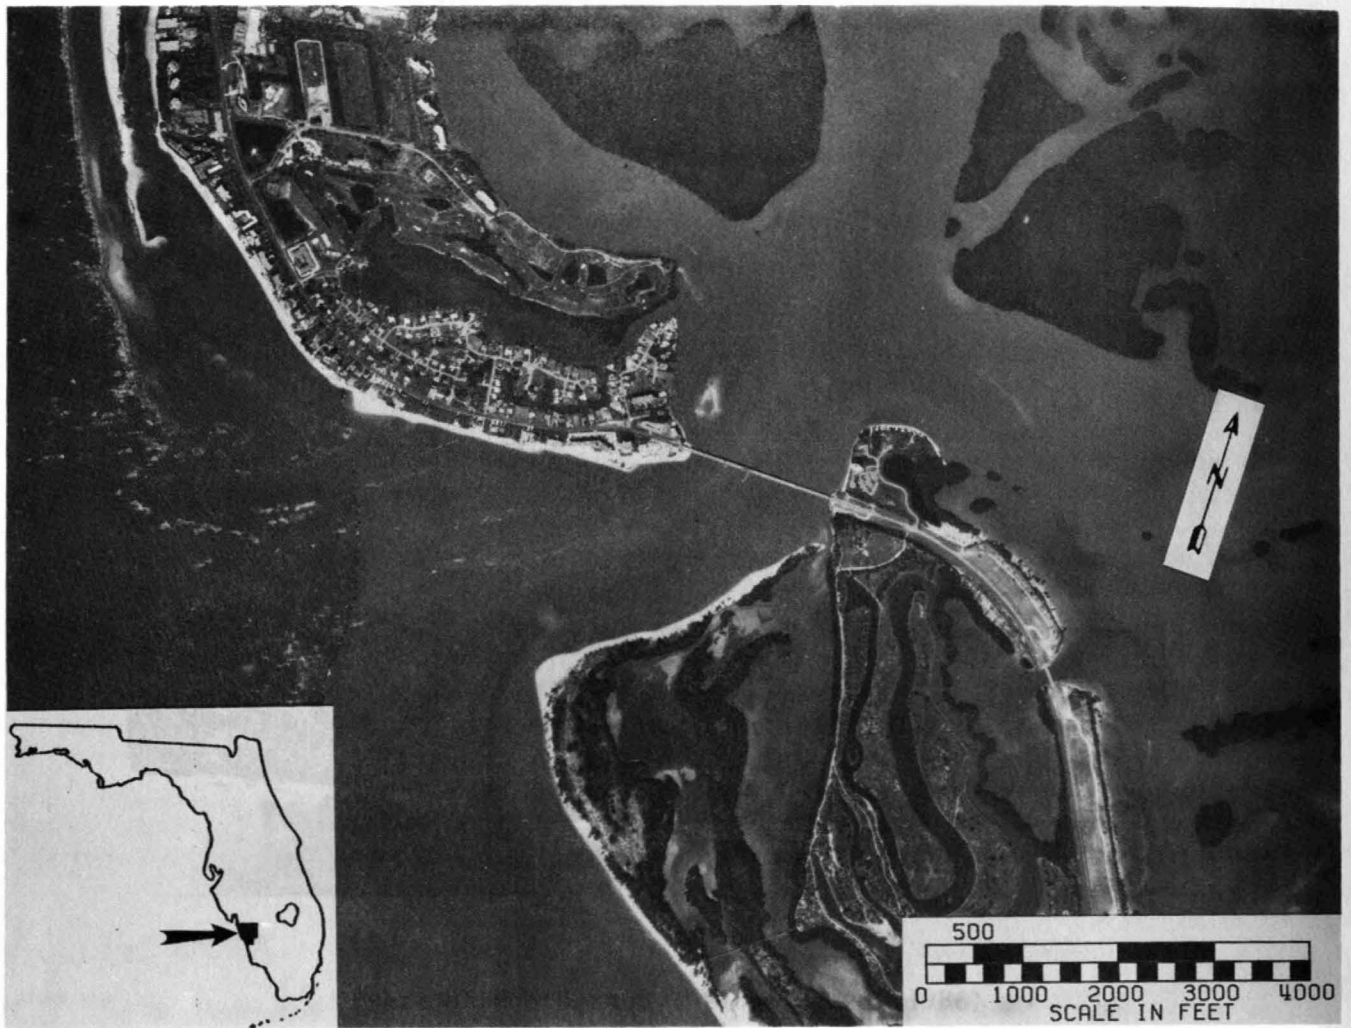
BIG CARLOS PASS

- This pass has remained unchanged during the last century.
- There has been no dredging or construction of training works (jetties).
- Channel dimensions: 1,500 ft. by 11 ft.
- In 1963, tidal prism increased when several small inlets to the south were closed by construction of a causeway.
- Not Federally or locally maintained.

Recommended Action

- If this pass is dredged, place dredged material on the south beach.

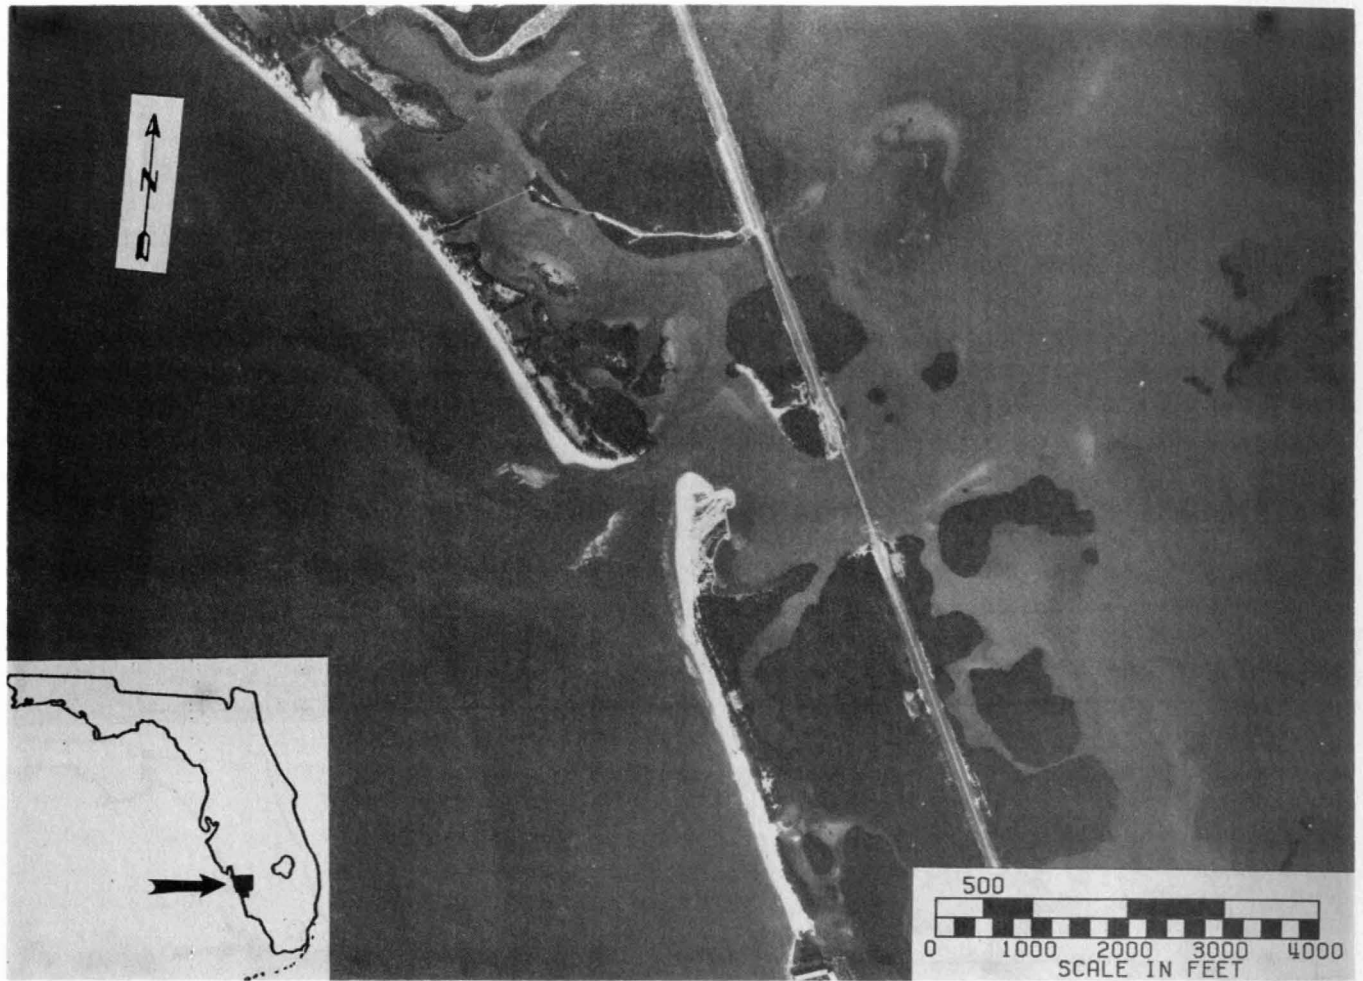
NEW PASS (LEE COUNTY)

- From 1963 to 1965, construction of a causeway between Fort Meyers and Bonita Beach caused closure of several small inlets between Big Carlos Pass and New Pass and increased the tidal prism of the two adjacent inlets.
- There has been no dredging or construction of training works (jetties).
- Not a Federal navigation project.
- Channel dimensions: 1,350 ft. wide by 7 ft. deep.

Recommended Action

- If channel is dredged, place material on the south beach.

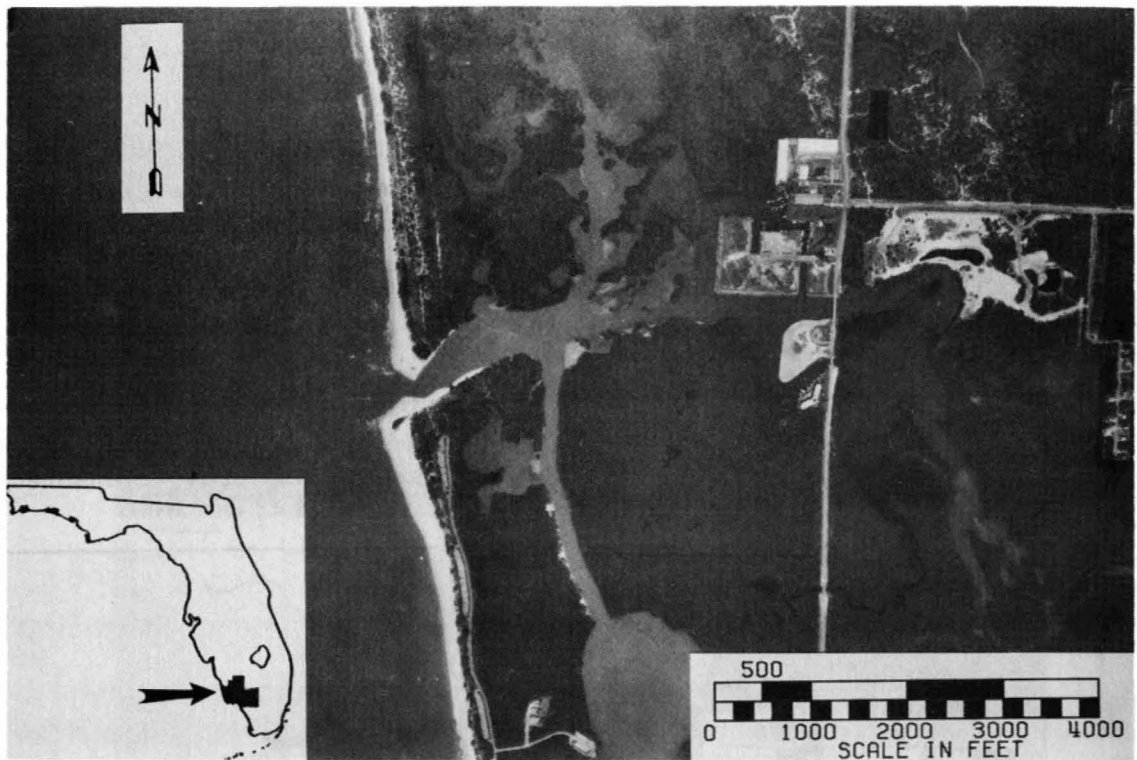
## WIGGINS PASS

- Prior to 1952, pass experienced frequent closures and was not navigable throughout most of the year.
- In 1952, changes in connecting channels increased the tidal prism by 50 percent; this change caused throat area to increase and closures were eliminated.
- Tidal prism further increased in the period 1960 to 1970; ebb shoal well-developed by 1974 and navigable channel was migrating.
- In 1983, pass dredged, channel dimensions: 200 ft. wide by 8 ft. deep.
- Pass is not Federally or locally maintained.

Recommended Action

- Place dredged material of beach quality on adjacent beaches according to documented erosional areas.
