M/V CONNECTED
Coral Reef Restoration Monitoring Report
Monitoring Events 2004-2005
Florida Keys National Marine Sanctuary
Monroe County, Florida

December 2006

Joe Schittone
Erik C. Franklin
J. Harold Hudson
Jeff Anderson

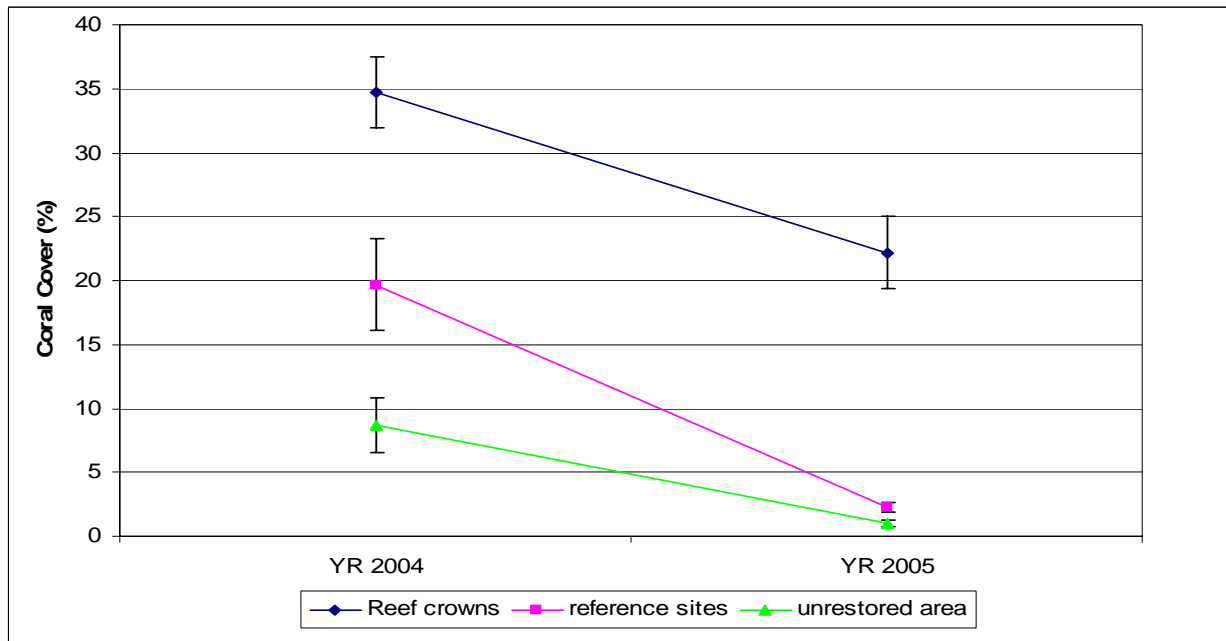
was observed at the damaged, unrestored site, where relative cover likewise decreased 88% (Table 2 and Figure 11).

The much greater reduction in coral cover in the reference zone can probably be attributable to the fact that most of the site lies below the bathymetry of the reef crowns; thus it served as a natural repository for the rubble and sediment which blanketed the whole area. This view is buttressed by the fact that damage (almost exclusively as a result of burial by storm-generated sediment) was differentially experienced among the reef crowns according to their elevation. For example, crowns which lay in a natural depression or “channel” were wholly smothered (e.g. reef crowns 91 and 92 in APPENDIX; these were buried in rubble which had to be excavated to ID the crowns for the photos.).

Figure 11. Trends in mean (\pm SE) coral cover (%) of the reef crowns, reference sites, and unrestored areas from 2004 to 2005.

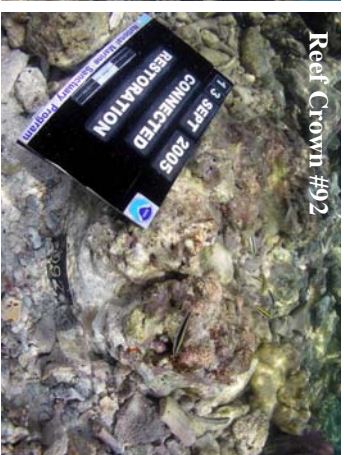
Reef Crown #92

As can be expected in a storm event, there was noticeable physical damage to some reattached *Acropora palmata* colonies. The tips of many fragments appeared to have been recently broken and other colonies showed signs of “sand blasting” (see photos in APPENDIX).
