FAILURE MODE FROM BACK ANALYSIS OF DEFORMED CANTILEVER SHEET PILE WALL

Abstract: The soil mass movement on failed slope had substantially deformed a sheet pile wall positioned at 6m from the new laboratory of Faculty of Mechanical Engineering (FKM Lab), Universiti Teknologi Malaysia, Skudai, Johor. To facilitate investigating the causes of the wall deformation, a computer modeling of slope stability is applied to simulate slope conditions before and after construction of the study area. The results of simulation analysis establish the fact that global soil mass movement started from the elevation of the newly filled water tank to downhill direction towards the installed sheet pile. Consequently, the mass movement generates a combination of mobilized shear force and lateral pressure larger than strength capacity of the sheet pile. In addition, the finite element analysis shows that the sheet pile might successfully intercept the slip plane of failure slope but the wall moves significantly forward because of inadequate passive resistance and required minimum penetration depth in order to achieve stability.

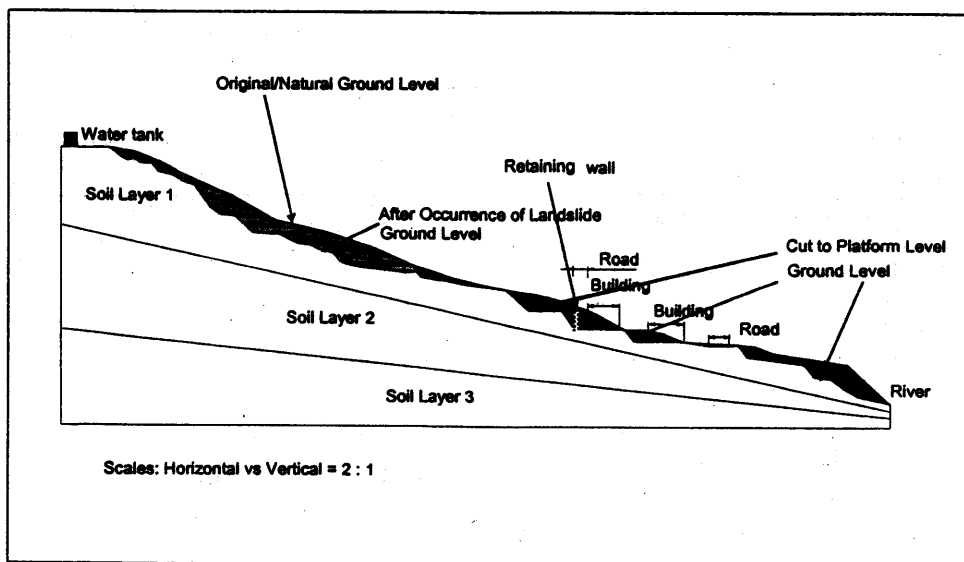
Figure 4: The geometric idealization of the slope

The geometric idealization of the slope at the FKM Lab. is shown in Figure 4 and it is modeled using the possibilities of the plain strain model. The soil profiles are simplified into three (3) layers while the bedrock is placed as the fourth material, with parameters as given in Table 1. For all soil layers, the Mohr-Coulomb model is applied,

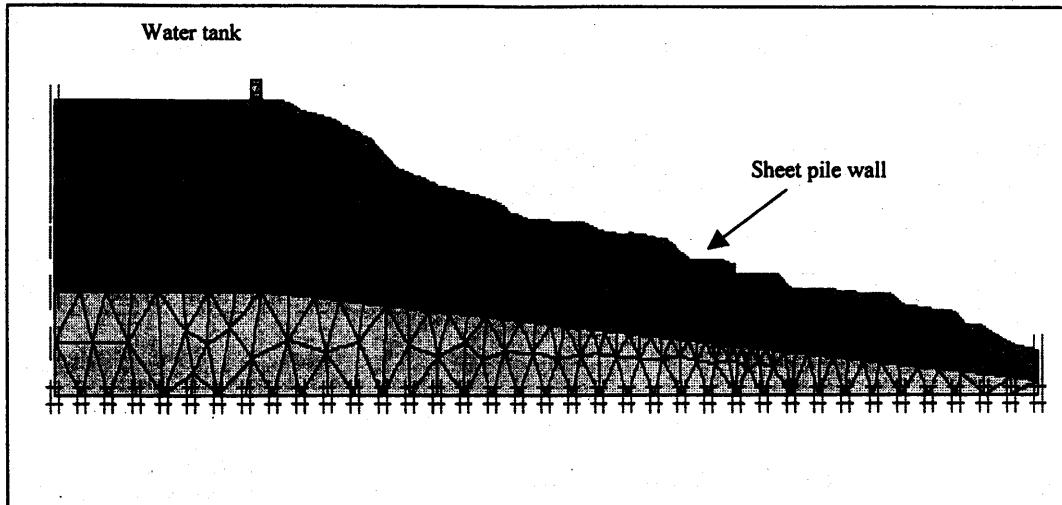
Figure 5: Mesh generation of geometric idealized slope

The slope geometry is divided into finite elements in order to perform finite element calculations, as shown in Figure 5. The type of element used in this study is 15-node triangular elements, which provides a fourth order interpolation for displacements and the numerical integration involves twelve Gauss points. The finite elements meshes are generated automatically, which is a built-in feature of PLAXIS V8.2[®]. The mesh generator is a special version of the Triangle mesh generator developed by Sepra (Brinkgreve & Vermeer, 2002).
