## Avary-Fulton House

# AVARY-FULTON HOUSE

## HISTORIC STRUCTURE REPORT

CLASS OF FALL 2015  
GEORGIA STATE UNIVERSITY  
CONSERVATION OF HISTORIC BUILDING MATERIALS

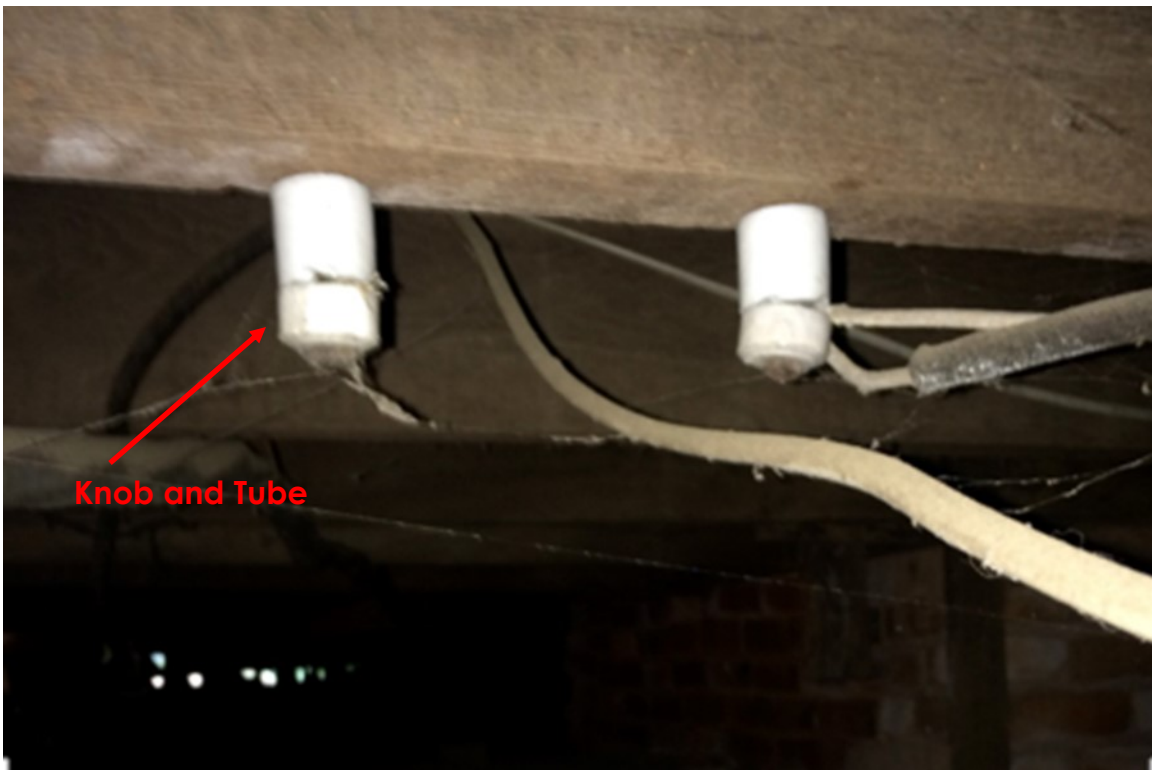
*Figure 11. Historic knob and tube wiring along side modern BX cable.*

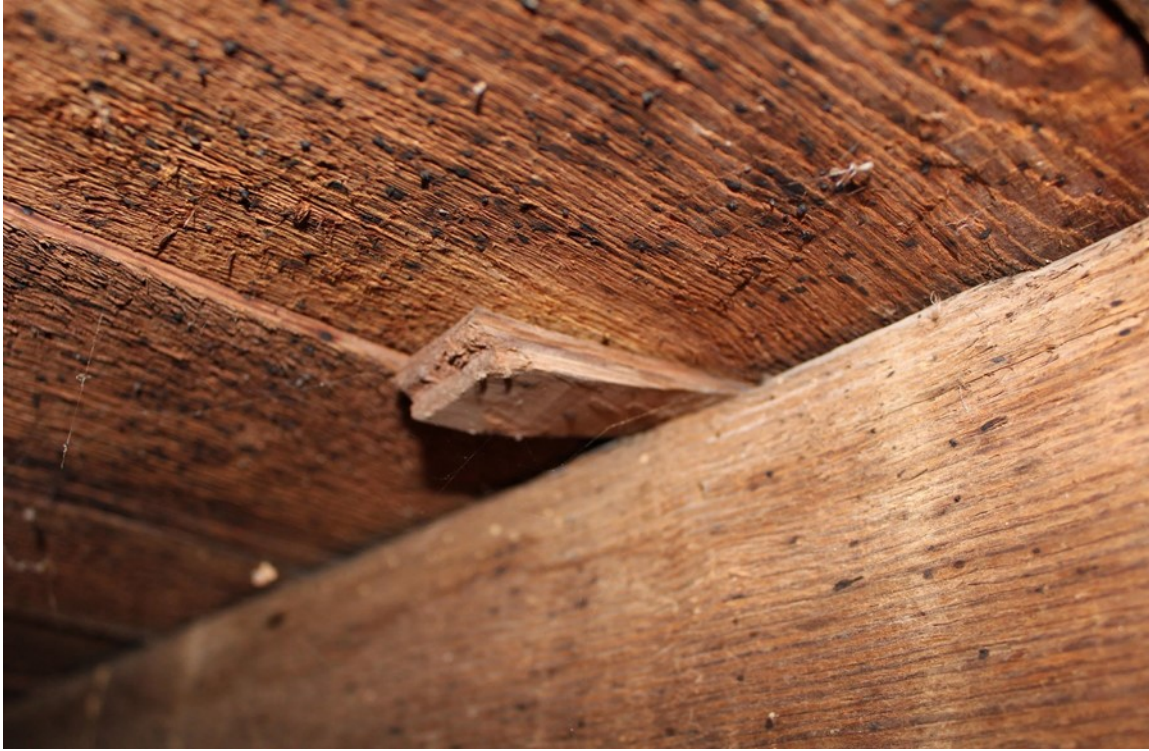
*Figure 14. Joist and subfloor shimmed to fix sagging floor under Room 101*

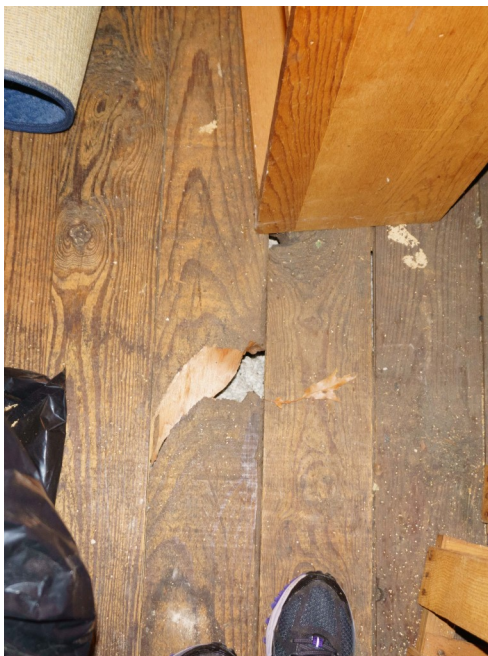
**Fig 64 Attic: Hole in the wood floor.**

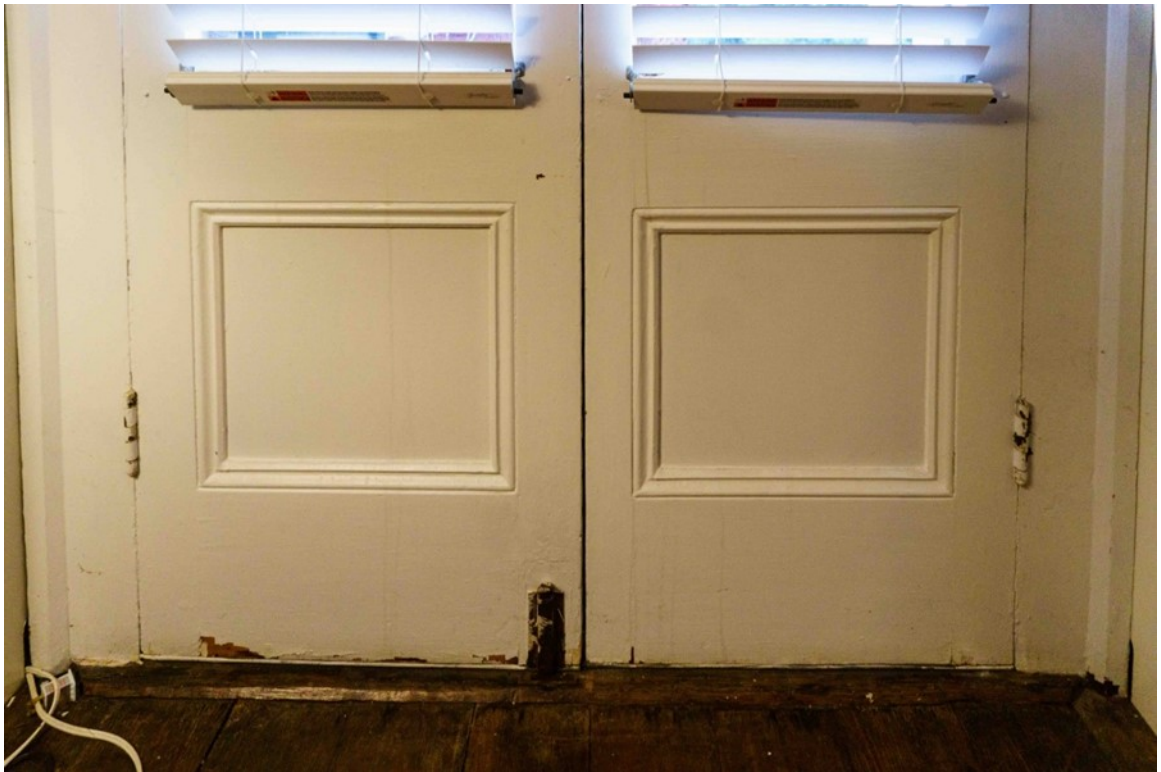
Paint is chipping off the bottom of the double doors, primarily on the left door (Figure 77).

*Figure 77 Room 101. Base of the double doors.*

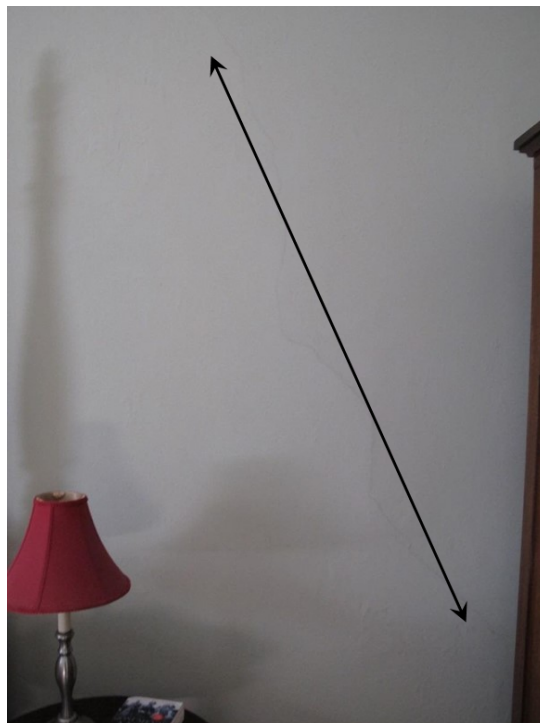
- The floor has a weak spot 3'7" west of the north side of the fireplace hearth.
- The plaster is cracking above the right corner of the south window (Figure 78) and on the west wall on the north side of the window. The cracks, as well as those in the other rooms, are a result of the house settling.

**Figure 79. Room 102. North of the window on the west wall.**

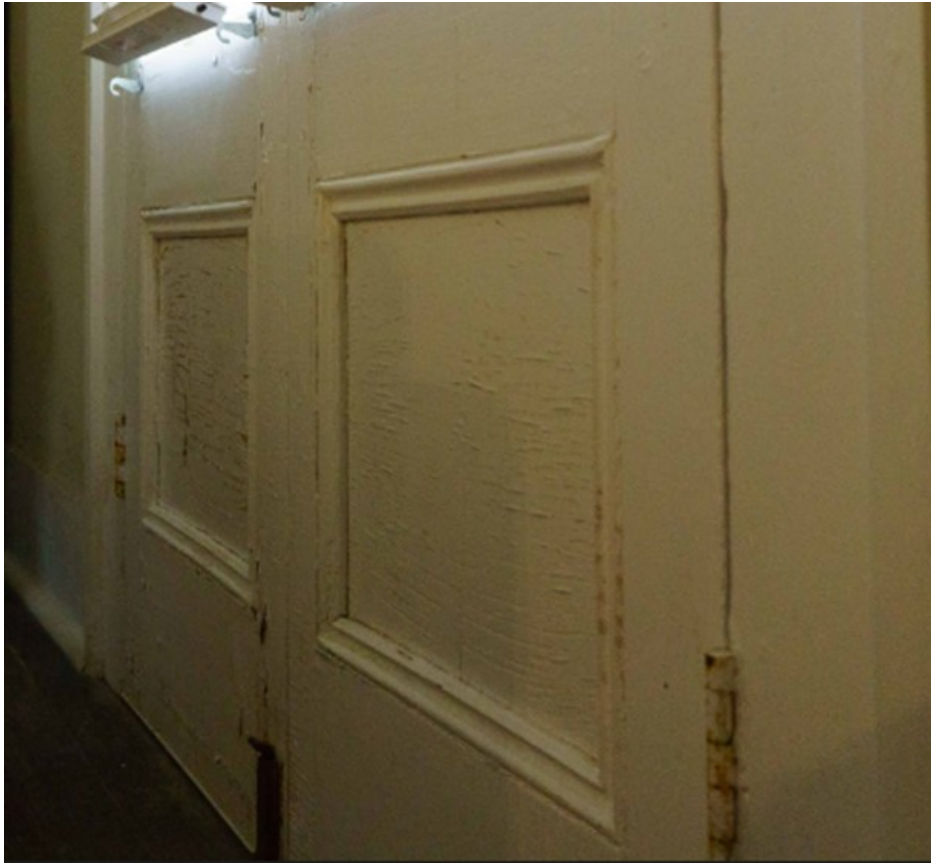
- The paint is crazing on the north and east walls including the lower panels on the double doors (Figure # and #).
- There are several cracks in the plaster on the upper portion of the west wall right of the fireplace (Figure #).

**Figure 84. Crazing on the lower panels of the double doors on the east wall.**

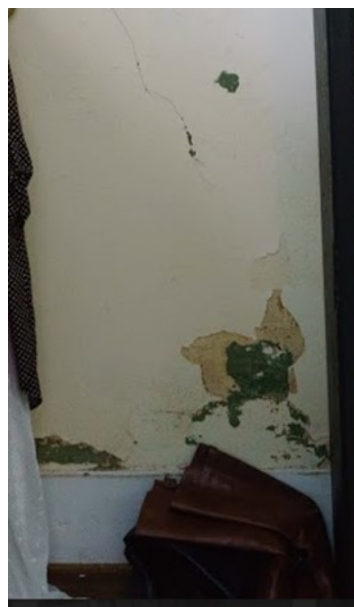
- Plaster is cracked in multiple areas but primarily on the south and west walls (Figure 89).
- Layers of paint are flaking off, mostly on the lower portion of the south wall (Figure 90).

**Figure 90** Picture on the left is of the paint layers flaking off the south wall in Room 201.

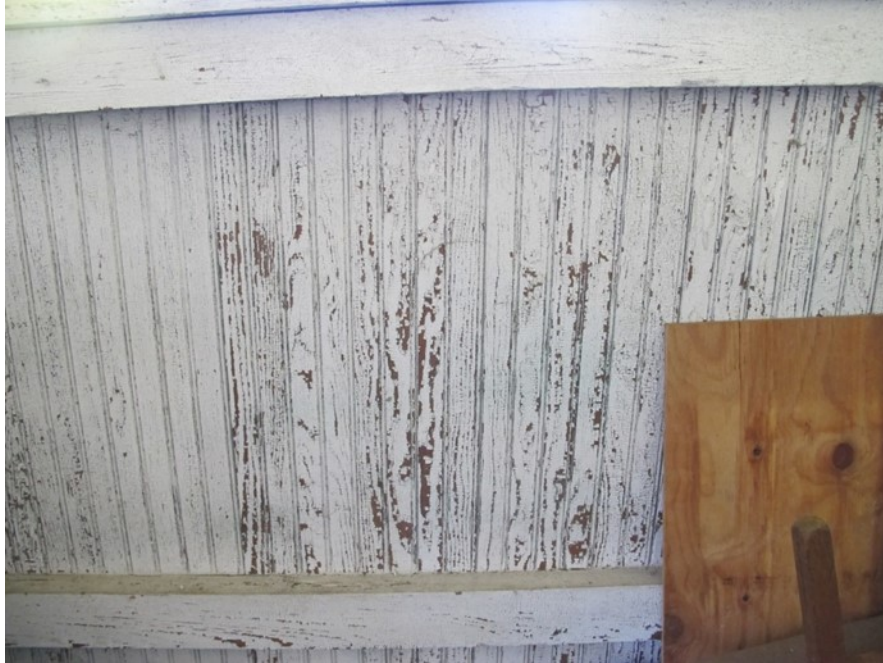
- Vinyl floor covering is worn off in various places. A large section is missing from the area in front of the north door (Figure 93).
- A lower section of the west wall on the northern side is rotting. It is caused by excess water due to the lack of a gutter (Figure 94).
- There are nails protruding through the beadboard above the rotting section (Figure 95).
- The paint is alligating on the beadboard of the north and west walls (Figures 95 and 96).
- A rafter is rotted by water infiltration. The source of this water needs to be found in order to prevent the problems from reoccurring (Figure 97).
- Paint on the south door is alligating and is worn off on the bottom sill.

**Figure 96. Alligatoring of paint on the north wall.**

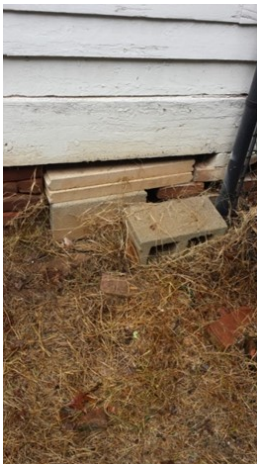
*Figure 100: South façade with concrete supporting brick pier.*

1. Consult a proper contractor familiar with historic mortar and foundation.
2. Repoint as necessary throughout the running brick foundation.
3. Rebuild the foundation with bricks on site
  - A. For the openwork/lattice brick work, rebuild/repoint bricks needed to keep the historic design for the entire structure.
  - B. And if concerned about rodents getting underneath the house, owners can patch voids with half-inch hardware cloth.

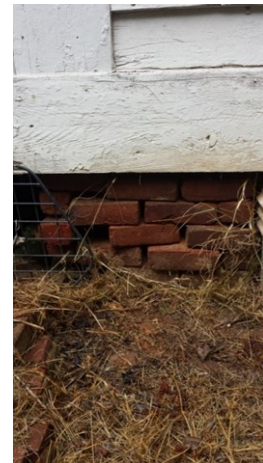
*Figure 101: South façade foundational brick pier recommended repointing*

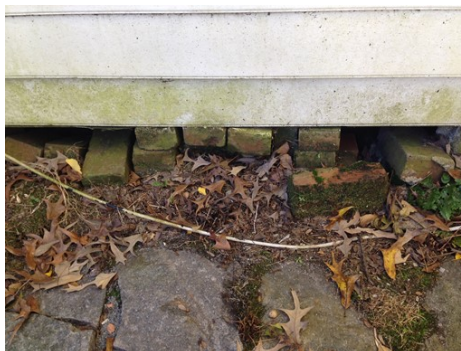
*Figure 102: West façade foundation with loose and deteriorating foundation.*

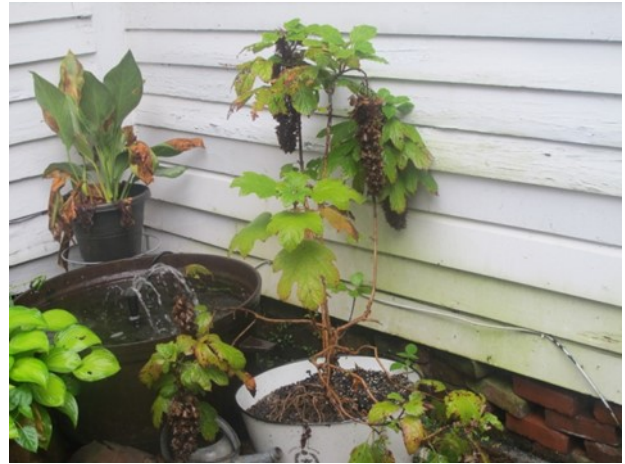
**Figure 109:** West Façade with vegetation too close to exterior siding.

1. Identify the cause of the moisture problem.
  - a. As seen in Figure 109, exterior vegetation is causing a microclimate and allowing moisture to seep into interior walls. Move plants away from house.
  - b. The second floor of the central addition has no external gutter system
    - Install the external gutter system to allow the flow of water to run away from the surface of the houses.
2. Repair rotted wood as needed and replace what is not stable.

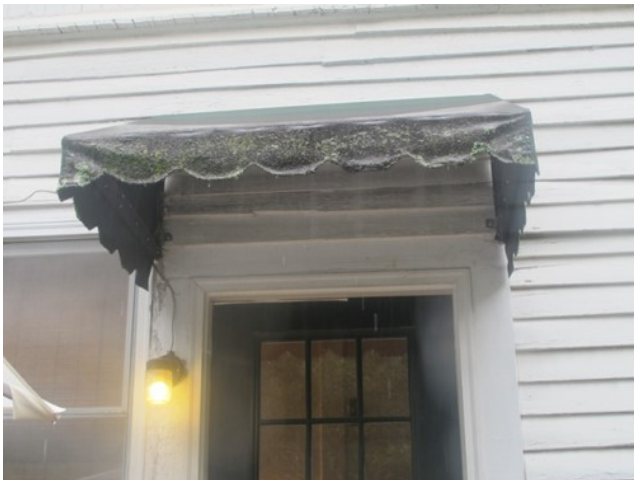
**Figure 110:** West Façade algae growing on awning due to excessive water.

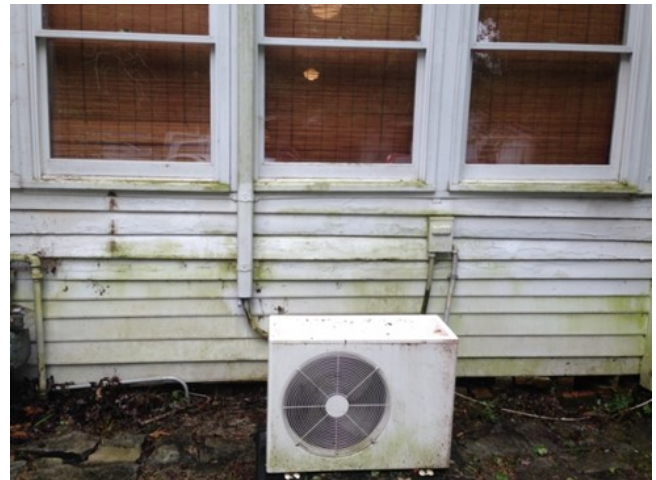
**Figure 111:** West Façade with microclimate visible underneath exterior windows.

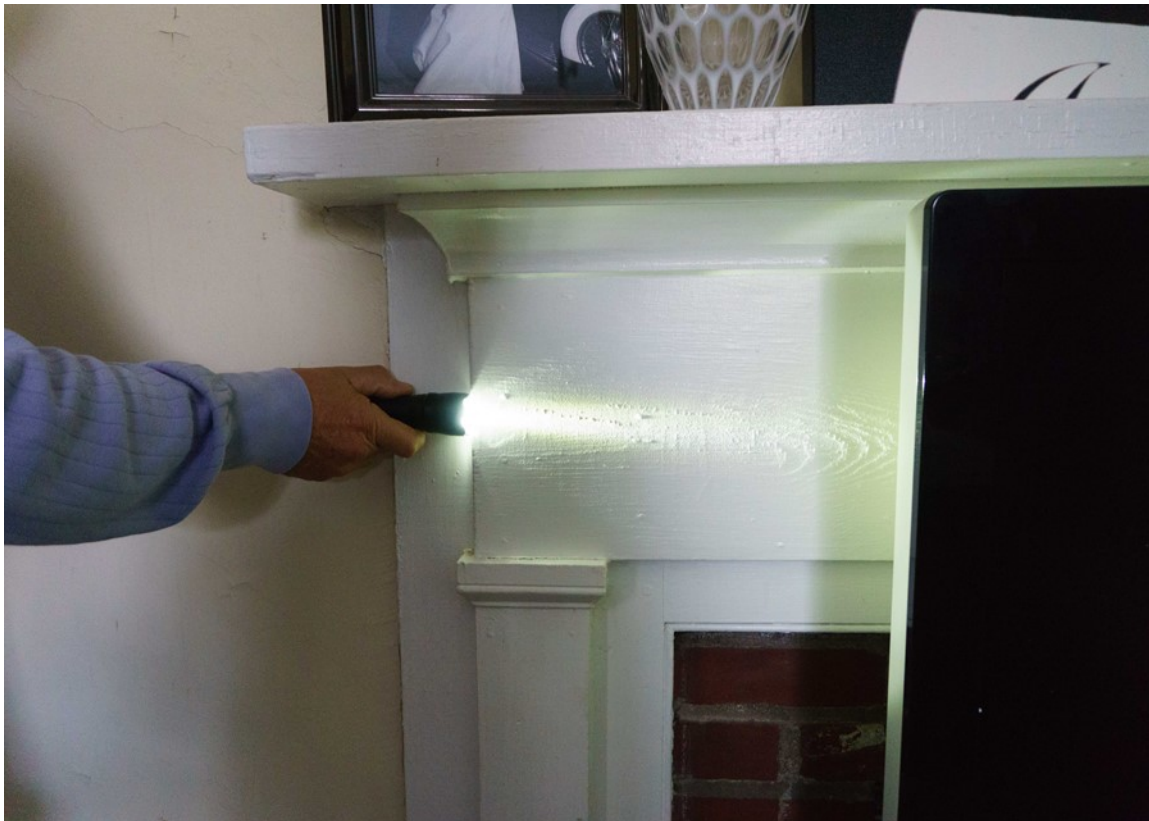
Walls have been painted and or papered at least 10 times. Mantel appears to have been grained.

Photo of Mantel showing graining outline.

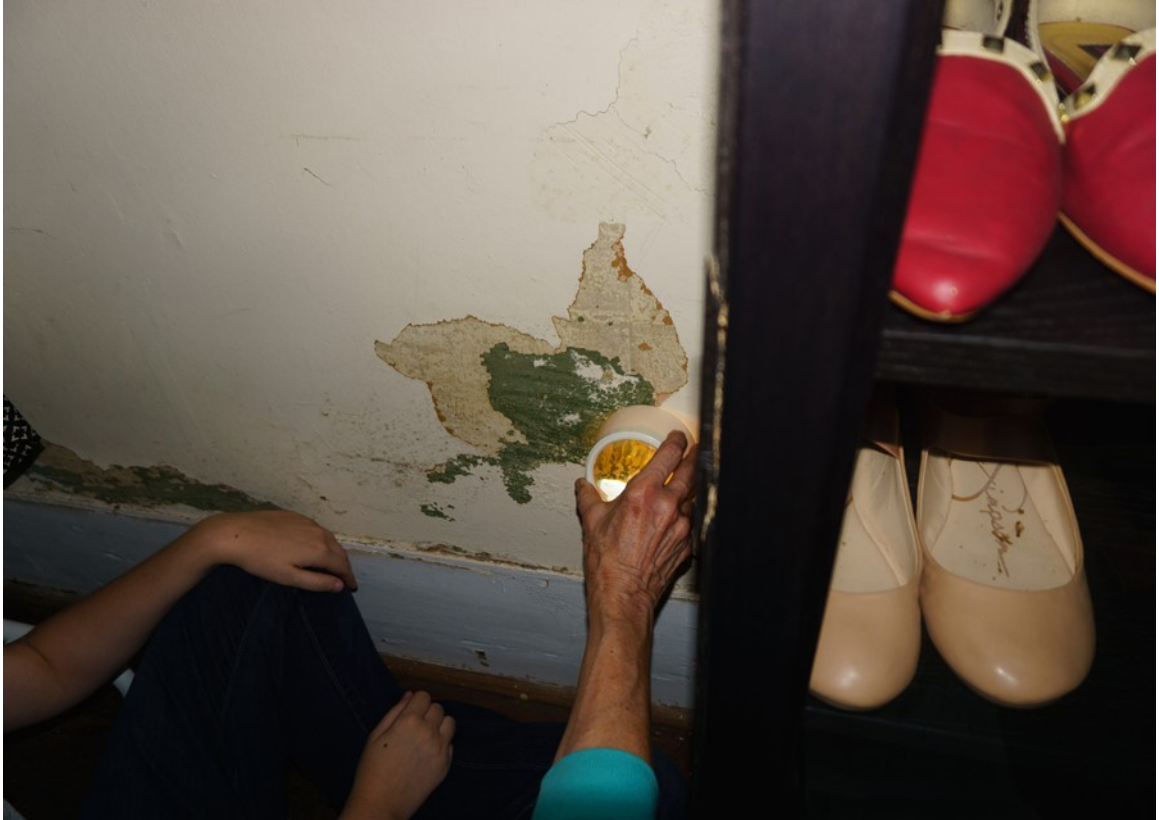
Photo of wall showing multi-colors.

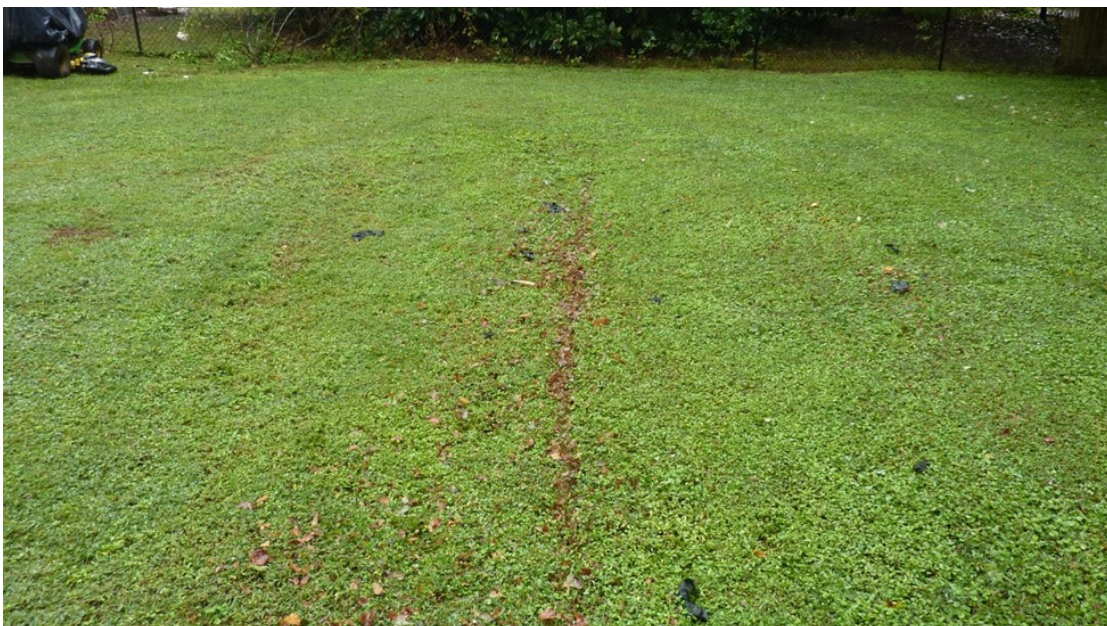
***Archaeological Feature 1***

Feature 1 is an ovoid depression located in the cleared portion of the rear yard southwest of the main house. This depression measures approximately twenty-five feet by fifteen feet and is oriented with its greater length along the east-west axis. No excavations were performed within the feature and investigations were limited to a visual inspection. Without a detailed investigation of Feature 1 through excavation, it is impossible to offer any interpretation as to the nature of this feature. The proximity of Feature 1 to a residence continuously inhabited since the mid-nineteenth century suggests that it is potentially cultural, however any assumptions about the nature of this feature would be pure conjecture. It is recommended that the property owners avoid

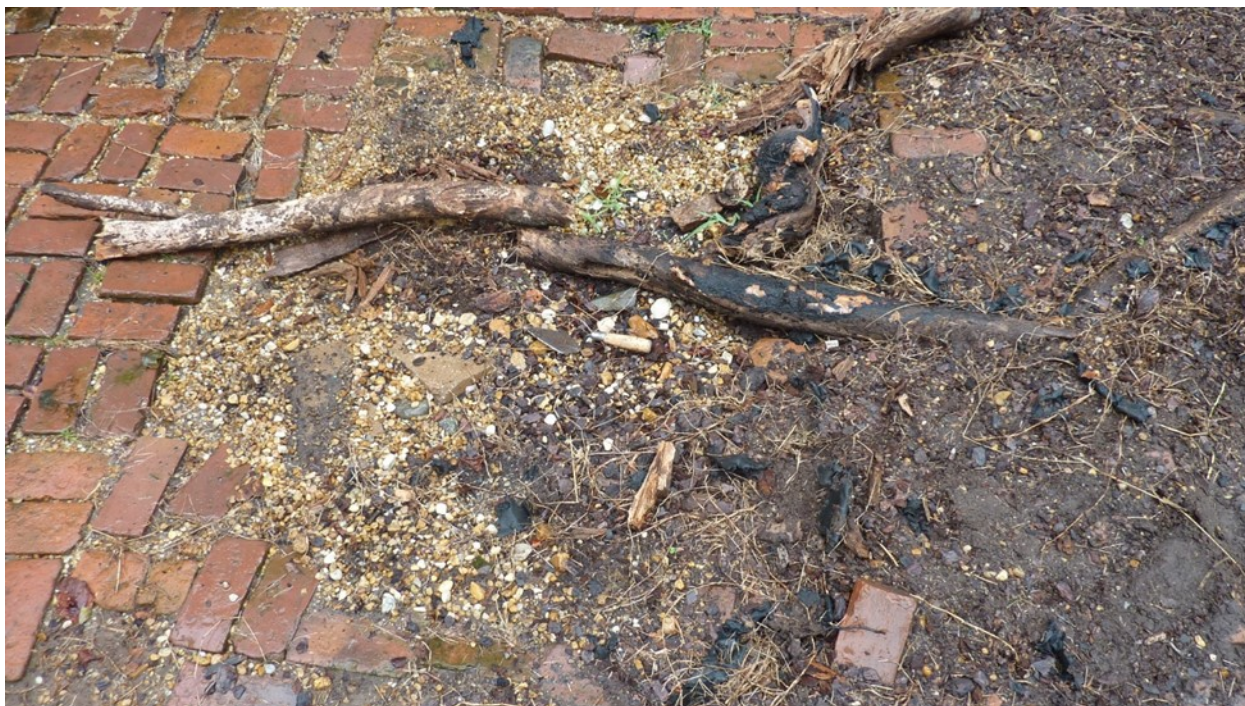
*Archaeological Feature 2*

Feature 2 is a round anomaly located within the boundaries of the single-coursed brick patio at the rear of the Avary-Fulton house. The feature measures approximately 4.5 feet by 4.5 feet. Upon visual inspection, this feature contained a sandy fill mixed with leaf litter and other plant materials. Oral communication with the current resident suggests that Feature 2 is a well, however no archaeological investigations aside from a visible inspection were performed to support this theory. Historic wells can provide a wealth of data concerning the material culture present at nineteenth century residences. The potential for archaeological research yielding significant information at Feature 2 is great enough to warrant its preservation. It is recommended that Feature 2 remain undisturbed until a thorough research plan can be devised.

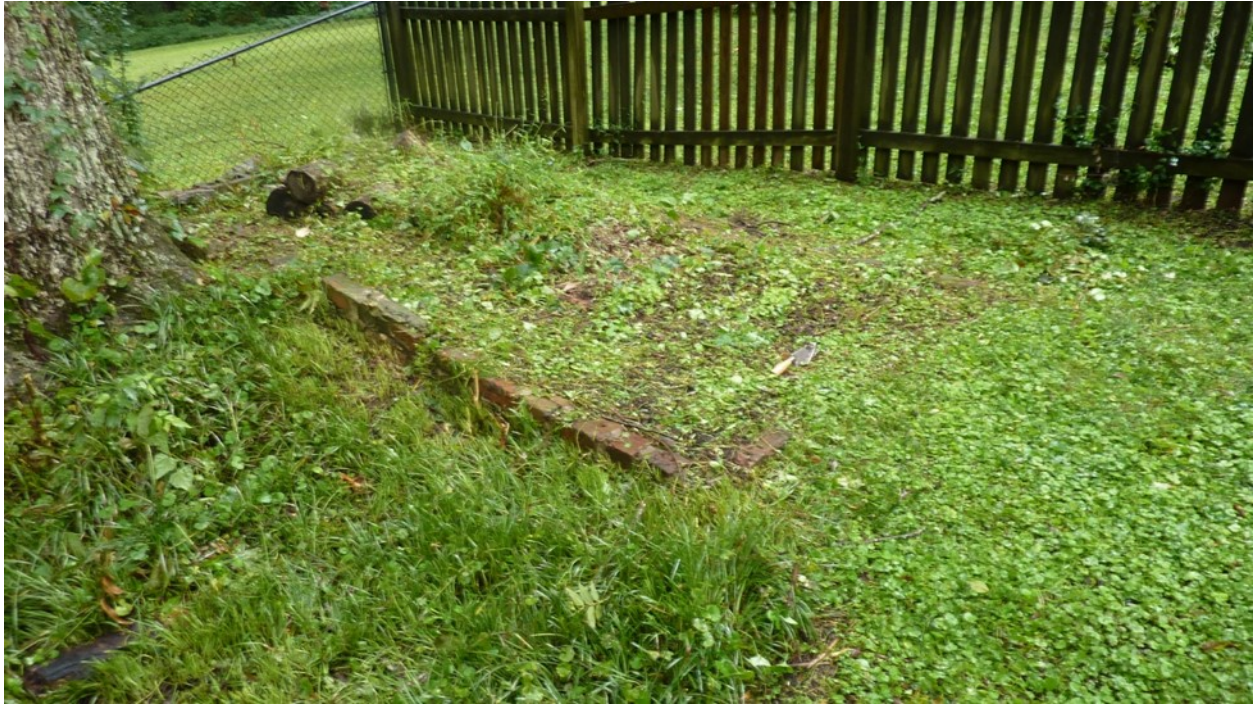
*Archaeological Feature 3*

Feature 3 is a low-lying rectangular brick and mortar foundation in the rear yard of the house. Oriented with its greatest length along the east-west axis, the feature measures 13 feet 10 inches by 6 feet. Archaeological investigations of Feature 3 consisted of a visual inspection and non-intrusive probing along the base in order to establish the feature's possible depth. A sandy loam fill covers much of the masonry structure's interior. As with all of the archaeological features associated with the Avary-Fulton House, it is recommended that Feature 3 remain undisturbed in its current state.
