## Sherrill House

# The Sherrill House

Forsyth County, GA

## Historic Structures Report

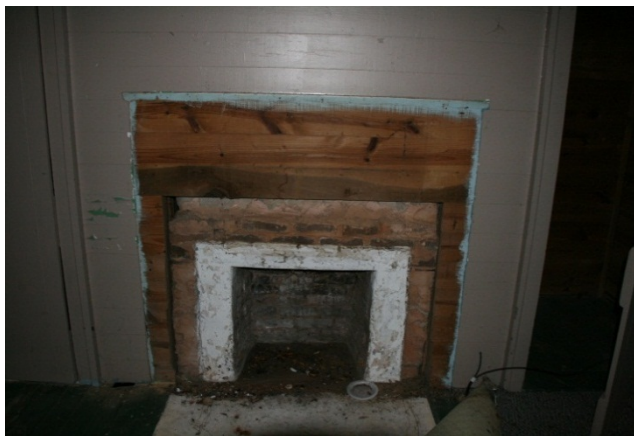
BC Figure 3: Fireplace in Room 104 that is missing a mantel

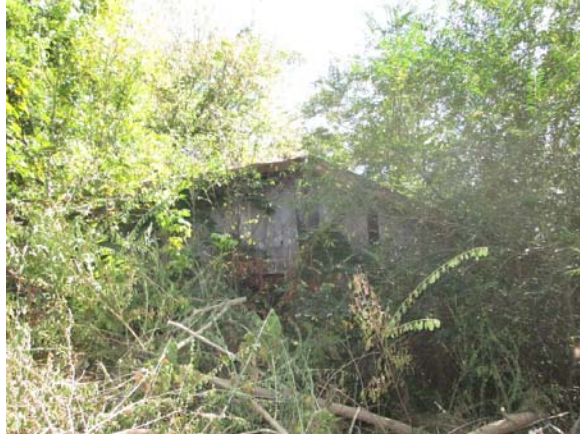
Behind the south and south west sides of the property, there are three outbuildings. The largest one is located directly south of the property (SD Figure 2). It is a simple wood frame construction that is structurally unsound. The roof is caving in and the eastern most wall is severely compromised. The walls of this structure consist of 16" planks. To the west of this outbuilding is a modern well (SD Figure 3).

SD Figure 2: Outbuilding

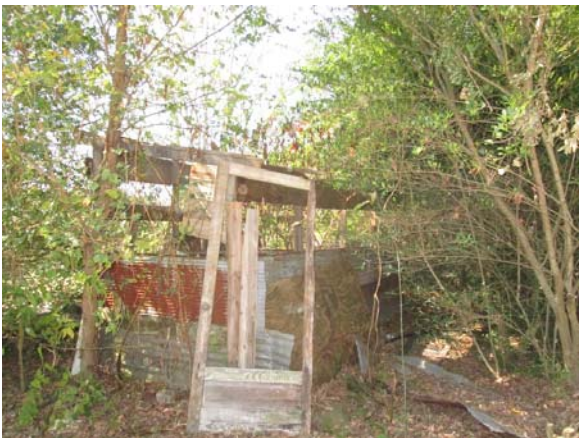
To the southwest of the house are what appear to be old dog cages or hen houses (SD Figure 5). There is also a trash pile that should be removed. About 50' from the old trash pile, located within some brush, is a pile of old brick, some of which looks burnt on one side (SD Figure 6).

SD Figure 5: Chicken House

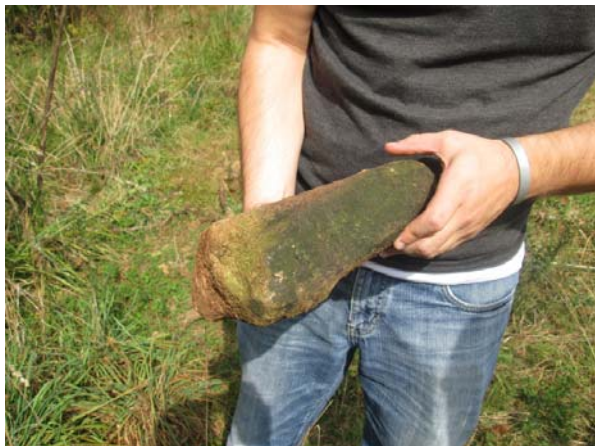
SD Figure 6: Burnt brick from pile behind the house

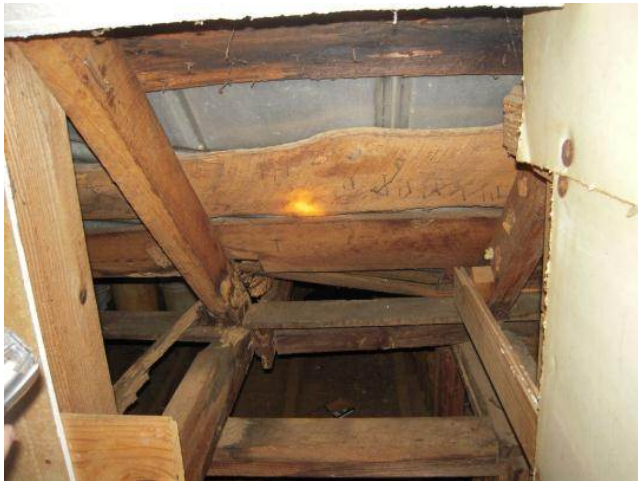
AD Figure 3: Remnants of wood shingles and underlying sheathing with visible nails

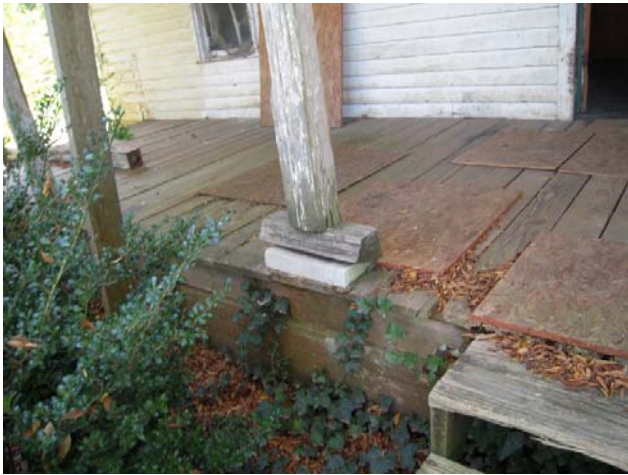
AD Figure 7: Unstable porch column on the North Facade by front door

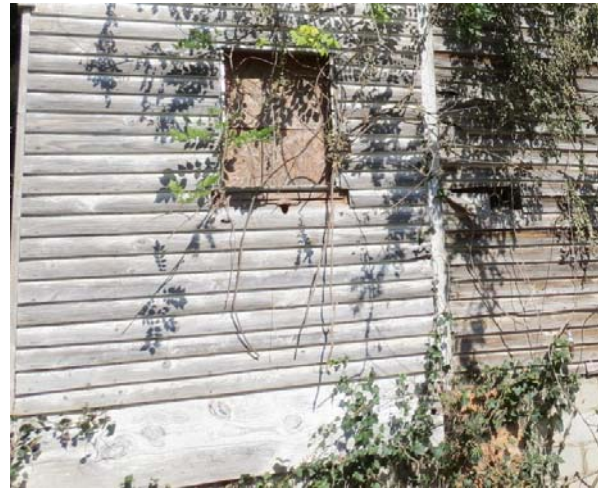
AD Figure 10: Variation in the paint color and the change of the clapboard siding on south façade

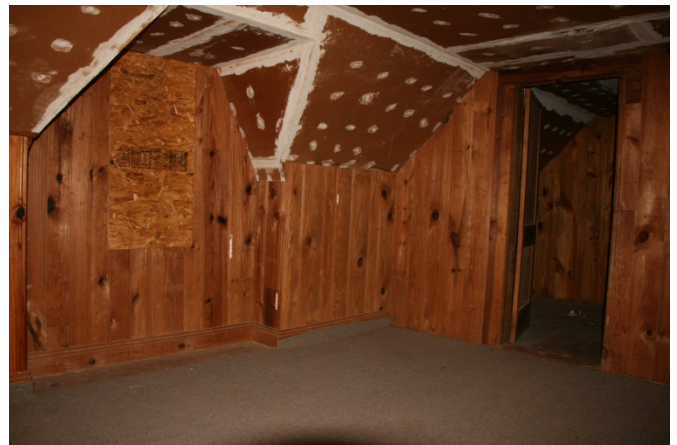
AD Figure 47: Room 203 looking west toward paneled walls and dry walled wall

Room 203 is located on the second floor above room 103 (AD Figure 47& 48) Room 203 is 11'-9" x 11'-11". Window W20 on the north wall of the room is on the north facade on the house and the window W21 on the west wall of the room is on the west facade of the house. The windows in this room are one-over-one single-hung<sup>98</sup>. Door D18 is an unpainted two-panel door that leads out to the upstairs hallway. The molding around the door is consistent with the molding downstairs in Room 102 with molding types one and two<sup>99</sup>. The floorboards underneath the carpet are rotten and uneven. The walls in Room 203 are angled and asymmetrical on the east-west sides. The walls in Room 203 have a mixture of wood paneling and gypsum board on the upper half of the wall. Room 203 has a second doorway, D20, on the south wall that leads to Room 205.

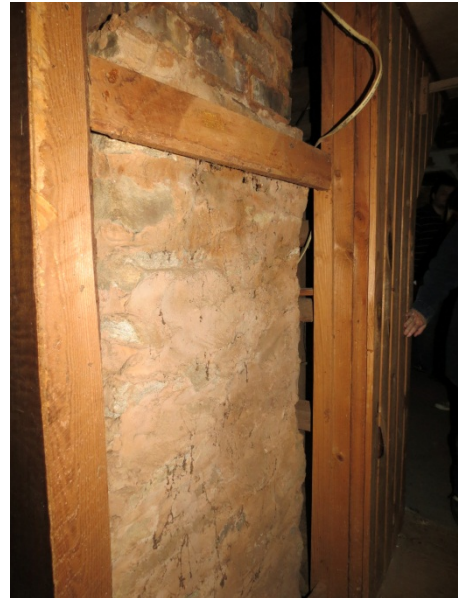
AD Figure 49: Room 205 looking south

Room 205 is situated above room 105 (AD Figure 49). The room is 18'-1" x 11'-11" Room 205 has various openings where the finished ceiling is visible and drop ceiling is visible. There is a large opening on the south wall of the room that makes the attic space in room 208 highly visible and accessible. At first entrance to room 205 there is a hole in the wall to the immediate right that exposes the north chimney and shows that it is stuccoed partially at the bottom (AD Figure 50) The walls in the room are Styrofoam insulation. The east wall of the room is entirely missing and the framing over room 102 is visible. There is visible moisture damage in the exposed framing. The wood floor in the room is cracked in several places. At the northwest corner of the room, there is a small closet space. The door, D21, is missing, but the closet space leads to more exposed framing.

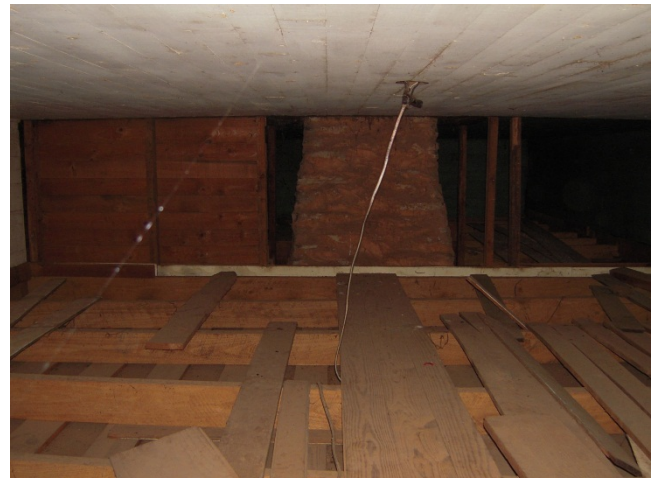
AD Figure 51: Attic space in Room 208

Room 208 is left open and the structural elements of the room are visible from room 205 (AD Figure 51). The room is not intended to be seen or accessed. Rafters and sheathing are visible. The south chimney is visible and is bricked with a stuccoed detail toward the base. There is vegetation starting to grow in the space. What serves as the floor for room 208 is really the original first floor ceiling to rooms 105 and 108. There is visible, loose wiring that has been run through the dropped ceiling to provide electricity to the rooms below. There is a single-light window, W22, which is on the south wall of the attic.<sup>100</sup>

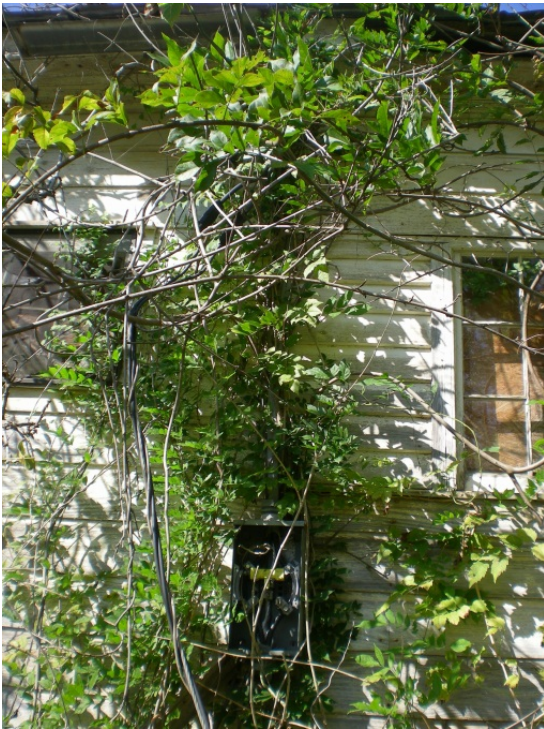
(CA Figure 16 and 17)

CA Figure 16: Electric meter obscured by overgrowth, east facade, facing west.

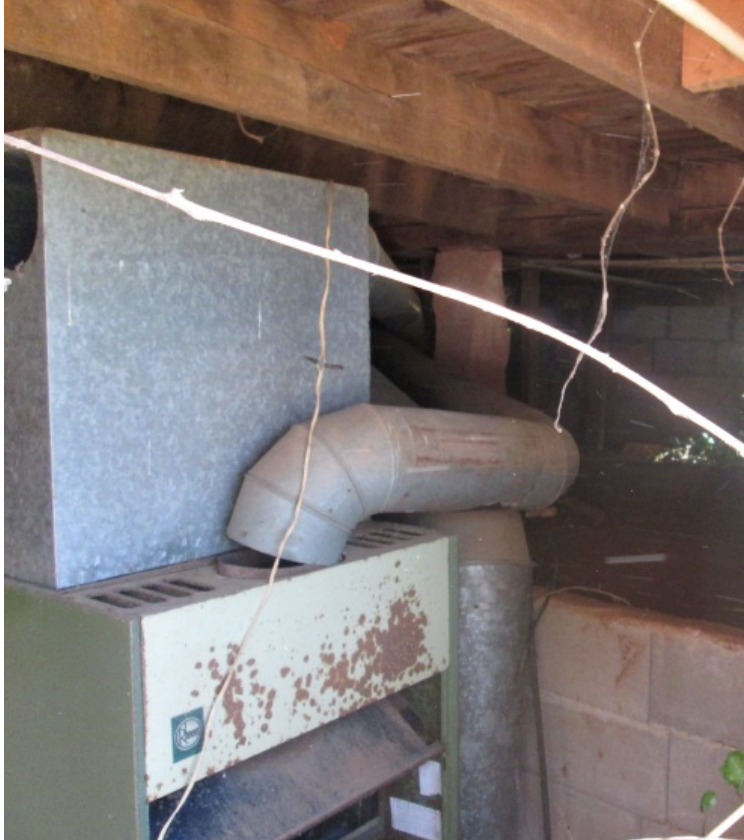
CA Figure 17: Heating unit and disconnected ventilation ducts. In crawlspace facing northeast.

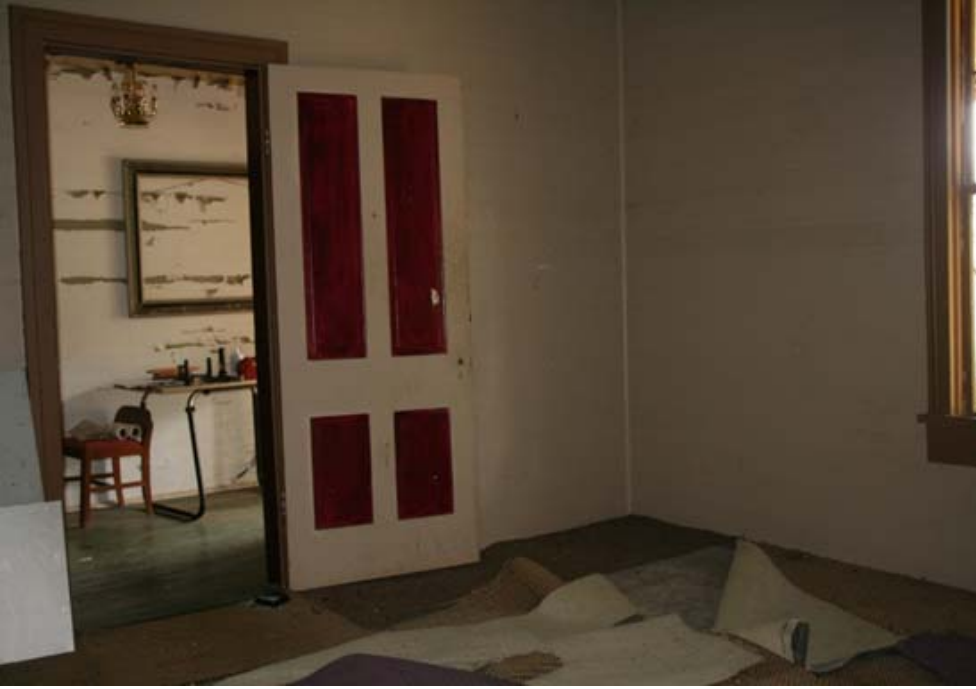
CA Figure 19: Room 101- Historic door (D1)

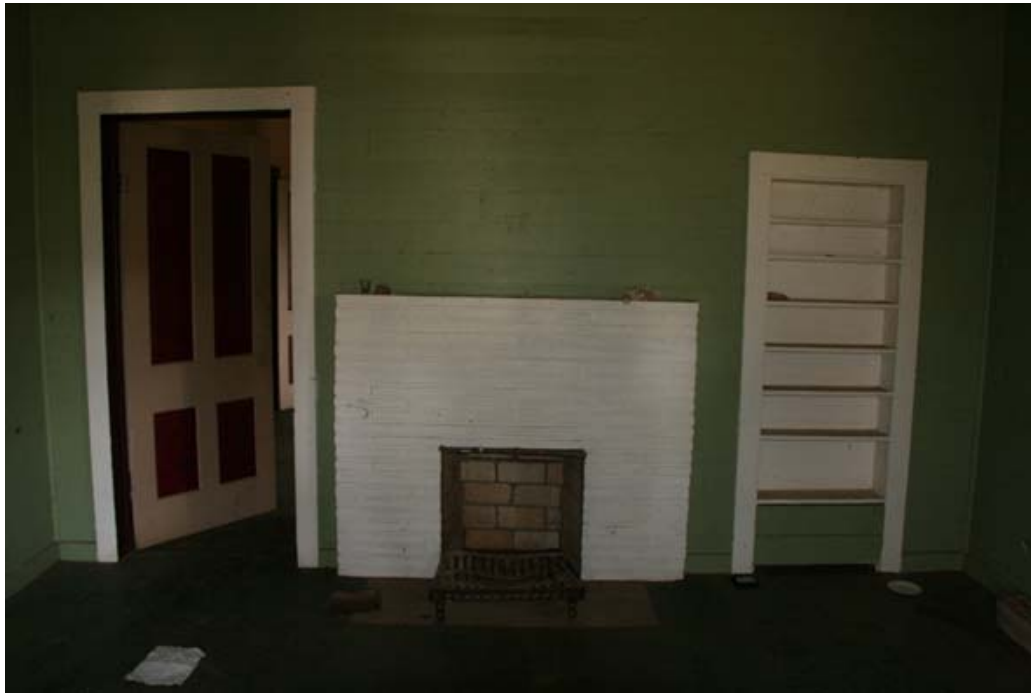
Overall this room is in good condition (CA Figure 21). The floorboards, the wood panel wall siding, and the ceiling are all stable. Acoustical tiling on the ceiling has been removed and staples remain. The two four-over-four, single-hung windows, Windows W3 and W4, need their muntins repaired or replaced. The broken lights need to be replaced. Broken glass needs to be removed from the floor. Dead vermin and animal excrement are present and are health hazards.

CA Figure 21: Room 103- Built-in bookshelf, coal burning fireplace

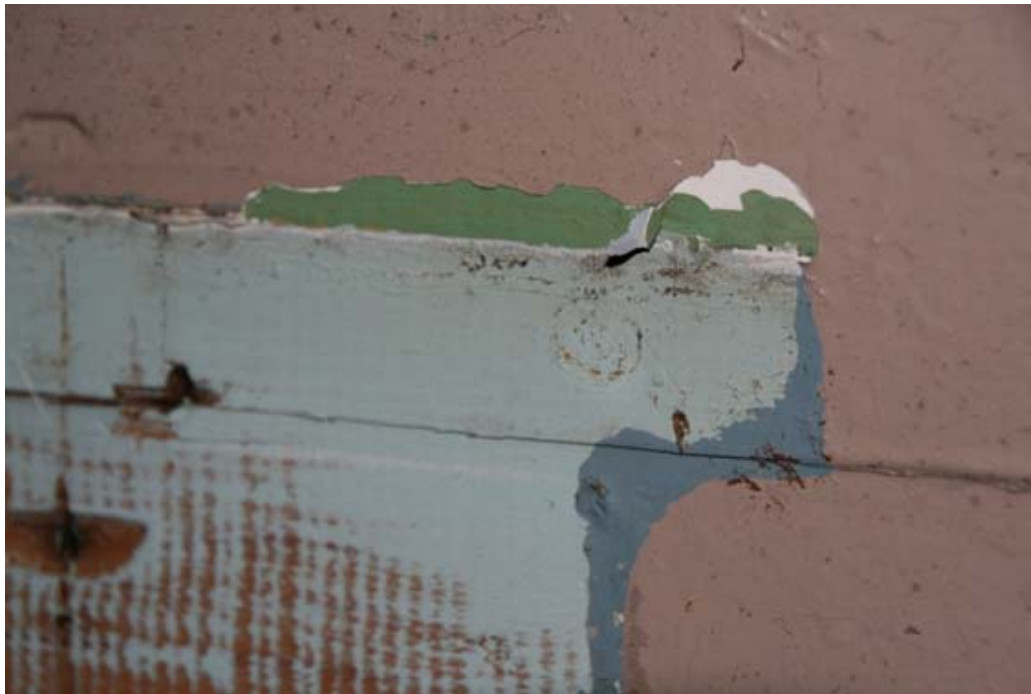
This room is very dark since the two windows, W5 and W6 are boarded up. The hardware on D4 is missing. Stained carpeting covers the wood flooring. No significant damage to the wood underneath the carpet is evident. A hole in the gypsum board<sup>117</sup>, drop-ceiling<sup>118</sup> shows water damage (CA Figure 23). The gypsum board was likely installed to cover the water damage but failed to fix the underlying cause of the problem. The current tan paint is peeling indicating it is latex based. A basic paint analysis taken near the missing mantel showed that there are six layers of paint. Light blue is most likely the original color of this room (CA Figure 22).

CA Figure 22: Room 104- Paint Analysis

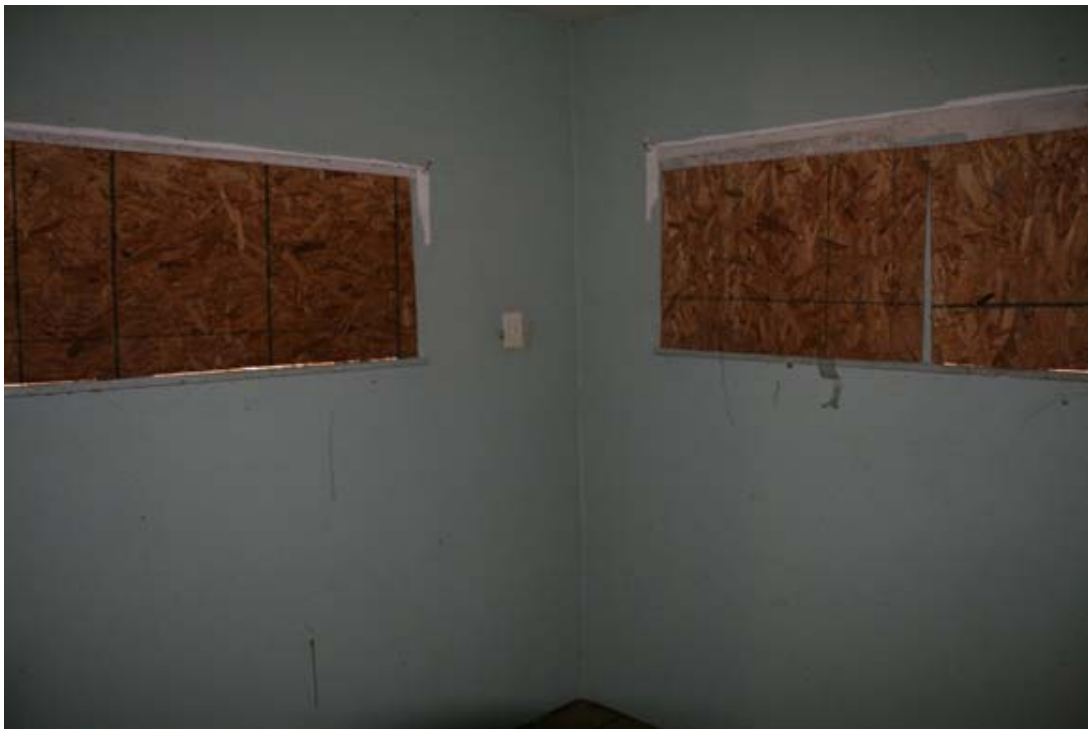
W11 and W12 in the room are boarded. Broken glass is on the floor. D14, leading into Room 107 is missing. The gypsum board covering the walls and ceiling are in good condition (CA Figure 26). A modern phone jack can be found on the east wall and electrical sockets are not operational.

CA Figure 26: Room 109-Gypsum board walls; boarded windows

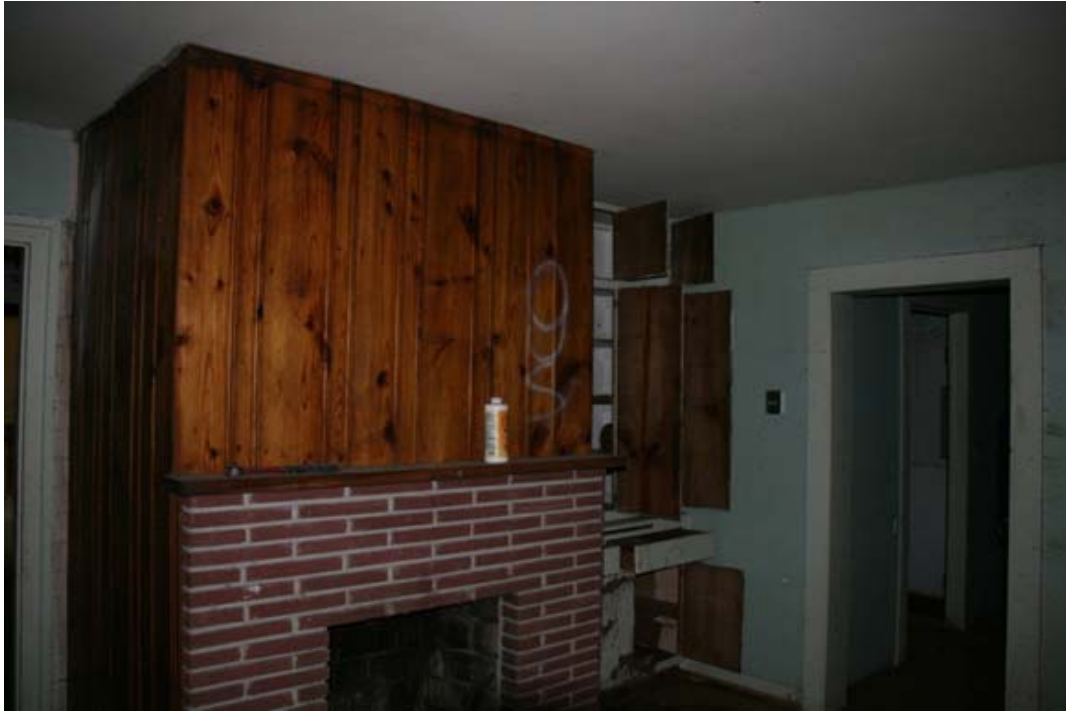
Major alternations are visible in this room since the building's original construction. Also, the mantel and wood paneling above the fireplace are additions (CA Figure 27). Spray paint is visible on the wood paneling. A major feature of the room is the cupboards that are built into the northeast wall. Dead insects and vermin are present in this area. Plants are growing through W14

on the south wall and W15 on the west wall. Vegetation is causing discoloration to the walls and moisture damage inside.

CA Figure 27: Room 110- Built in cabinets; mantel and wood paneling

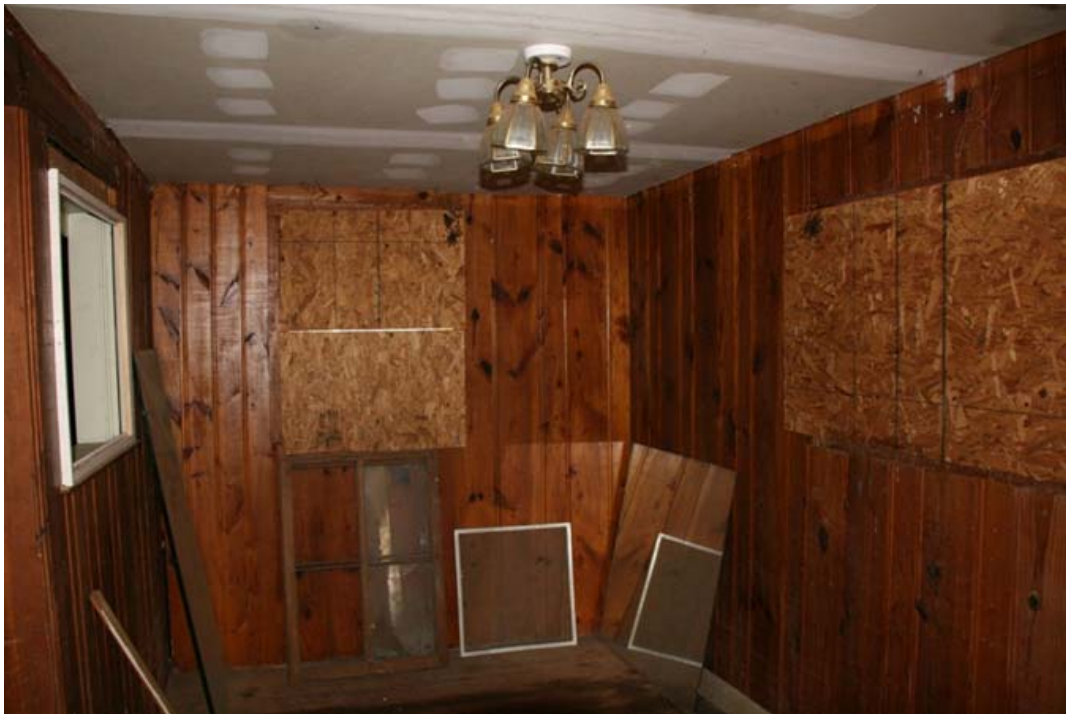
The ceiling is covered with patched gypsum, and water damage is seen from the ceiling and walls. Mud daubers and their nests are found on the OSB covering the windows. D17 is missing all of its glass, leaving this room exposed to the elements. (CA Figure 28)

CA Figure 28: Room 111-Boarded windows, wood-paneled walls

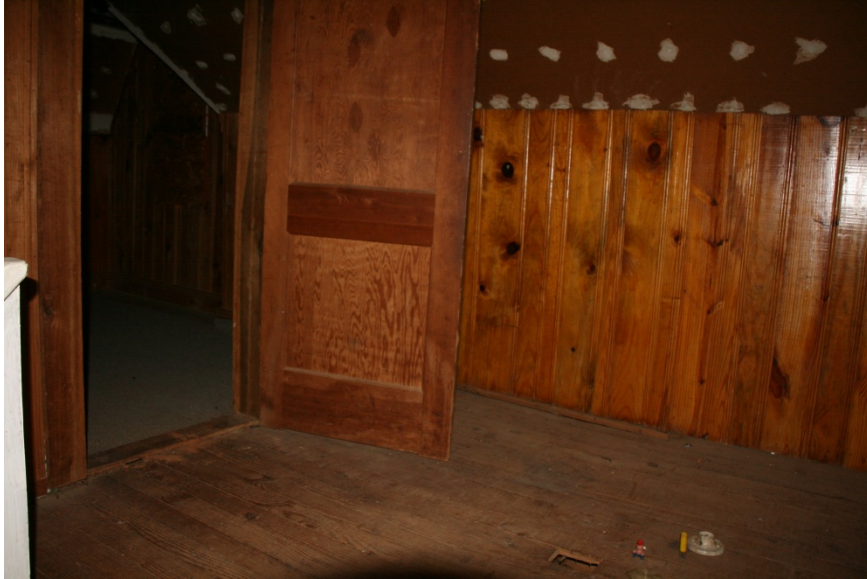
There is no hardware on Door D19 and Door D22 except for hinges which appear to be basic consumer grade products. The staining on both doors does not match that of the paneling. (CA Figure 30 and 31) It does not have the high gloss of the paneled boards.

CA Figure 31: Room 202-Door D22 without high gloss stain prominent against high-gloss finish on north wall behind it. Bottom center of picture shows the hole in the floor to access ceiling light in Room 102.

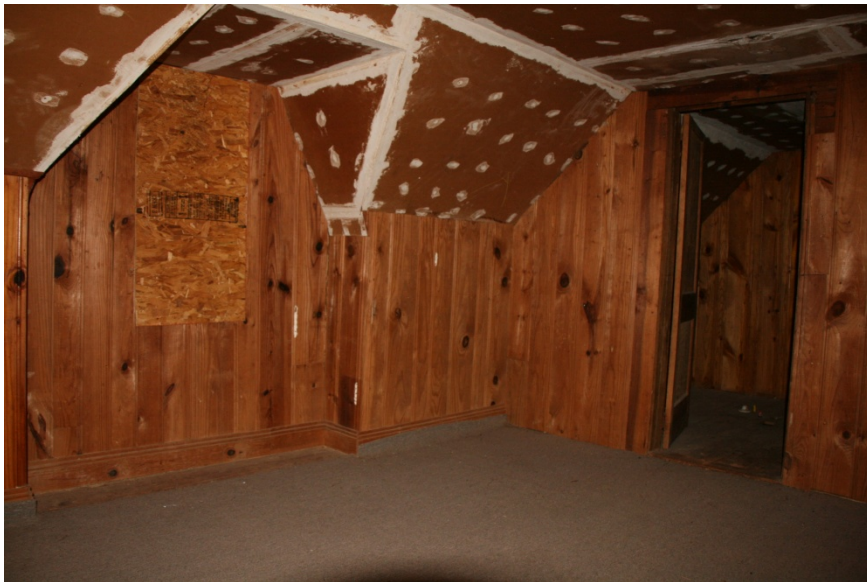
This room is in the best overall condition of the three north rooms on the second floor. (CA Figure 32) The gypsum board in this room is in good condition but has never been painted. The two single one-over-one windows W20 and W21 have been boarded up from the inside, so conditions could not be fully assessed. Based on an exterior assessment, all elements of the windows appear to be in place and are in relatively good condition. Mud daubers' nests can be found all over the walls of this room. Other nesting insects were found throughout the entire room. There is one electrical outlet on the south wall in this room.

CA Figure 32: Room 203's level of finish and condition is better than those observed in Rooms 201 and 202.

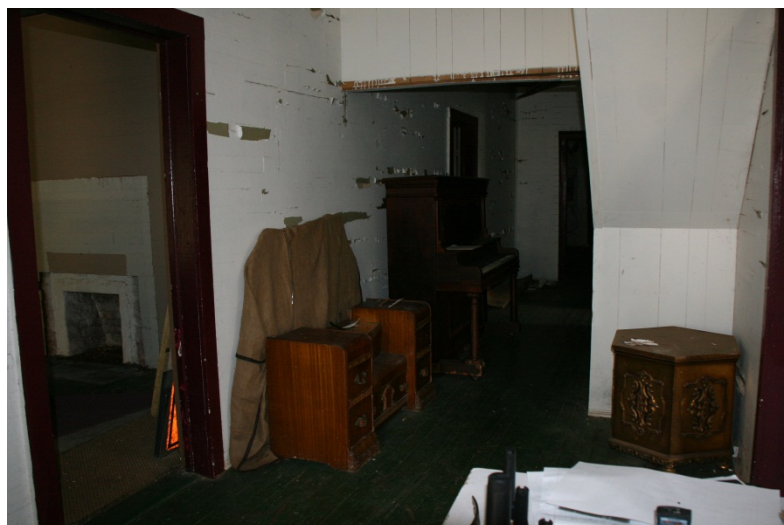
Stairway and wall in Room 102 are currently covered in peeling latex paint. Latex paint often does not adhere well to early paint layers. There are two early colors on the wall and the latex paint was applied later as a decorative scheme. The original analysis for the hallway indicates that the hallway was painted with blue-grey walls and white trim. The more recent paint layers were applied within the past four decades. The two layers under the latex layers were applied mid-twentieth century. The stair railing was initially painted white, and then it was painted green when the hallway was painted green.

Room 102 and peeling Latex paint on walls
