# RESILIENT INFRASTRUCTURE

## RE-TESTING OF A FIRE-DAMAGED BRIDGE

Alexander M.C. Au,  
Senior Bridge Engineer, Highway Standards Branch, Ontario Ministry of Transportation, Canada

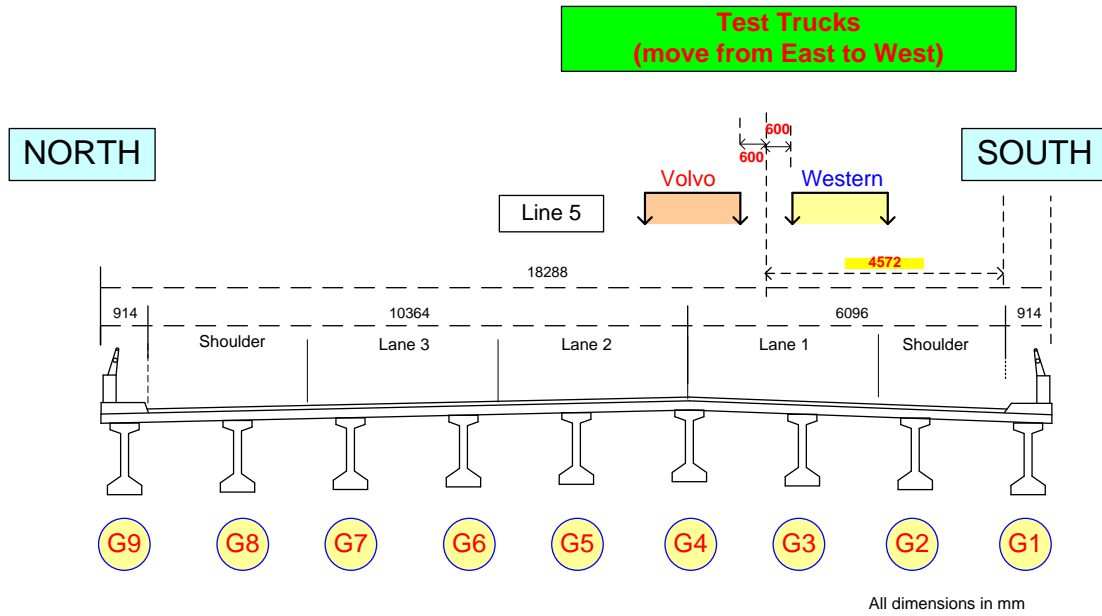
Figure 4: Load Line 5 on the Bridge

Based on the theoretical analysis and results from the load test in 2008, Girder 3 was known to experience the maximum response due to test trucks positioned transversely at load line 5 as shown in Figure 4. The second load test was carried out on November 23, 2014. The load test in 2008 was carried out in early October. The average temperatures at the site were different for both tests. However, the data obtained was processed after the test so that temperature effects were eliminated. Therefore, the resulting data were mainly due to live loads. For both tests, identical live loads were applied and so, the results from both tests were directly comparable.

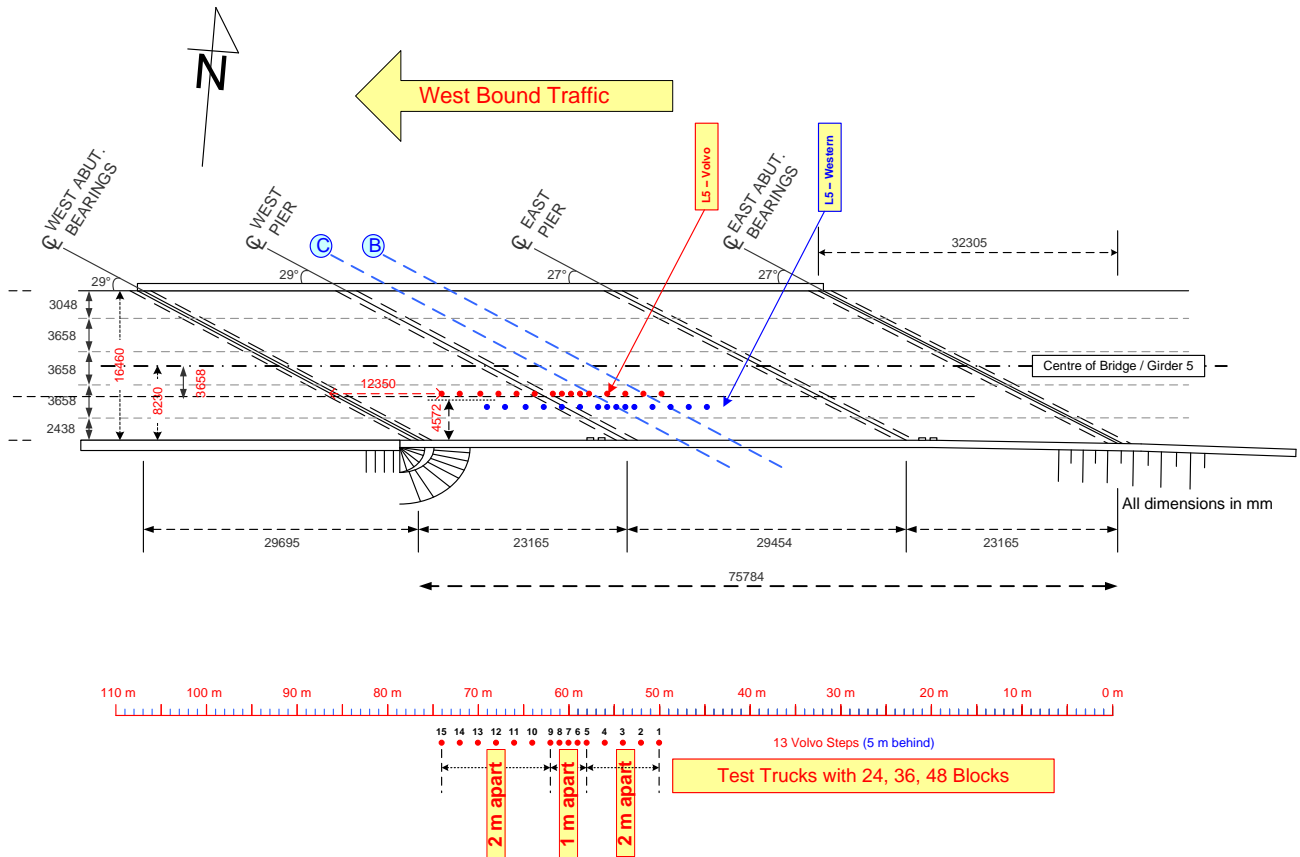
Figure 5: 15 Step Locations for the Test Trucks

Two test trucks loaded incrementally with concrete blocks to a maximum total gross vehicle weight of 650 kN and 668 kN respectively were moved together across the structure in 15 pre-determined steps. Three load levels were considered (i.e. 24, 36 and 48 concrete blocks per test truck). Each concrete block is about 1 tonne. The test trucks were moved along load line 5 that maximized the load effects on girder #3 (from south). Figure 4 indicates the transverse locations of the test trucks and Figure 5 shows the 15 load steps. 9 out of 15 steps were identical to that applied in the 2008 load test. 6 more steps were considered in the second test in order to generate a broader range of behaviour. The maximum load will generate about 65% of the load effect caused by CHBDC (CSA 2006) design live load and 118% of the CHBDC (CSA 2006) SLS load. Because the bridge is carrying Highway 401 westbound collector traffic and there is a hospital nearby, it was decided not to close the bridge completely and to leave one lane opened during the load test. Although leaving one lane opened during bridge test is unusual, the following mitigations were used to minimize the influence of the data for girder 3: i) the test was performed in the early hours

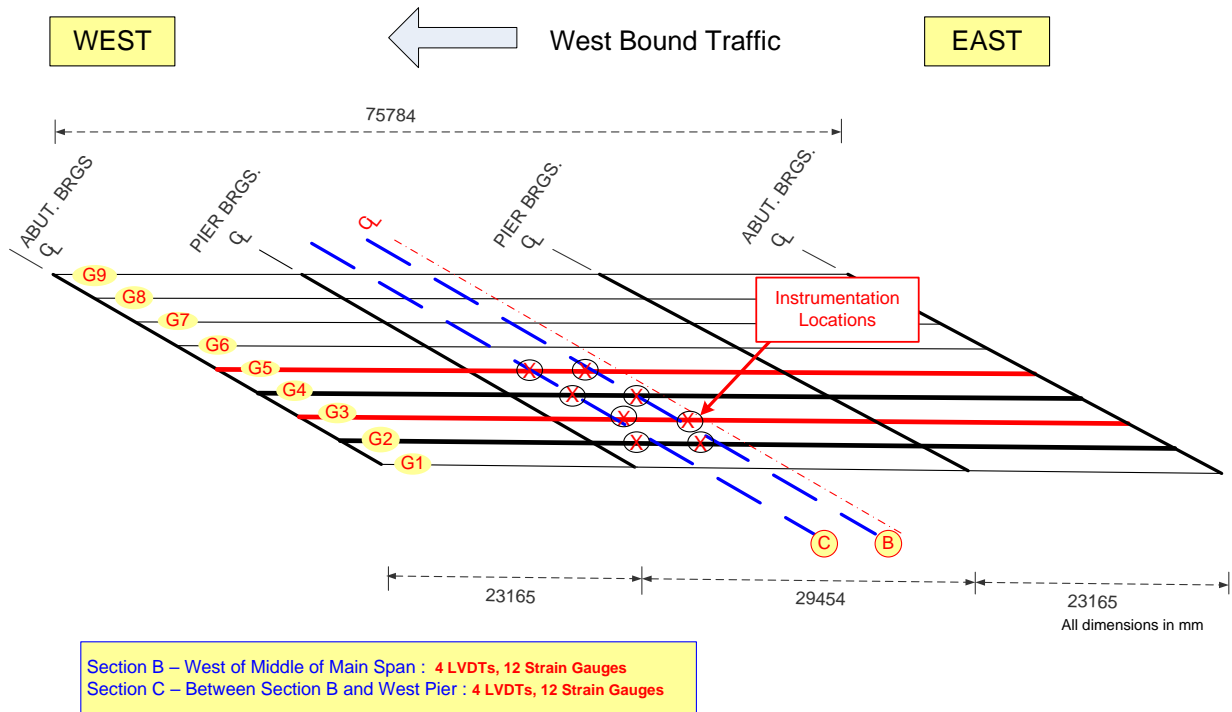
Figure 6: 8 Instrumentation Locations

From the experience of the load test in 2008, 8 locations on two sections B and C from girders 2 to 5 were monitored. There were 3 strain gauges and 1 LVDT on each location. A total of 32 gauges were installed. Figures 6 and 7 indicate the instrumentation locations. Figure 7 shows the channel numbers identifying 8 LVDTs and 24 strain gauges. Figure 8 shows typical LVDT and strain gauges. LVDTs were installed directly on the concrete surface to avoid the CFRP sheet. All strain gauges were installed directly on the top of the CFRP sheet. It was assumed a perfect bonding between strain gauges and CFRP warps (see Cerullo et. al. 2013). The instrumentation was carried out in the early hours on two separated Sunday mornings (November 9 and 16, 2014). Due to the repair of the girders and the installation of CFRP wraps, it was difficult to install the gauges exactly at the same locations as in the load test of 2008. Therefore, the gauge locations in this test were installed as close as possible to that installed in the 2008 load test. The performance of the strain gauges was a concern because instrumentation was carried out in November under wet conditions and near zero temperature. On the test day, one of the LVDTs and some strain gauges were found to be malfunctioned. In order not to further delay the test, these gauges were not fixed and were ignored.
