Investigation of Premature Distress Around Joints in PCC Pavements: Parts I & II

JOINT TRANSPORTATION RESEARCH PROGRAM

INDIANA DEPARTMENT OF TRANSPORTATION
AND PURDUE UNIVERSITY

Report Numbers: FHWA/IN/JTRP-2012/25 & FHWA/IN/JTRP-2012/26

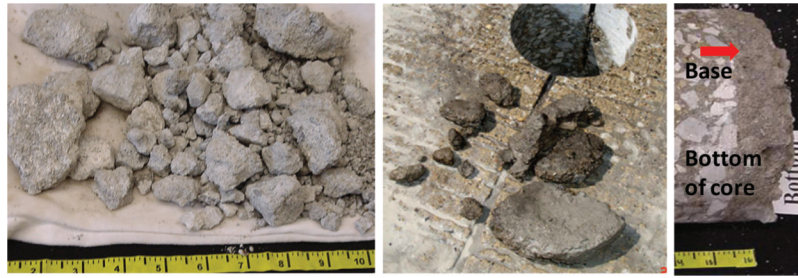
Figure 4.3 Examples of some of the base material cemented into larger chunks (left and center), and cemented onto the bottom of the core (right).

Sometimes the bottom of the core hole was hard and solid and no base material could be retrieved other than what was fused to the bottom of the core.

Based on the samples and drainage information collected, summarized and presented in Table 4.1 and Figure 4.2 it appears that where the base was a solid, fused mass the drainage was slow at the core hole and where the base was granular, with or without larger chunks, the drainage was moderate to very good. All core holes that had poor drainage were at joints. In Sections 1 and 2 where the drainage was measured at both joint and non-joint locations, the drainage was measurably reduced at the joints (1C, 1F, 1J, 2F)
