DEGRADATION ASSESSMENT OF NUCLEAR POWER PLANT EXTRACTION STEAM PIPING AFTER LONG TERM SERVICE

Degradation due to ageing in a Nuclear Power Plant's Extraction Steam Piping has been assessed. Samples of twelve years old seamless carbon steel SA 106B pipe have been taken and subjected to metallographic examination, hardness testing, radiographic examination and ultrasonic thickness measurement to investigate and analyze ageing in piping material. Metallographic examination of aged sample revealed irregularly distributed graphite nodules in ferrite grains and on grain boundaries as well, the reduction in pearlite phase has also been observed from 40% to 25%. This Transformation in microstructure has reduced hardness of steel. Reduction in hardness has found 20.4% and 0.7% on inner and outer layer of the pipe material respectively. Corrosion pits having average depth of 0.07 mm have been found on external surface. Radiograph of aged pipe revealed material removal and wall thinning due to erosion on inner surface of pipe. The extent of erosion had been checked, which has found 8.7%.

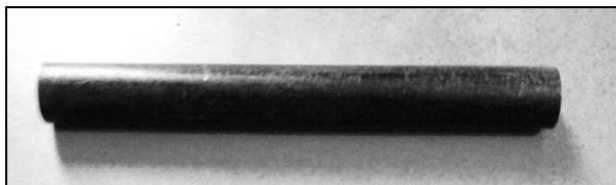
Figure 2 SA 106-B Seamless Pipe (As received)

Visual examination shows no disturbance in the uniformity of as received pipe (Figure 2). Whereas, aged pipe shows marked surface corrosion (Figure 3), confirming the long term service in sea shore environment. Corrosion has the potential to reduce a product's design life by premature degradation [23]. Examination of corroded surface under metallurgical microscope (Figure 4) revealed formation of 0.07 mm deep corrosion pits.

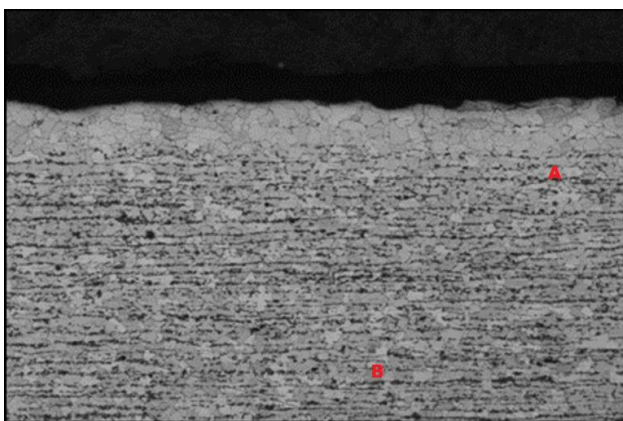
Microstructure of new carbon steel pipe exhibits bands of pearlite and ferrite (see Figure 8); which is typical of the extruded material [27]. Inner surface layer of new pipe is showing decarburized layer up to 0.1 mm occurred during cooling of steel to room temperature after hot extrusion [28]. This anisotropic structure shows poor resistance to impact load.

Figure 8 Nital Etched Microstructure of New Seamless SA 106B Pipe, 100X (A= Pearlite, B= Ferrite)
