Analysis and Diagnosis of the Church of Santiago in Jerez de la Frontera (Spain)

E. Rodríguez-Mayorga ^(*), E. Yanes-Bustamante ^(*), A. Sáez-Pérez ^(*)

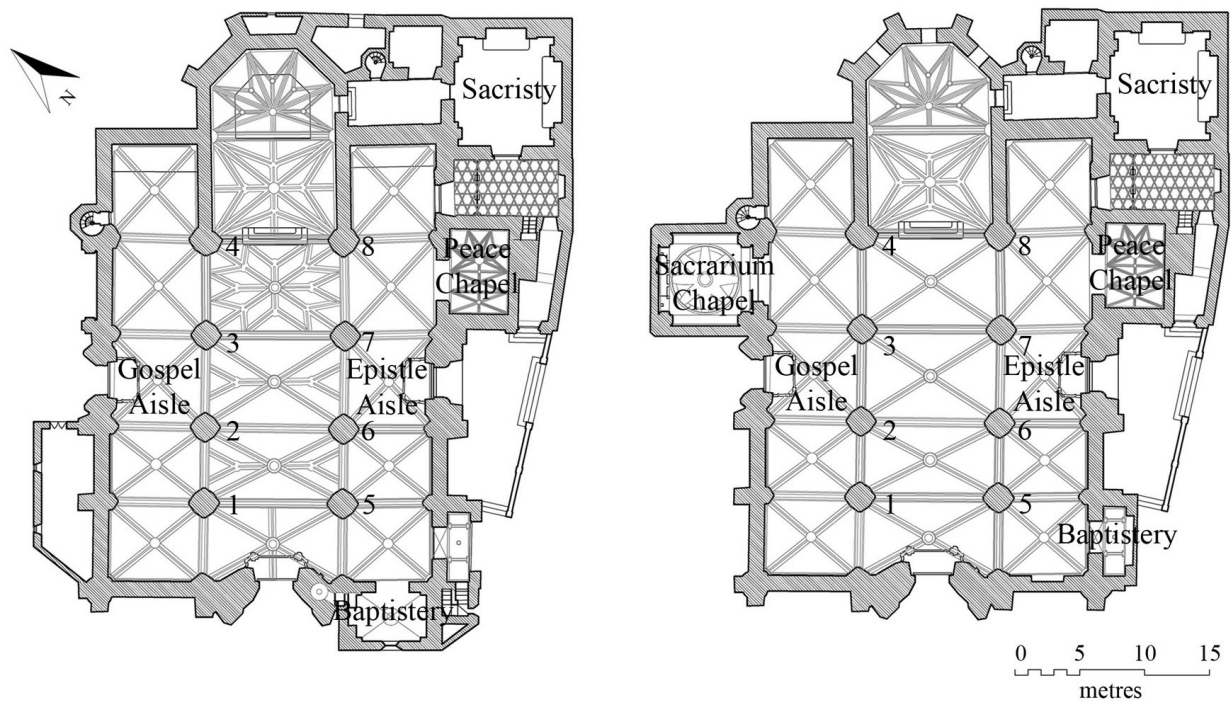
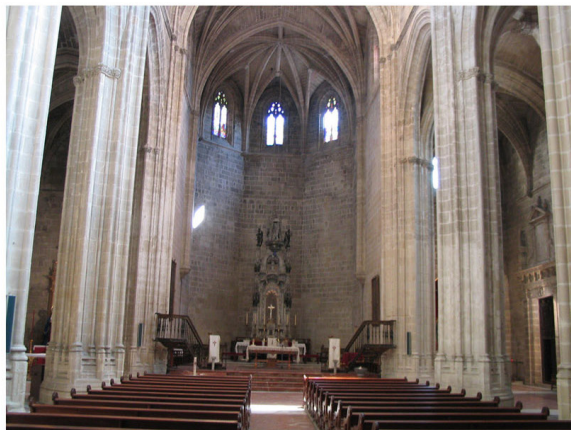
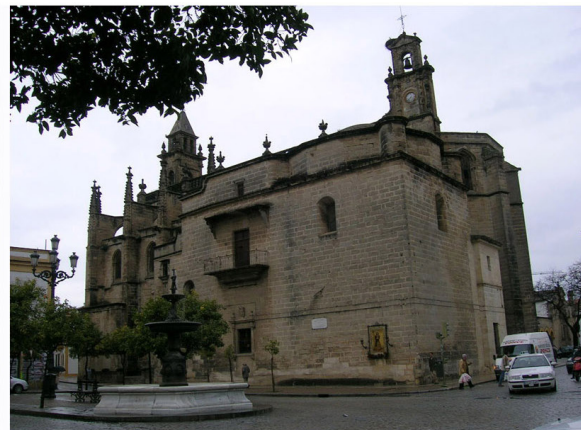
Figure 1. Church of Santiago: Plan in the XVI century (up left), current plan (up right) and some views (down).

The construction of the church of Santiago has occurred gradually along history, since it has been enlarged and embellished many times. Figure 1 shows the comparison of the plan of the church in the XVI century and the current plan, where the differences are noticeable. All these modifications have as a result a building which general measurements are approximately $43 \times 25 \text{ m}^2$ in plan and 20 m height at the central nave.

- Flying buttresses are missing in the two planes closer to the apse. The buttress in the east end wall is also missing and the buttress attached to the Sacramentum chapel is longitudinally drilled to host the spiral stairs (Figure 1).

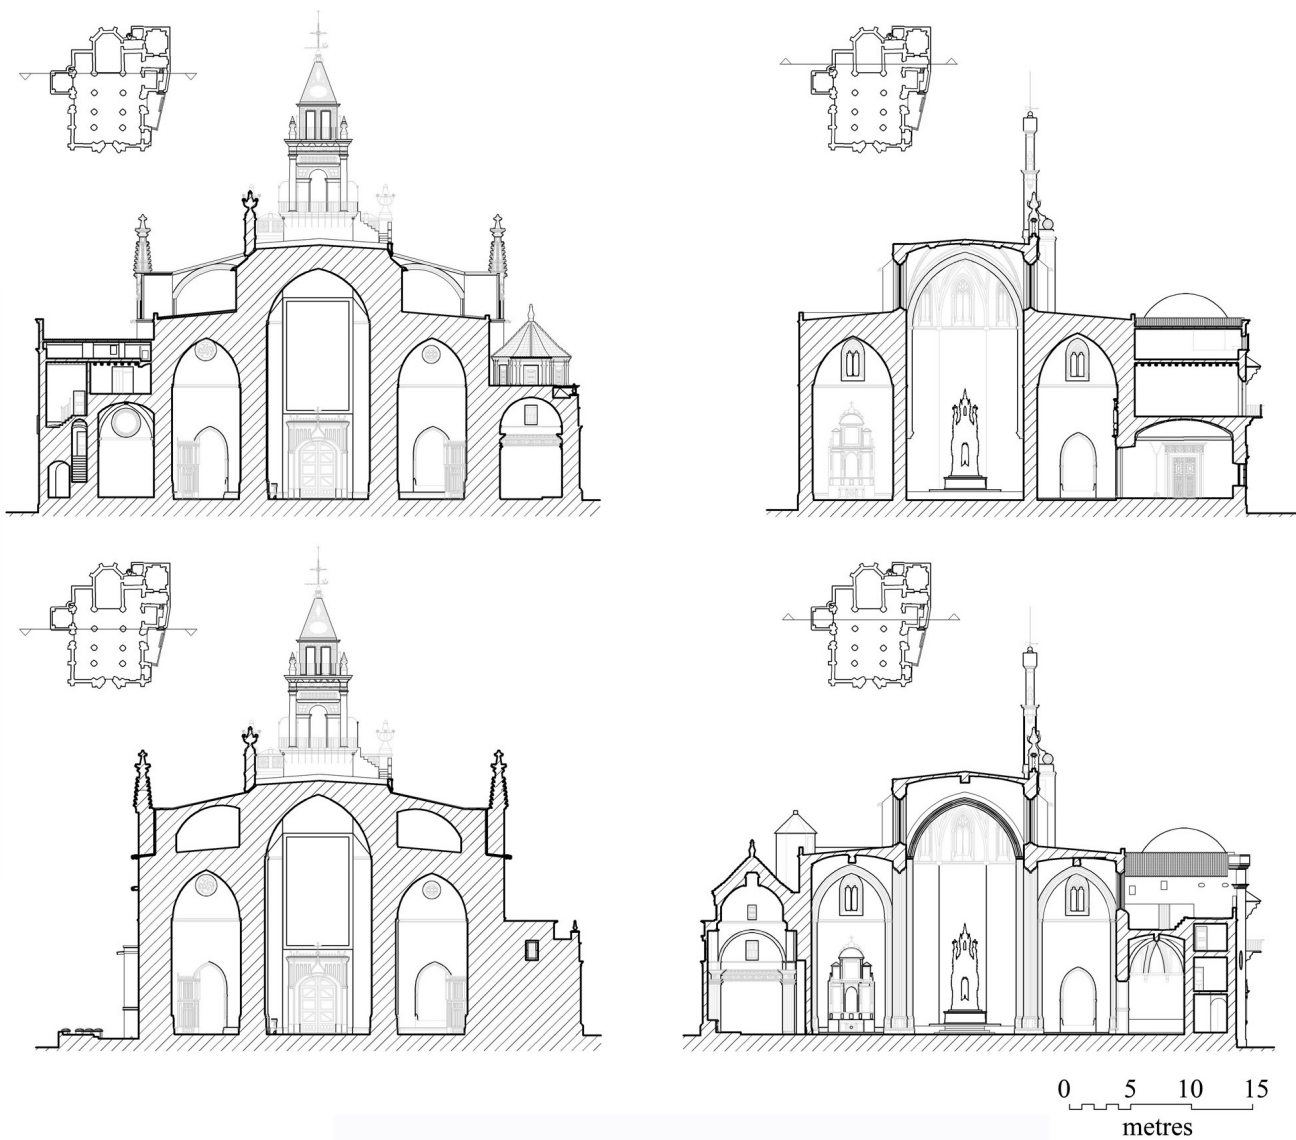
Figure 6. Church of Santiago: Transversal sections.

The structure of the church of Santiago is mainly Gothic. Gothic architecture is characterised by the relationship between geometry and equilibrium (16) (17). However, a geometrical analysis of the church of Santiago reveals some geometric irregularities which deeply affect its structural behaviour. This geometric analysis has been based on a survey carried out by classic methods. These irregularities can be listed as follows (Figures 1 and 6):

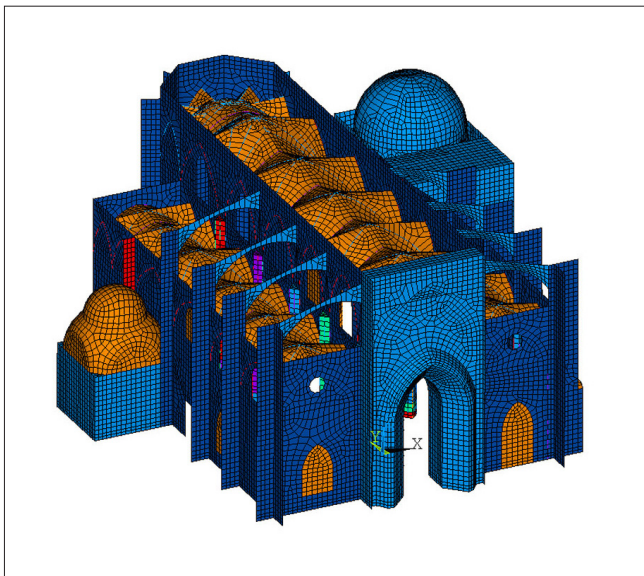
Figure 9. Numerical simplified model of the church of Santiago.

A simplified finite element model using 4-node shell and 2-node beam elements was carried out with the ANSYS® Multiphysics™ software (19). The resulting model has 48.880 elements and 41.487 nodes, as Figure 9 illustrates. Only dead loads (including the vault infill) were considered for this preliminary calculation. Linear elastic analysis was done assuming it as a simplification (20) to better understand the global behaviour of the structure. Material properties for the calculations were obtained from the tests (13). FE is a tool that has been successfully applied to masonry analysis. Although the use of solid elements and material non-linearities would have been more suitable for this kind of structures (21), due to the fact that the analysis should be done over the whole structure and that the objective was obtaining qualitative global characteristics of the behaviour of the temple, just a preliminary simplified model was done. At any event, in the final part of this section, the validity of the analysis is verified by comparing the FE model behaviour with the observed damage patterns.

As pointed out above, the FE results were favourably compared with the plane thrust line analysis and the observed crack pattern, thus validating the model. For instance, Figure 10 shows the FE analysis of the same plane considered for the previous thrust line analysis (columns 2 and 6), where the concentration of vertical stresses in the exterior area of the buttress close to column 2 (1.045 MPa in the lower sections) can be easily identified. The compressive test carried out to this buttress stone led to characteristic compressive resistance values from 1.6 MPa to 1.2 MPa in dry and saturated conditions, respectively (Table 1). This fact explains the cracking observed in this area (as shown in Figure 4).

To check the potential benefits of the consolidation and homogenization of the material through grout injection, a new calculation was performed using the same F.E. model developed in section 5.2 (Figure 9), but setting all the material properties to match those of column number 1. Column 1 is adopted as reference since, although it is not an original one but reconstructed, it presents the largest resistance values and the basic aim would focus on homogenising the mechanical properties of all the columns. The results in terms of stresses improve, as it may be seen by comparison of results in Figures 12 and 13. Table 3 is similar to Table 2 with the values obtained from the calculations in this hypothetical situation of a homogenized material. The favourable effect of consolidation and homogenization can be easily checked by comparison of Tables 2 and 3. The load values that each column has to bear are more homogeneous than in the initial situation and the values of expected stress levels are more similar among columns. Although, due to the geometrical irregularities that cannot be corrected, some heterogeneity in
