# Analysis of constructive pathologies of a building constructed on expansive ground and repair proposal

For this analysis, we provide as a case study the repair proposal project on the housing development located on block 4 PP G-4 UE-1, Guillena, Seville, by assignment of the owners association.

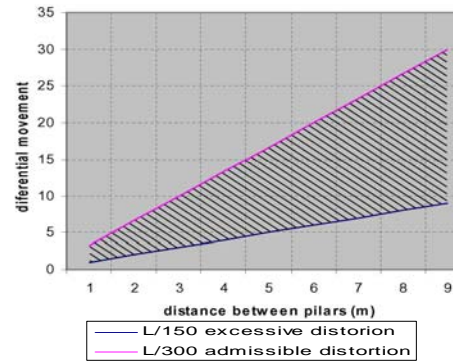
Figure 3. Abacus to relate the angular distortion L/150 y L/300 with the distance between pillars and the differential movement

The abacus in figure 3 relates the maximum angular distortion for the S.L.S. and the U.L.S. with the distance between pillars and the differential movement. The shaded area in the chart placed between the distortion values  $L/300$  and  $L/150$ , represents the differential movement that, although it causes damage in the building, it does not involve a risk to the structural stability.
