PITTING CORROSION SUSCEPTIBILITY OF SUPER AUSTENITIC STAINLESS STEELS IN SEA WATER

C.A. Loto

Department of Mechanical Engineering
University of Lagos, Akoka
Lagos, NIGERIA

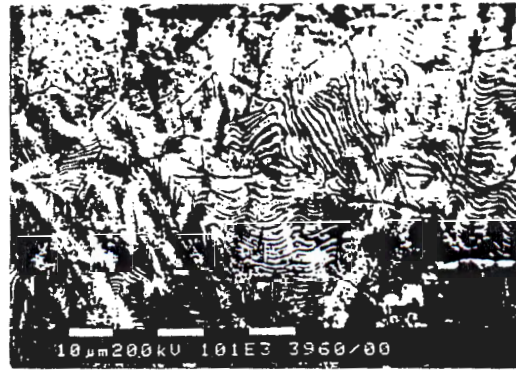
(a)

The as-received tubes surface, for example as in Figs. 1(a) and 2(a) were rough with etch-like appearance. The grain boundaries were microscopically visible in some cases. A comparison of some of the tubes surface before and after the test shows some distinct difference with respect to changes in surface feature(s), Fig. 1(b) and 2(b). In particular, sites of local corrosion attack could be located in the tested 316L alloy.

- 1(a) S.E.M. Micrograph of the as-received inner surface of AL6XN (NO8367) alloy tube.
- (b) S.E.M. Micrograph of the corroded inner surface of AL6XN alloy exposed to sea water environment.
- 2(a) S.E.M. Micrograph of the as-received inner surface of 316L (S316603) alloy tube.
- (b) S.E.M. Micrograph of the corroded inner surface of 316L alloy tube.
3. Optical microscope photograph of the split and cleaned tested alloy tubes exposed to sea water in a specially designed test rig.
- 4(a&b) S.E.M. micrographs of two different features of microscopic corrosion pits on the inner surface of AL6XN (NO8367) alloy tube exposed to sea
