Full scale testing of wind turbine blade to failure - flapwise loading

Citation (APA):
Jørgensen, E. R., Borum, K. K., McGugan, M., Thomsen, C. L., Jensen, F. M., Debel, C. P., & Sørensen, B. F. (2004). Full scale testing of wind turbine blade to failure - flapwise loading. (Denmark. Forskningscenter Risoe. Risoe-R; No. 1392(EN)).

Abstract A 25m wind turbine blade was tested to failure when subjected to a flapwise load. With the test setup, it was possible to test the blade to failure at three different locations.

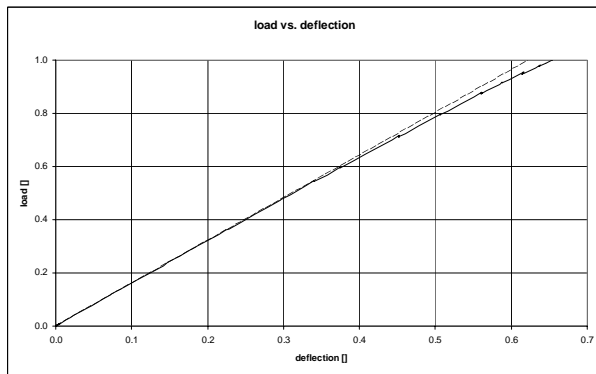
Even though the effect, which is much smaller in test of section three than in section one (because of the size of the deflection), a non-linearity is seen in figure 13. In this figure the blade gets more flexible with increasing load and therefore it is indicating “real” non-linearity in the blade (structural or material damage). It is seen that compared to the initial stiffness the blade is approximately 5% more flexible at full load, i.e. load at which value the blade failed.

Figure 13 Load vs. deflection during the test of section 3 until fracture (load applied at 11.3m and deflection measured at 11.1m)

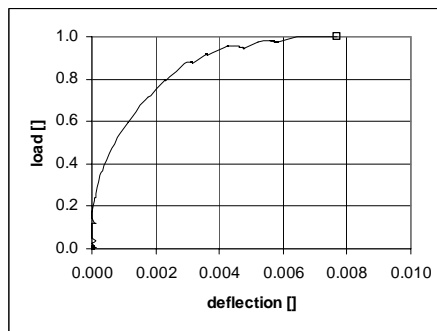
The local deflection at 4.3m is shown in figure 20 and it is seen this curve that it is close to a not stable situation, i.e. the deflection is increasing even though there is no increase in the load.

Figure 20 Local deflection at 4.3m, load at 11.3m

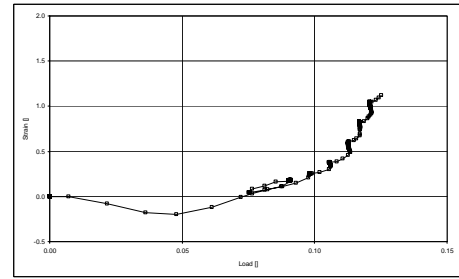
At a specific spot on the blade in test section 1, the skin is visually observed to be buckling. The strain gauges in this area, showed at the same time very high compressive and tension strains. According to figure 27 the strain gauge located on the top of the buckling wave (strain gauge #201.1) showed tension and in the bottom (strain gauge #199.1) showed compression as expected. The area of this debonding of the skin laminate, indicated by the strain gauge measurements as well as seen visually, was corresponding very well with the areas of improper bonding as found in the ultra sonic measurement prior to the test. It should be mentioned that the skin laminate is only a minor part of the load carrying part in a flapwise load situation. The results are shown here for the good correlation between strain gauge measurements, the visual identification and the prediction of the bonding situation based on the ultra sonic test of this area. Even though the skin only contribute as a minor part to the strength of the blade in a flapwise load situation the blade actually failed in this area of delamination (20.1m from the root section).

Figure 26 Strain gauge measurements at 20.1m (strain gauge #201.1)

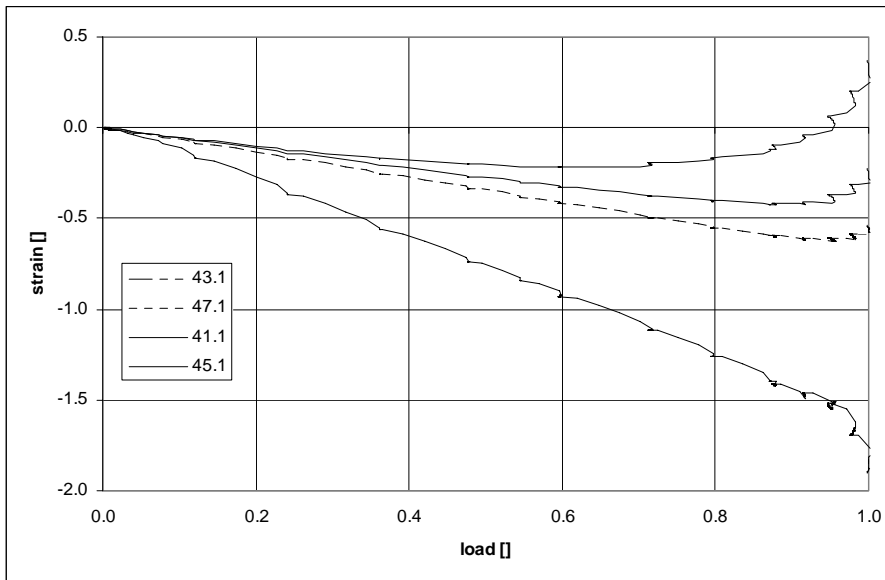
During test of section 3, the blade failed at 4.4m close to the largest chord. In the figure below the strain is shown as function of the load for the strain gauges located in the area of where the failure happened. The strain is seen to be non-linear especially for strain gauge “45.1” which is close to the location where the blade finally failed.

Figure 28 Measured strain on four locations during test of section 3, showing non-linear behaviour

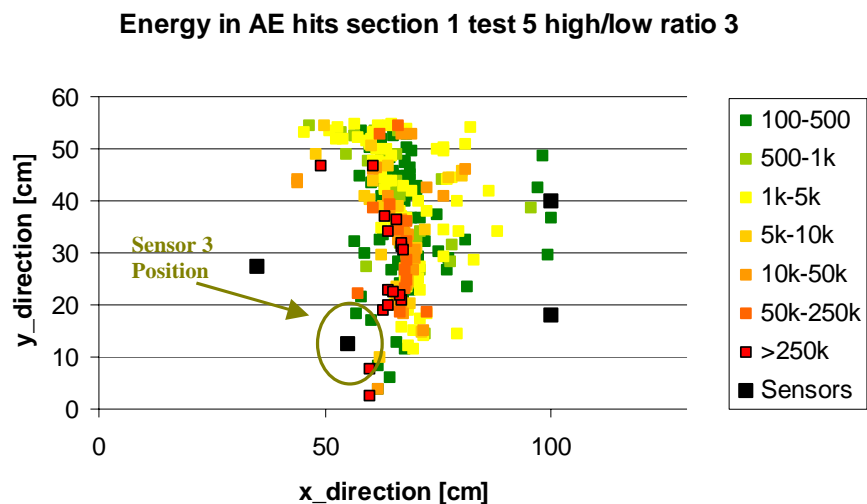
A LABVIEW system location plot was generated from data sampled during loading up to 77% of the load at failure. This plot corresponded exactly with the failure that occurred during a subsequent loading.

Figure 31 LABVIEW system localisation of AE events prior to failure. High activity events distributed along ultimate failure chord. Note position of sensor 3.

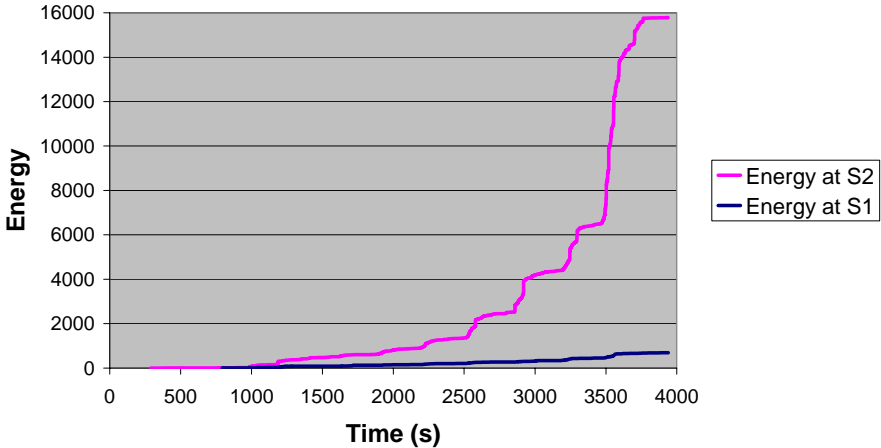
In the first loading sequence for this test section there was an accumulated stress wave energy count of 16000 recorded at SPARTAN sensor 2, positioned as a guard at the 15.3m loading yoke. By comparison there was only 700 recorded at SPARTAN sensor 1 positioned at the 11.3m clamping yoke, far closer to the desired failure chord. At a load cell voltage of 3.63V, it was suggested, by the AE operatives, that the load should be released and the blade inspected. This was due to a rapid increase in the activity level for SPARTAN sensor 2 during the load increase to 3.63V, followed by an extremely long period during load hold where AE activity continued.

Figure 32 Cumulative stress wave energy trace showing the relative activities at S2 (loading yoke) and S1 (close to desired failure chord). Note also the rapid increase in stress wave activity at S2 indicating that failure is approaching.

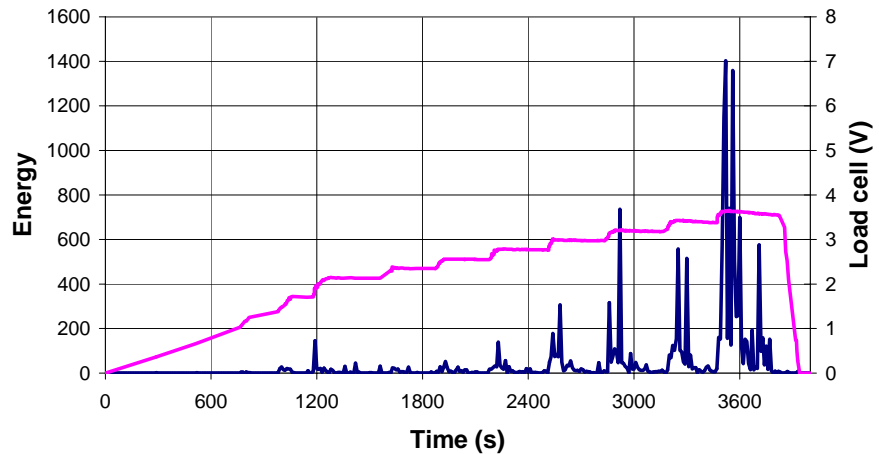
Figure 33 Stress wave activity (blue) detected during step-wise loading of the blade (section 2). The high activity levels and long “die-off” time during load hold indicates the blade is close to failure.

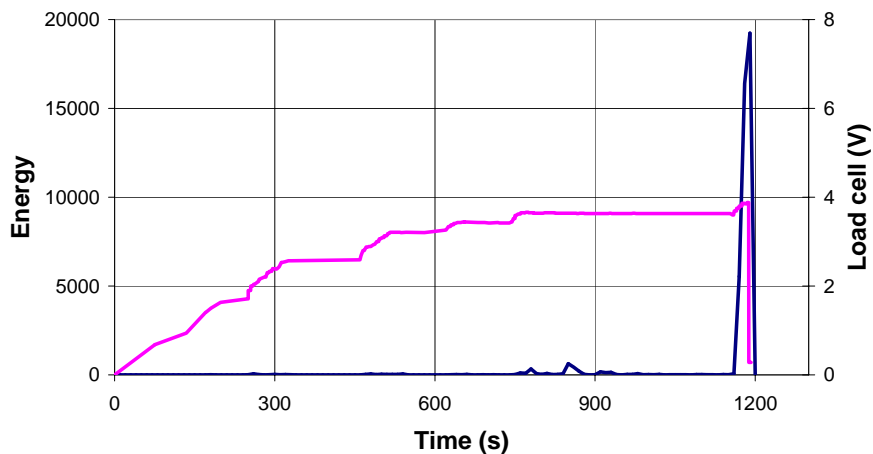
After inspection, the load was reapplied. Loading up to 3.63V again generated far less activity than the first loading (in accordance with the Keiser effect). At load hold for 3.63V however, activity was again registered at Spartan sensor 2. When the load was increased further, the blade failed at the 15.3m loading yoke. Blade failure occurs at 3.88V, thus the final inspection of the blade prior to failure occurred after it had been loaded to 93% (3.63/3.88) of its ultimate strength. This gives far greater possibility of interpreting failure causes and investigating initial damage than only having access to the destroyed structure and attempting to infer causes during a “post-mortem”.

Figure 34 Stress wave activity during the second loading of blade section 2.

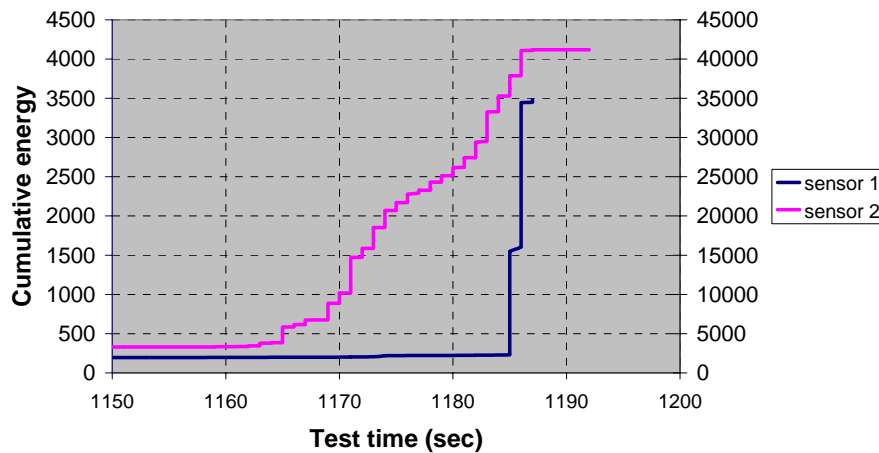
The failure of section 2 at the 15.3m loading yoke was unwanted, but as seen in the calculations (simple FE model) prior to the test and the AE readings during the test it was not a surprise. At the moment of failure however the broken blade “sprang back” against the clamping yoke. At this point it was observed that SPARTAN sensor 1 signalled a significant burst of AE activity, where it had previously been relatively inactive. A close inspection of the blade at this area was carried out. It was eventually discovered that lateral cracking inside the central loading spar (x =11m) had been generated and this became significant during the testing of section 3.

Figure 35 The first y-axis shows cumulated energy detected on S1. The second y-axis shows cumulated energy at S2. S2 shows a “gradual” release of energy typical of composite failure. S1 is almost silent until a sudden burst of energy when the blade “springs back”

the interior of the blade was reinforced at the 11.3m loading yoke. This successfully prevented the growth of the lateral cracks and permitted load to failure at the 4.5m chord. And once again, the AE activity recorded throughout this loading successfully identified 4.5m as the failure chord in preference to the 7m chord.
