## Improved design of large wind turbine blade of fibre composites based on studies of scale effects (Phase 1). Summary report

Risø-R-1390(EN)

# Improved design of large wind turbine blade of fibre composites based on studies of scale effects (Phase 1) - Summary Report

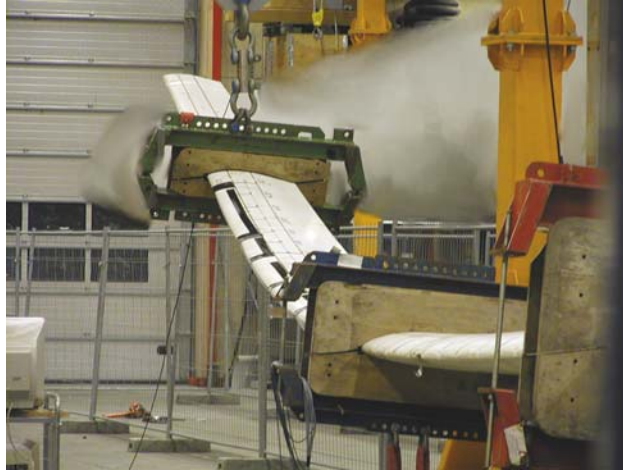
The global deflection of the blade was found not to be very sensitive to the damage that happens in the blade. It is therefore very difficult to give any criteria based on the global deflection about how close the blade is to failure. Fig. 2.5 shows the deflection of the blade (Test section 1) before failure and Fig. 2.6 shows the failure zone in the blade just after fracture.

*Fig. 2.5 Test of section 1; the blade deflects significantly before failure occurs.*

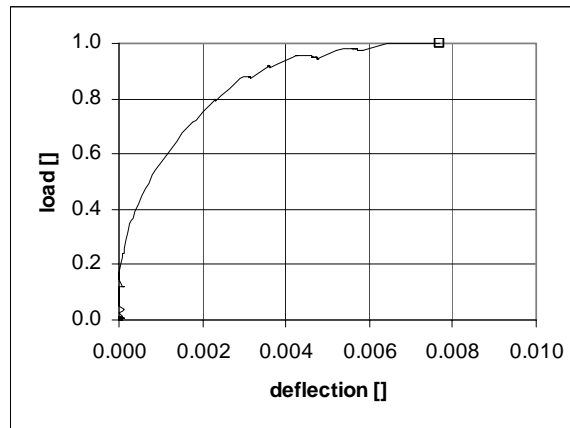
The local deflection is shown versus the load in Fig. 2.7 and the graph shows clearly, how the deflection grows without applying more loads, i.e. the curve becomes flat when the load is close to the load of failure of the section (last point in this curve).

*Fig. 2.7 Local deflection at 4.3 m, load at 11.3 m.*

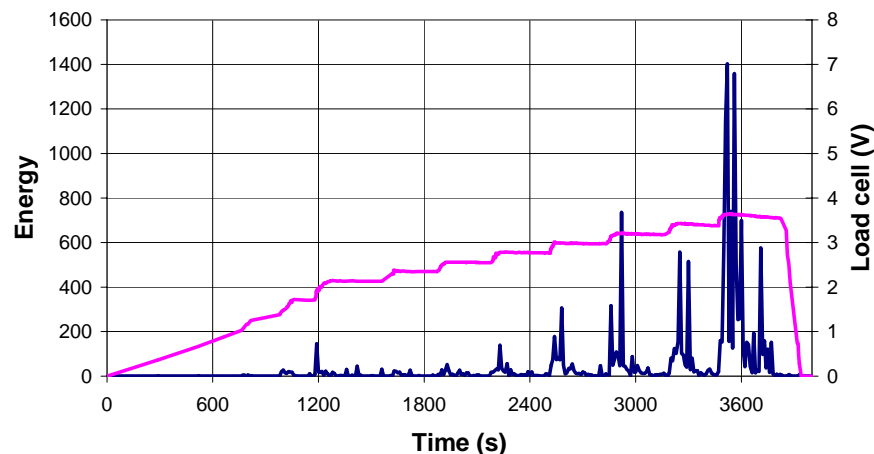
During the tests, acoustic emission from the blade was also measured. It was proved to be a very promising method to use during static tests of blades. The measurement gave information concerning the severity as well as the localization of the damages in the blade. Fig. 2.8 shows how the acoustic activity increases when getting close to the failure and also how this activity continues for a long time although the load is kept constant (or decreases slightly).

*Fig. 2.8 Stress wave activity (dark blue) detected during step-wise loading of the blade (section 2), shown along with the load level (pink) as a function of elapsed test time. The high activity levels and long “die-off” time during load hold (nearly constant load) indicate that the blade is close to failure.*

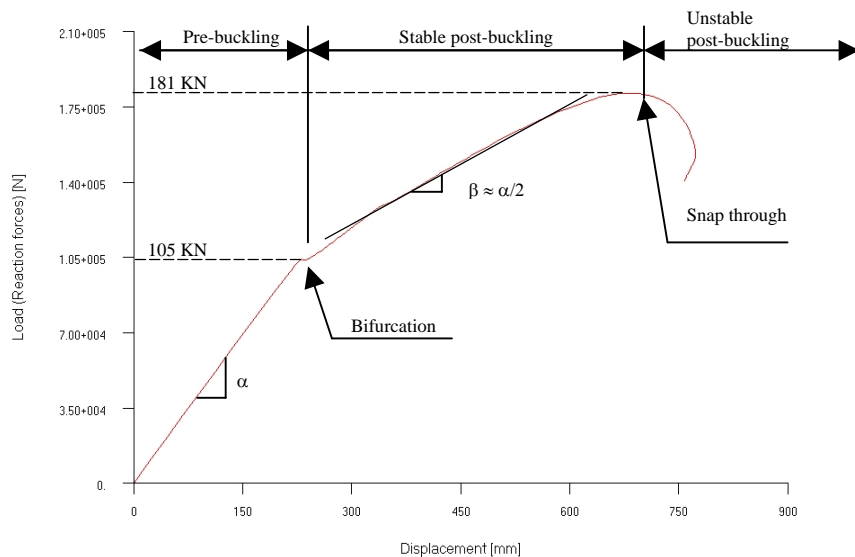
A deformation plot of the main spar i.e., the relationship between the applied load and the displacement in the load direction (y-direction) is shown in Fig. 4.3. The curve exhibits linear behaviour (prebuckling) up to 105 kN where the bifurcation point is reached and a geometrical nonlinear response goes up to 181 kN and the “snap through point” is reached. This “snap through” point is characterized with not having any load-carrying capacity after the limit is reached.

*Fig. 4.3. Load-displacement graph of the main spar from FEM-simulation (relationship between applied force and the displacement of the force).*

The load-displacement path exhibits stable postbuckling behaviour after the bifurcation point is reached, and the stable postbuckling phase stops at the snap-through load of 181 kN.

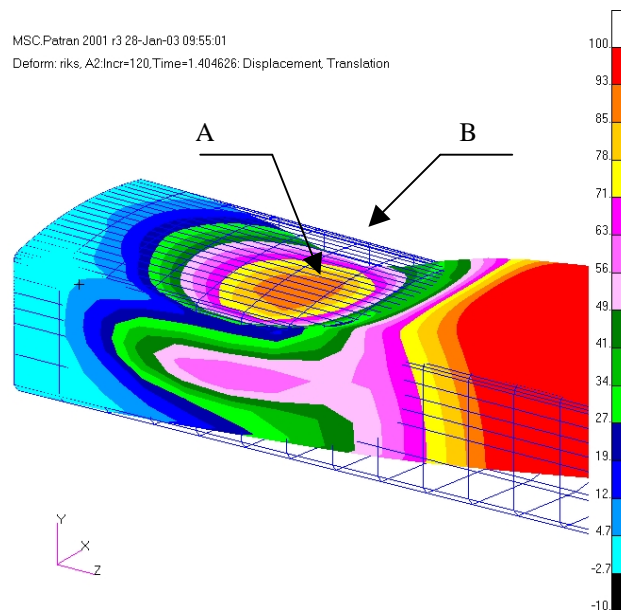
The deformation plot shows a relatively large local downward deformation of the compression flange, in point A on Fig. 4.4.

*Fig. 4.4. Displacement plot of post buckled section (displacement in the y-direction). The color range is in mm.*

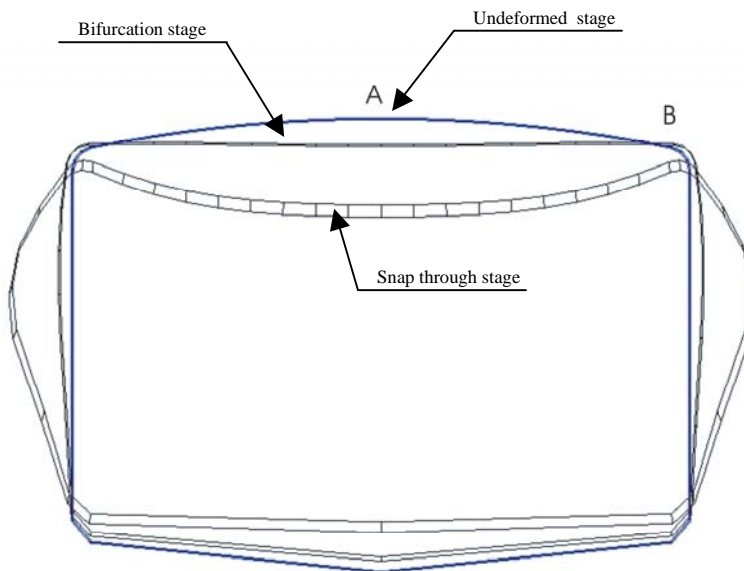
When the load reaches a certain level, the deflection of the flange, will “snap through”. See the three deformations stages in Fig. 4.5.

*Fig. 4.5. Transverse section of the main spar. Three deformations stages are shown.*

Following snap-through, the compression flange will find a new stable equilibrium. See deformation stage 3 in Fig. 4.5, where it can still carry some compression load but on a lower level than before the “snap-through” point was reached. The reduction in load carrying capacity will effect in collapse of the main spar if the surrounded structure does not have the capacity to carry this extra load. In all cases there is an eminent risk that there will be a permanent damage after such a “snap-through” limit has past.

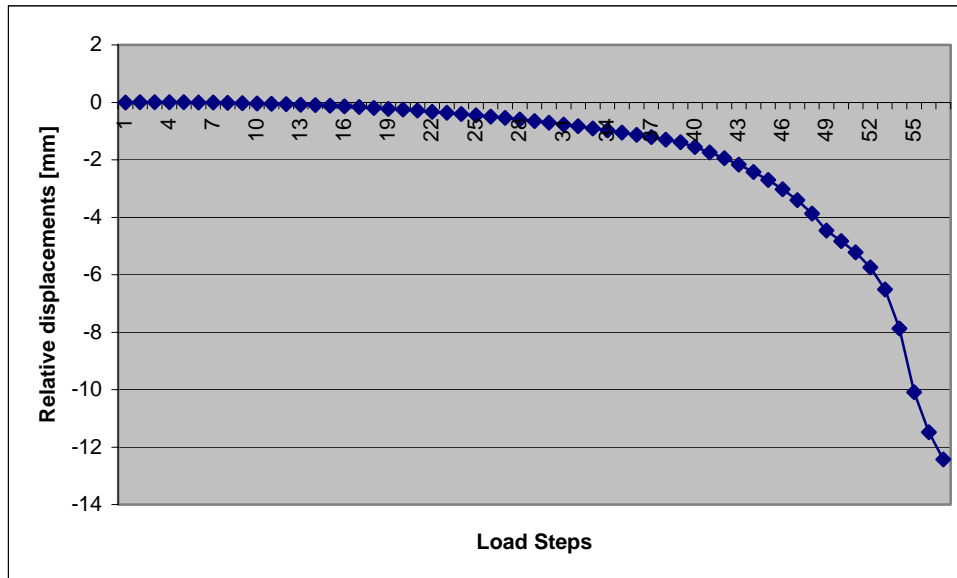
*Fig. 4.6. Displacement versus load from the FEM-model. The displacement is in the y-direction where point B is subtracted from point A.*

When we compare full-scale measurements Fig. 4.7 and FEM-simulations Fig. 4.6, the “relative deflections” in point A minus point B, show almost the same behaviour, which confirms that we actually have the bifurcation point just before the blade collapses.

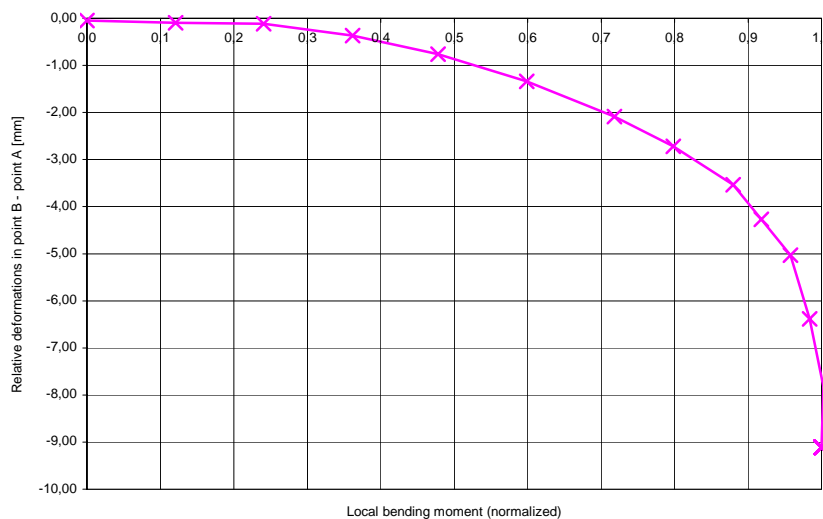
*Fig. 4.7: Displacements versus load recorded at the full-scale test (test section 3)*
