Fukushima: Status for en igangværende ulykke

Bent Lauritzen og Erik Nonbøl

Risø DTU

Fukushima

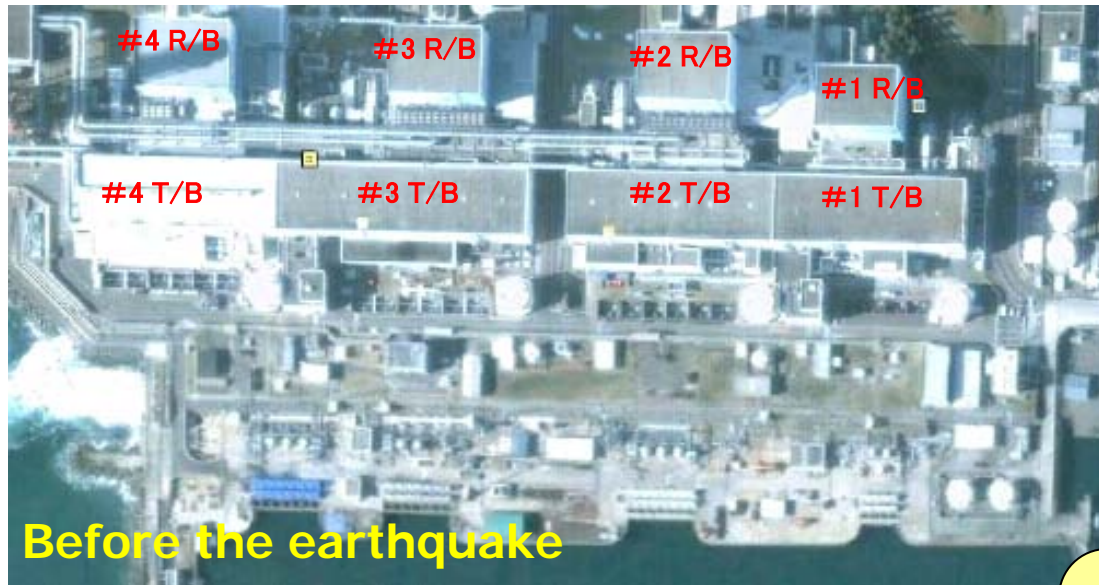
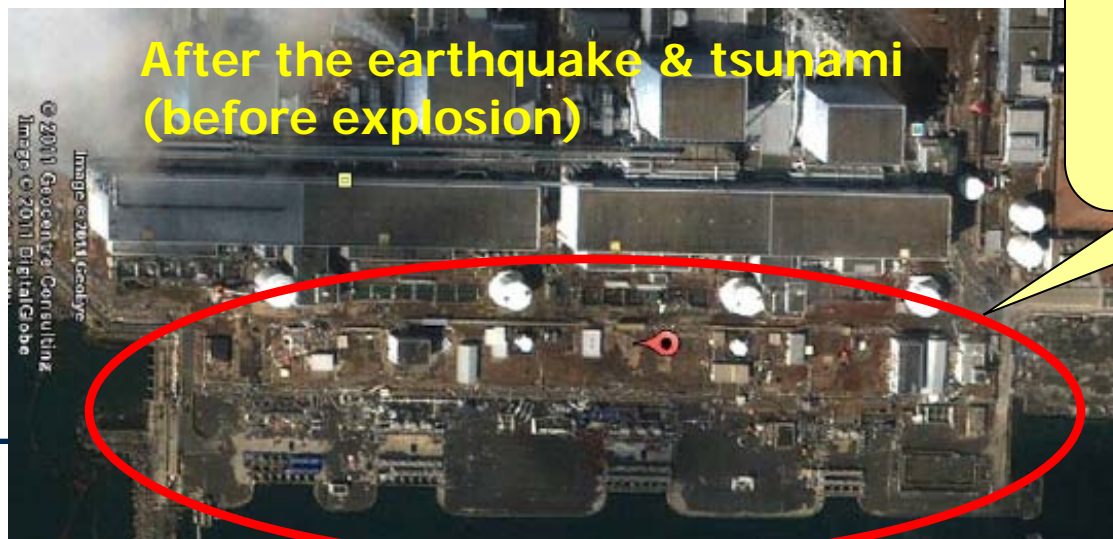
Fukushima 1 (Dai-ichi) NPP

Many structures facing the bay are destroyed

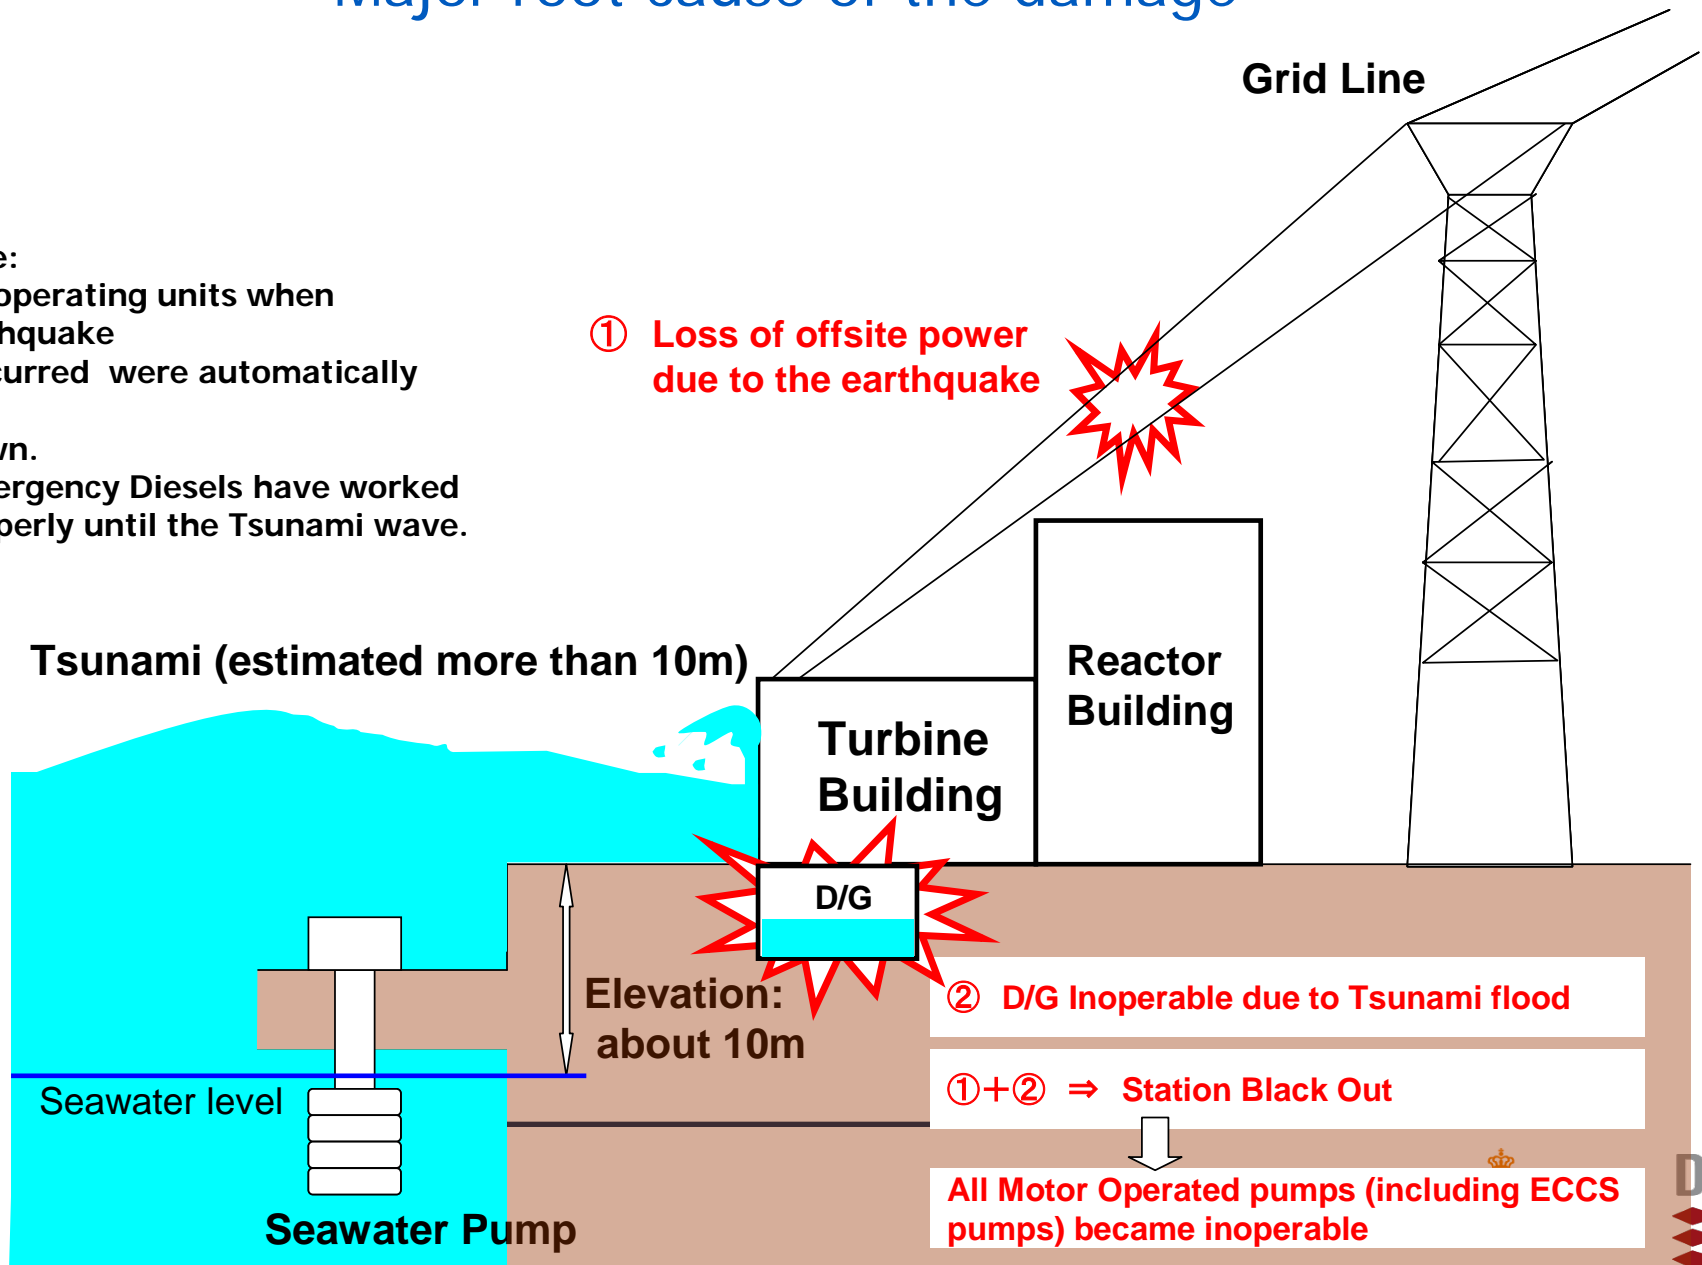
Major root cause of the damage

- All operating units when earthquake occurred were automatically shut down.
- Emergency Diesels have worked properly until the Tsunami wave.

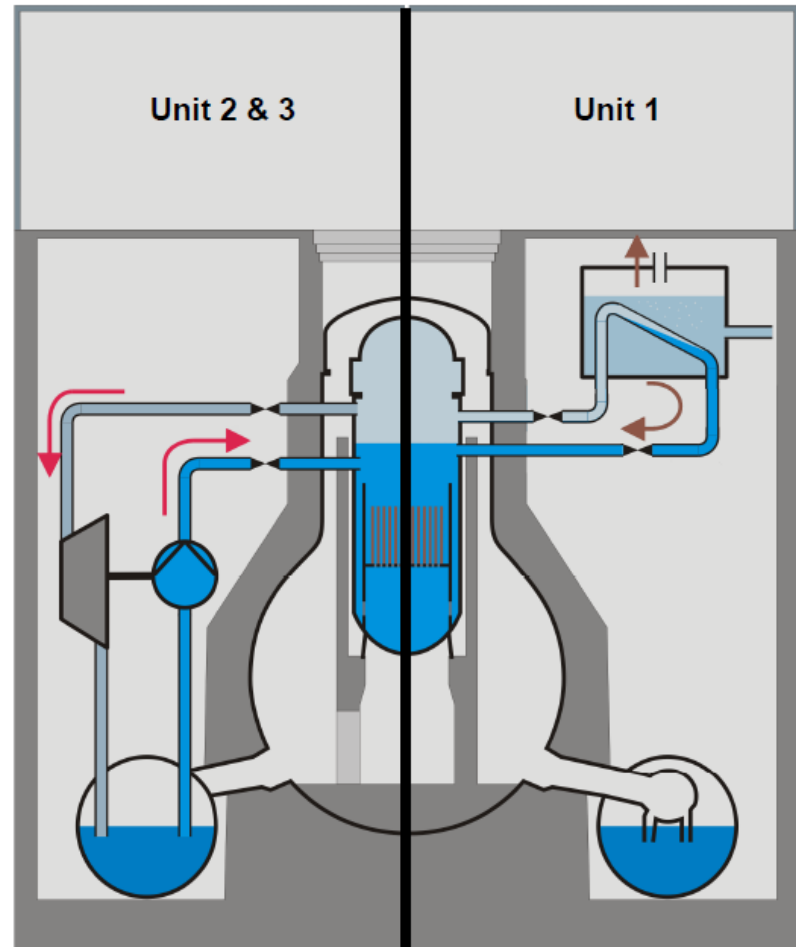
- ▶ 11.3. 16:36 in Unit 1
 - ◆ Isolation condenser stops
 - ◆ Pool empty?

- ▶ 14.3. 13:25 in Unit 2
 - ◆ Reactor Isolation pump stops
 - ◆ Pump failure?

- ▶ Decay heat produces steam in reactor pressure vessel
 - ◆ Pressure rising
- ▶ Opening the steam relieve valves
 - ◆ Discharge steam into the wet-well
- ▶ Decreasing of the liquid level in the reactor pressure vessel

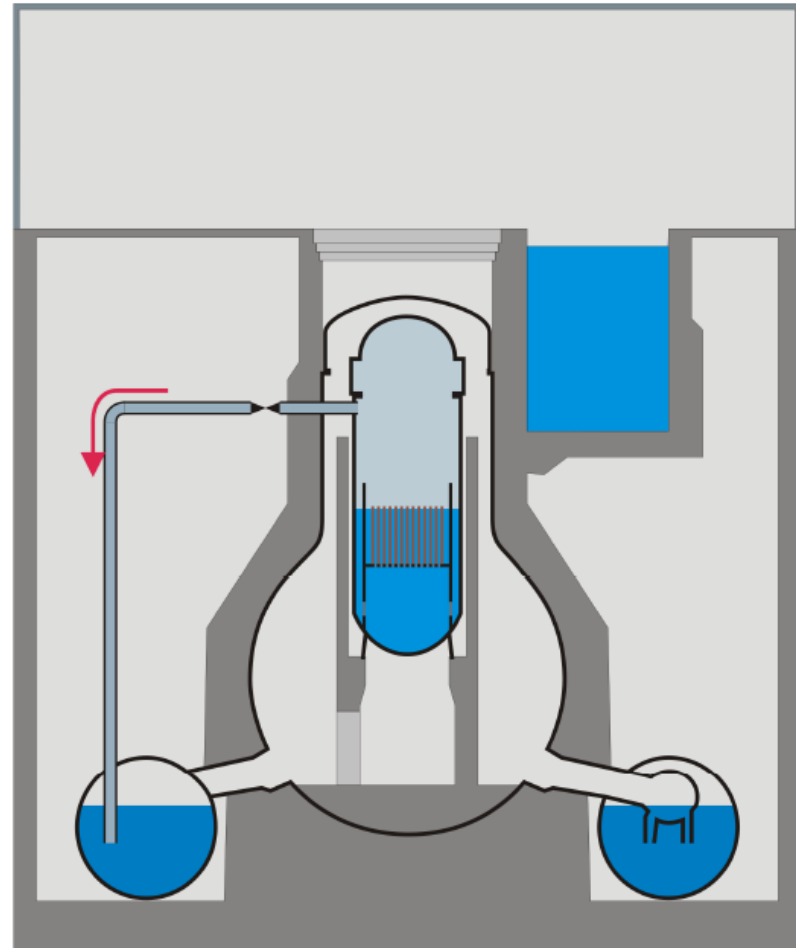
- ▶ Measured, and here referenced liquid level is the collapsed level. The swell level is higher due to the steam bubbles in the liquid
- ▶ ~50% of the core exposed
 - ◆ Cladding temperatures rise, but still no significant core damage
- ▶ ~2/3 of the core exposed
 - ◆ Cladding temperature exceeds $\sim 900^{\circ}\text{C}$
 - ◆ Ballooning / Breaking of the cladding
 - ◆ Release of fission products from the fuel rod gaps

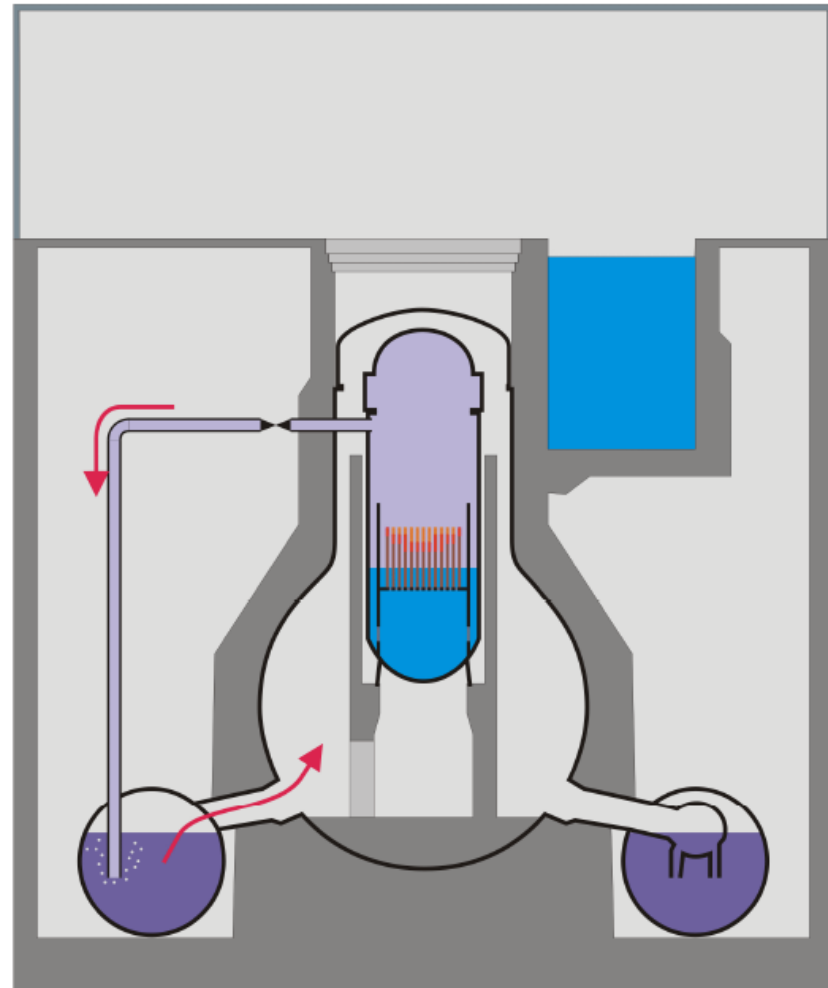
- ▶ ~3/4 of the core exposed
 - ◆ Cladding exceeds ~1200°C
 - ◆ Zirconium water reaction starts under steam atmosphere
 - ◆ $\text{Zr} + 2\text{H}_2\text{O} \rightarrow \text{ZrO}_2 + 2\text{H}_2$
 - ◆ Exothermal reaction heats the core additionally
 - ◆ Generation of hydrogen
 - Unit 1: 300-600kg
 - Unit 2/3: 300-1000kg
 - ◆ Hydrogen gets pushed via the wet-well, the wet-well vacuum breakers into the dry-well

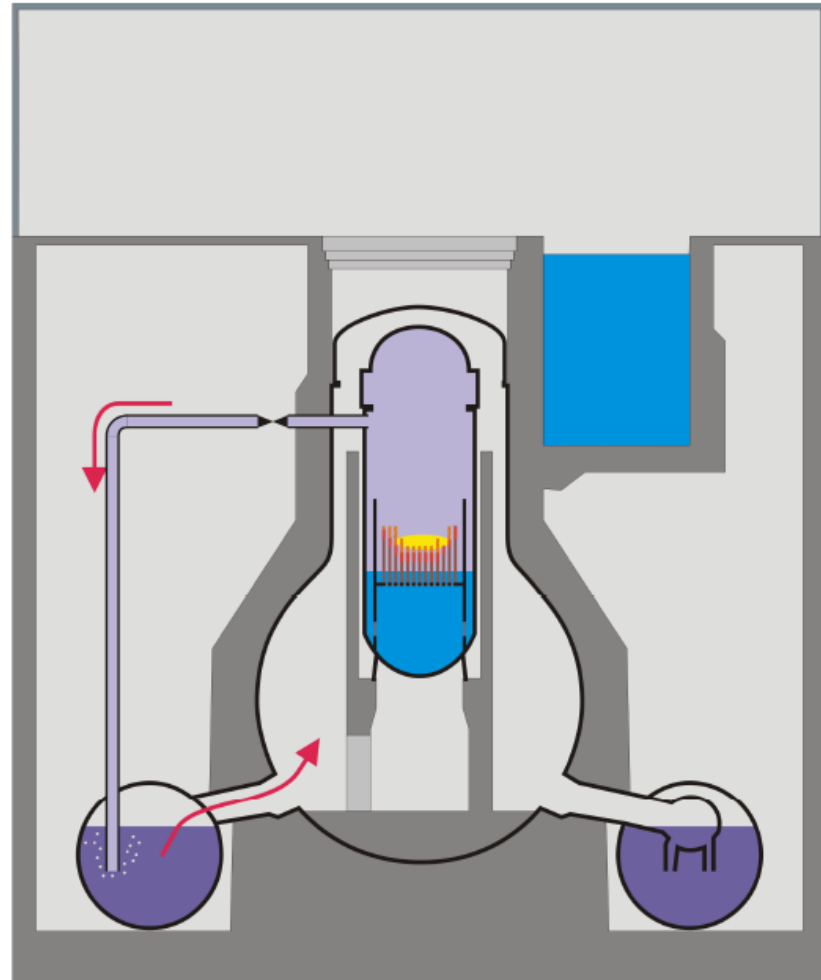
- ▶ at ~1800°C [Unit 1,2,3]
 - ◆ Melting of the cladding
 - ◆ Melting of the steel structures

- ▶ at ~2500°C [Unit 1,2]
 - ◆ Breaking of the fuel rods
 - ◆ debris bed inside the core

- ▶ at ~2700°C [Unit 1]
 - ◆ Melting of Uranium-Zirconium eutectics

- ▶ Supply of seawater to the reactor pressure vessel stops the core melt in all 3 Units
 - ◆ Unit 1: 12.3. 20:20 (27h w/o water)
 - ◆ Unit 2: 14.3. 20:33 (7h w/o water)
 - ◆ Unit 3: 13.3. 9:38 (7h w/o water)

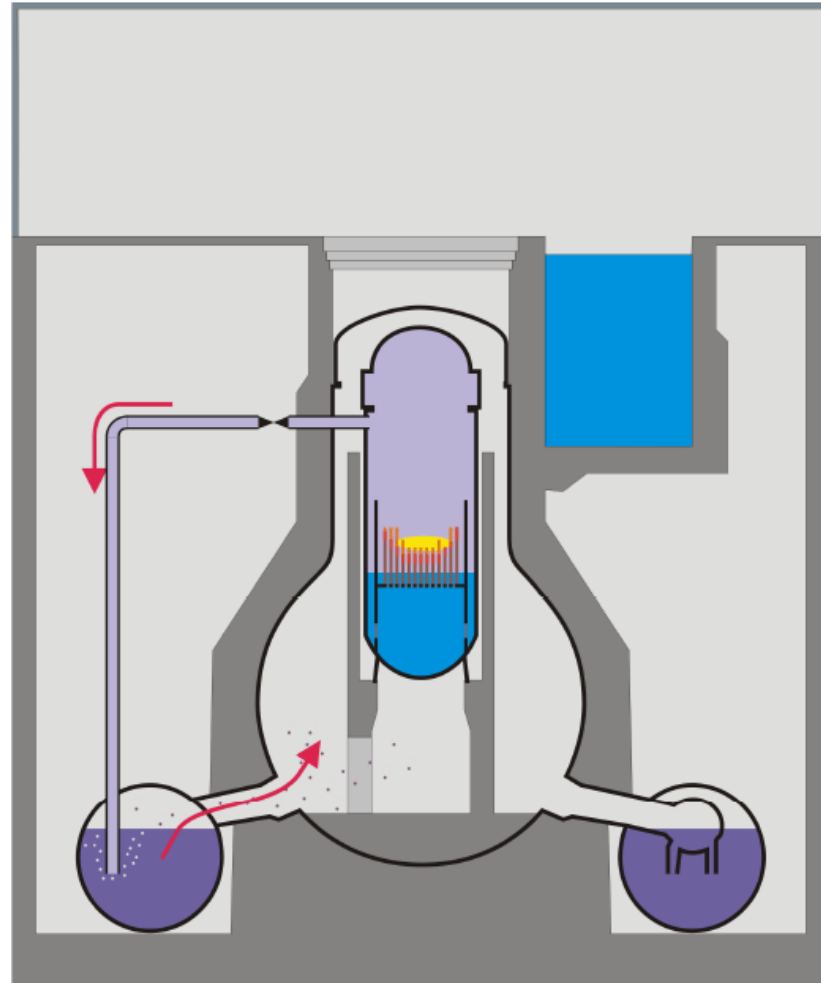
- ▶ Release of fission products during melt down
 - ◆ Xenon, Cesium, Iodine,...
 - ◆ Uranium/Plutonium remain in the core
 - ◆ A part of the fission products condensate to airborne aerosols
- ▶ Discharge through valves into water of the condensation chamber
 - ◆ Pool scrubbing binds a fraction of aerosols in the water
- ▶ Xenon and remaining aerosols enter the dry-well
 - ◆ Deposition of aerosols on surfaces decontaminates air

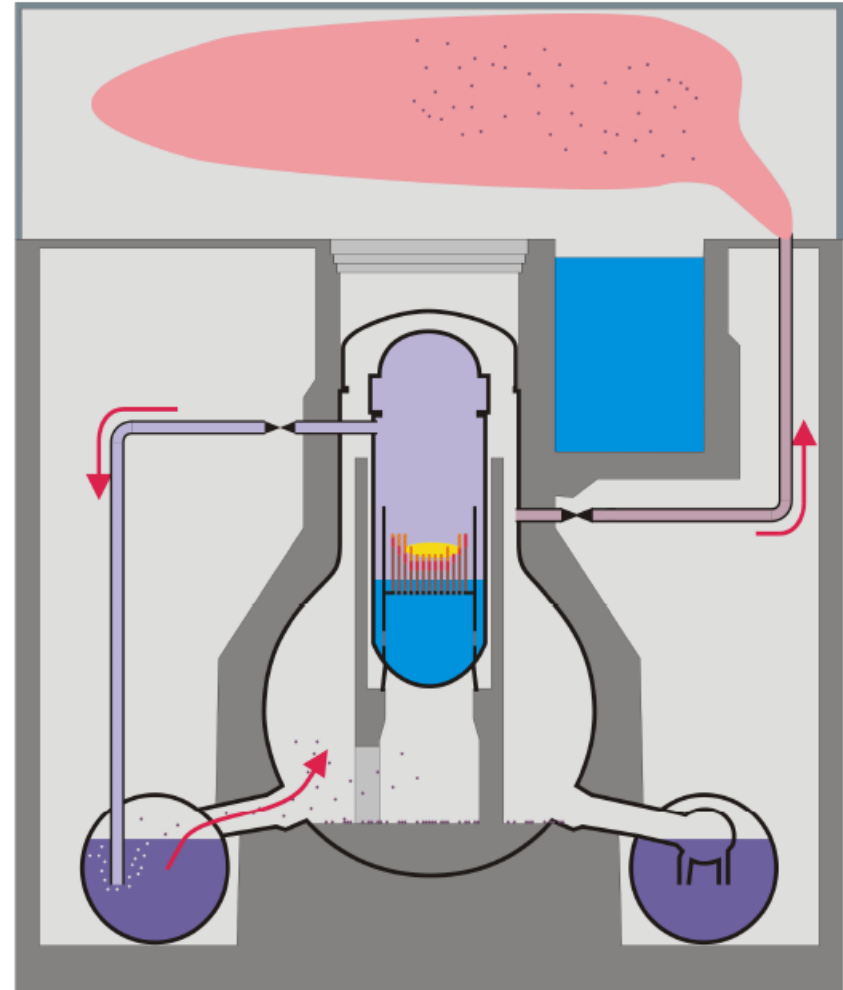
- ▶ Containment
 - ◆ Last barrier between fission products and environment
 - ◆ Wall thickness ~3cm
 - ◆ Design pressure 4-5bar

- ▶ Pressure reached up to 8 bars
 - ◆ Normal inert gas filling (Nitrogen)
 - ◆ Hydrogen from core oxidation
 - ◆ Boiling in the condensation chamber

- ▶ Depressurization of the containment
 - ◆ Unit 1: 12.3. 4:00
 - ◆ Unit 2: 13.3 00:00
 - ◆ Unit 3: 13.3. 8:41

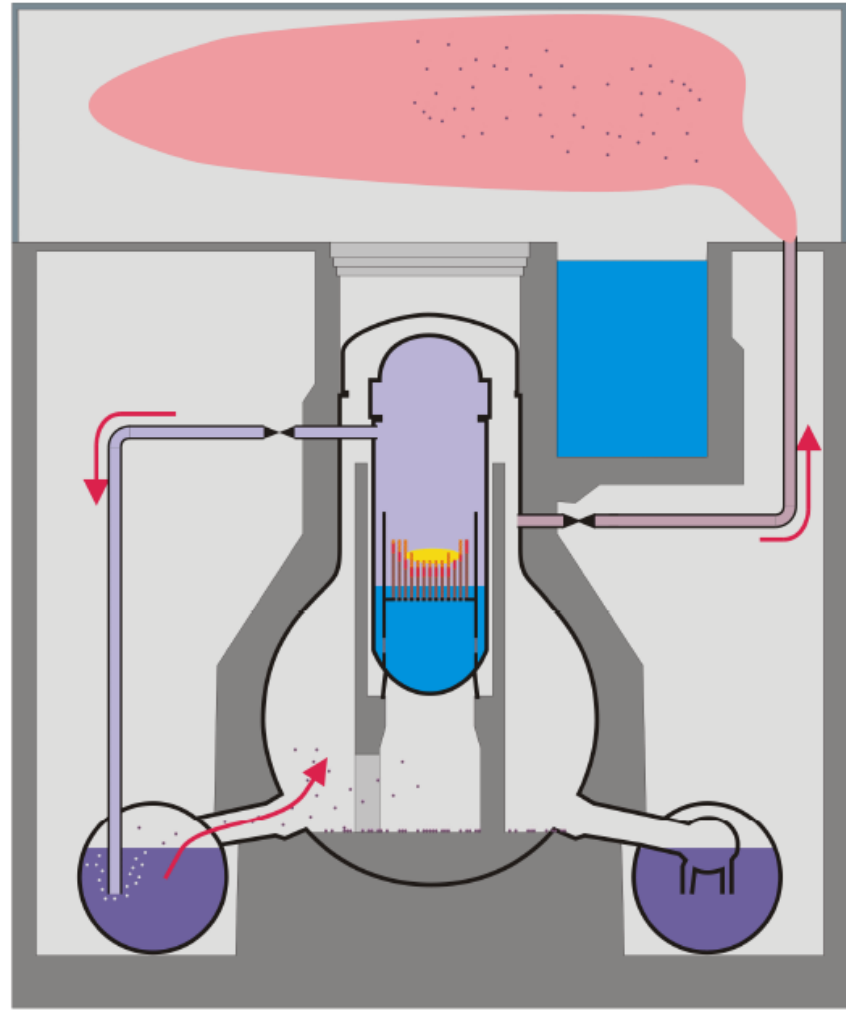
- ▶ Positive and negative aspects of depressurizing the containment
 - ◆ Removes energy from the containment (the only way left)
 - ◆ Reducing the pressure to ~4 bar
 - ◆ Release of small amounts of aerosols (Iodine, Cesium ~0.1%)
 - ◆ Release of all noble gases
 - ◆ Release of hydrogen

- ▶ Gas is released into the reactor service floor

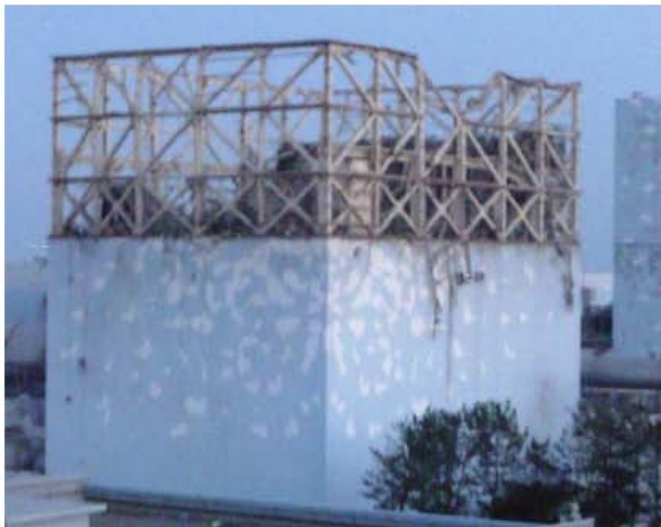
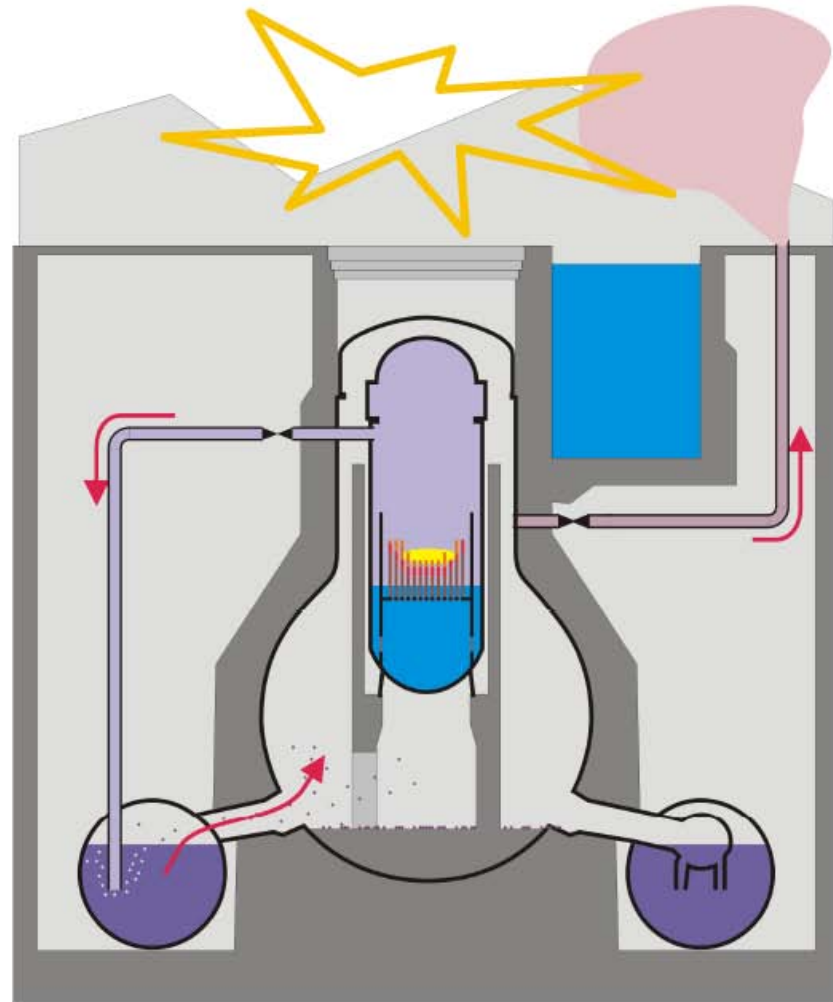
► Unit 1 and 3

- ◆ Hydrogen explosion inside the reactor service floor
- ◆ Destruction of the steel-frame construction
- ◆ Reinforced concrete reactor building seems undamaged

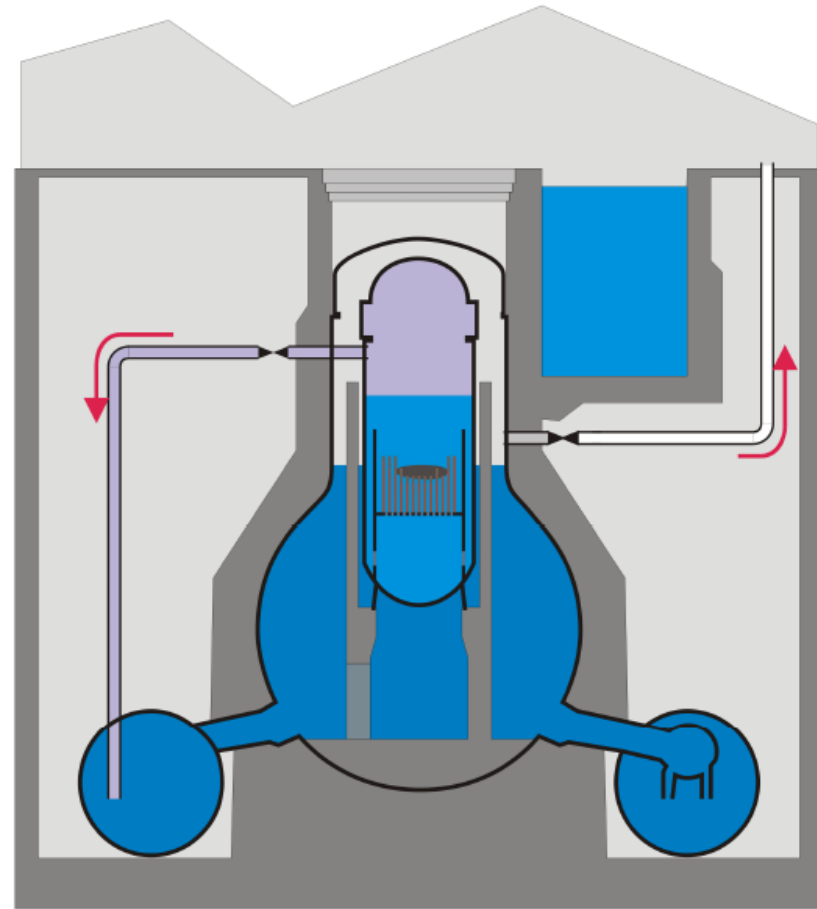
- ▶ Current status of the reactors
 - ◆ Core damage in Unit 1, 2, 3
 - ◆ Building damages of Unit 1-4
 - ◆ Reactor pressure vessels feeding with seawater in all units by mobile pumps
 - ◆ Containment in Unit 1 flooded

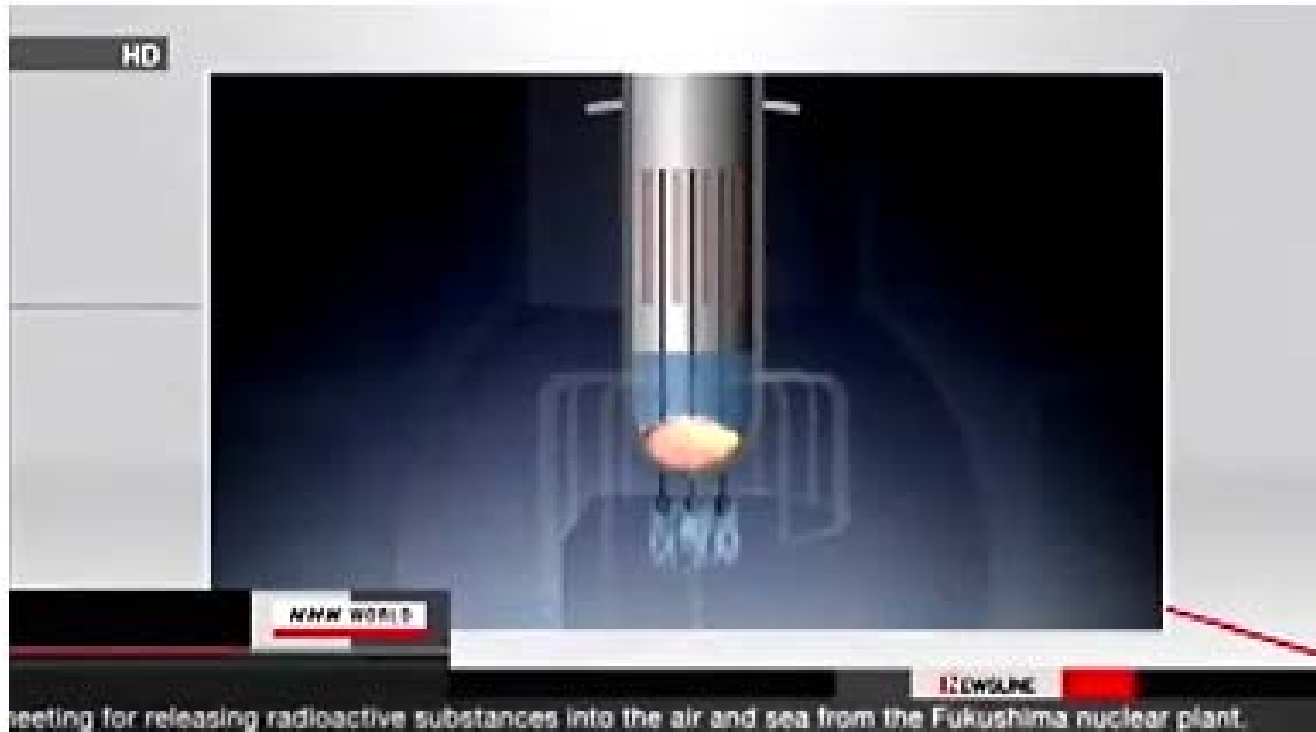
Melted fuel in unit 1

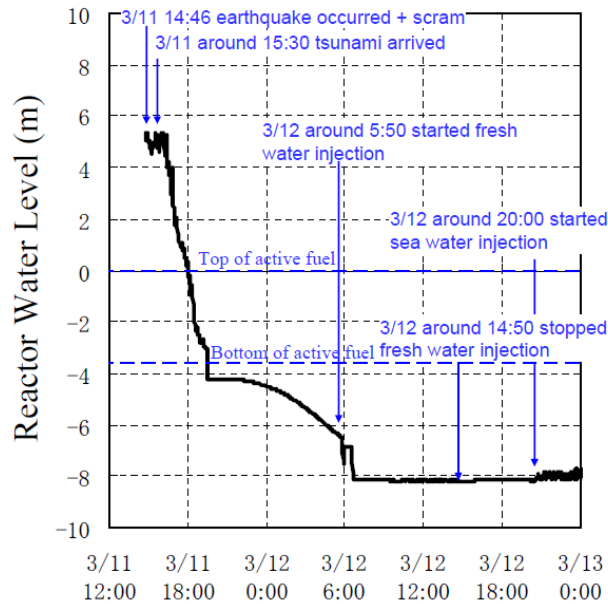
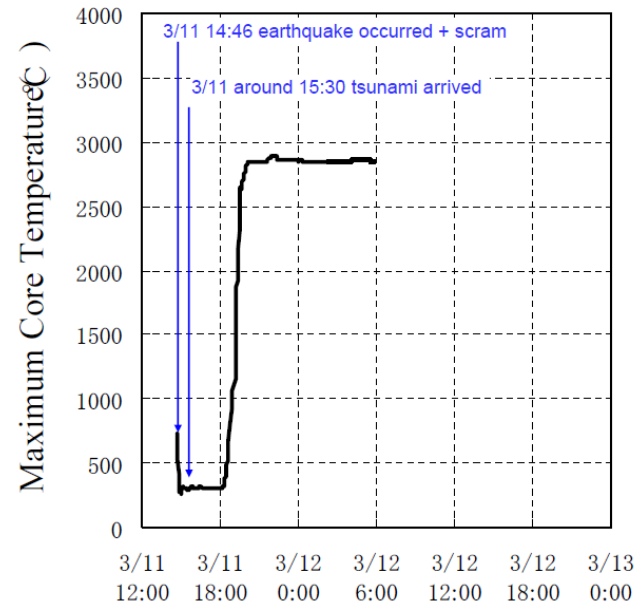
Unit 1: Reactor Water Level, Maximum Core Temperature (Analysis Result)

Key assumption: IC lost its function after the tsunami arrived at around 15:30

- reached top of active fuel in 3 hours (around 18:00) after the scram
- reached bottom of active fuel in 4 and a half hours (around 19:30) after the scram

The core temperature started increasing when the reactor water level became lower than top of active fuel, then reached the core melting temperature.

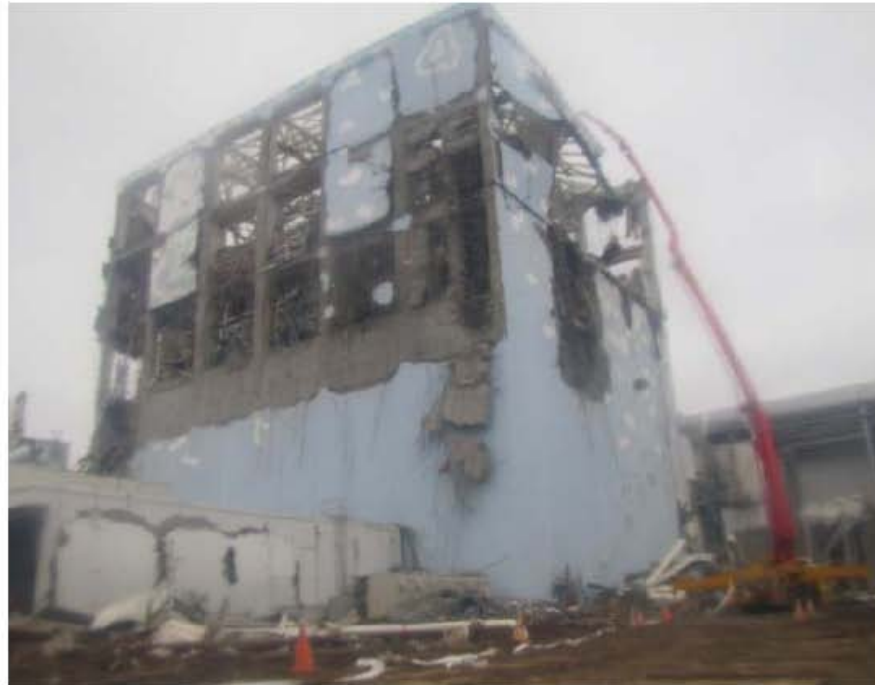
Photo: Water spray into the SFP in Unit 4 using concrete pump truck

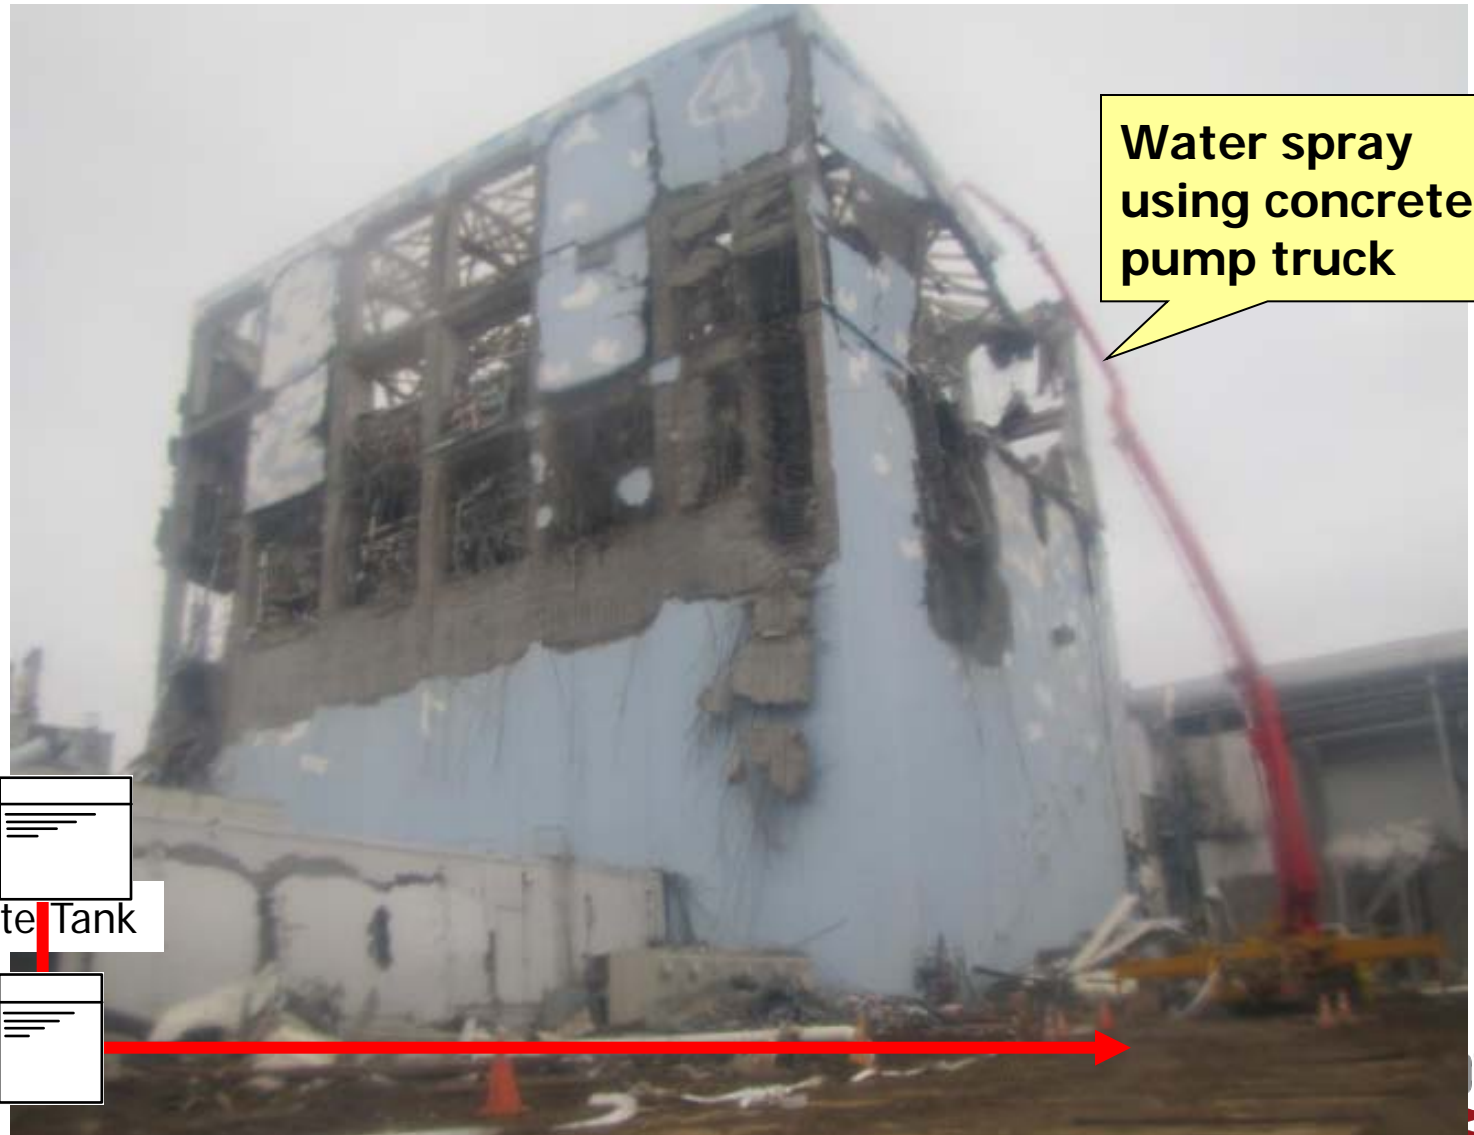
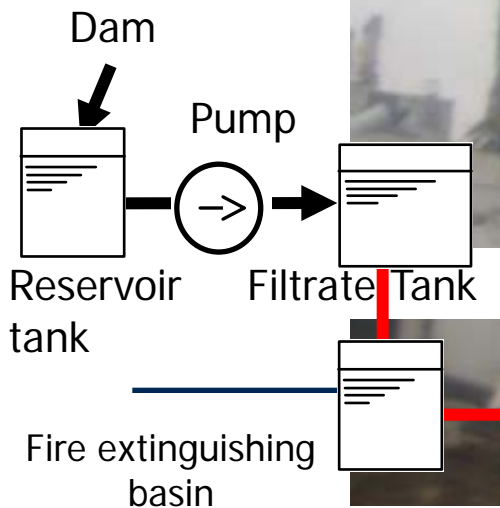
Water spray into the SFP of Unit 4 using concrete pump truck
