Analysis and diagnosis of timber structures in Porto historical centre

T. Ilharco, J.M. Guedes & A. Arêde

Faculty of Engineering, University of Porto, Porto, Portugal

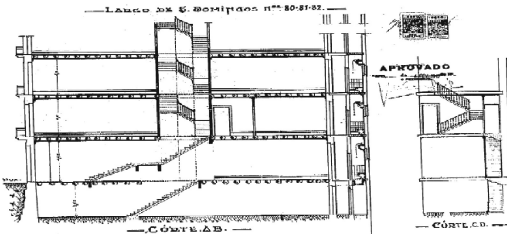
Figure 7. XX century (1946) refurbishment project of São Domingos building, XIX century (1856). Porto historical municipal archive.

structural schemes that sometimes are hardly recognizable without that input. In some buildings, the consultation of the old projects makes easier the perception of structural alterations to the initial project, contributing to the understanding of many observed damages. The reading of old manuals that refer to construction technologies used at the buildings time period is another helpful instrument.
