Strengthening of Structures Damaged by the Azores Earthquake of 1988

Aníbal COSTA
Associate Professor
FEUP
Porto

António Arêde
Assistant Professor
FEUP
Porto

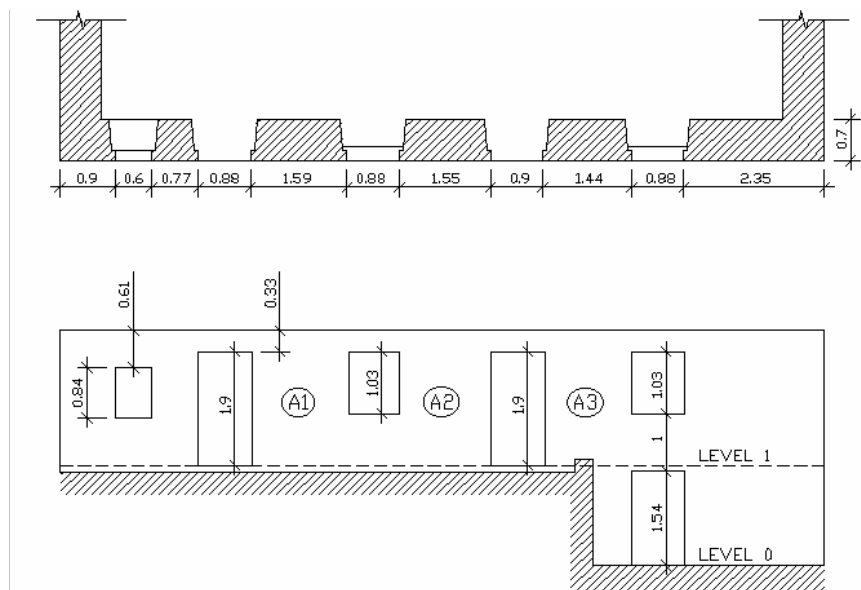
Fig. 6 – Partial schematic representation of the layout and elevation of house A

Results herein presented refer to tests on house A, which is partially schematized in fig. 6 both in plan view and in elevation. The panels are identified as: A1, for the original one; A2, for the steel mesh reinforced panel; and A3, for the poured grout reinforced panel.

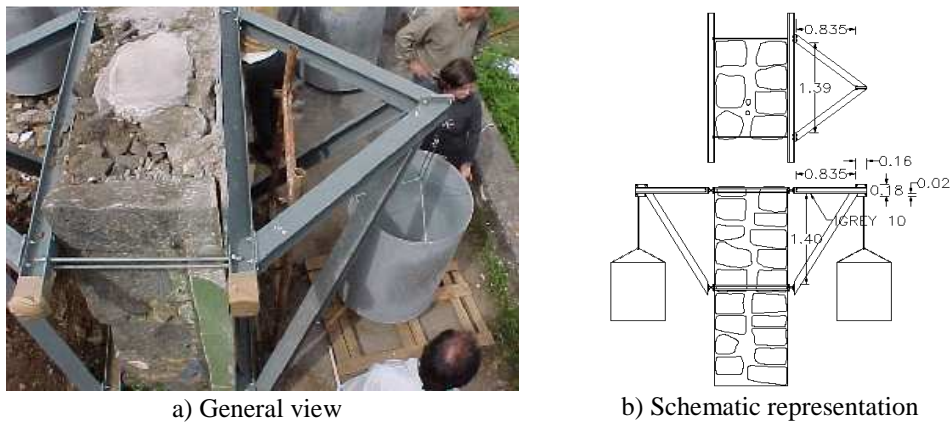
a) General view
b) Schematic representation
Fig. 7 – The auxiliary steel structure used in the tests.

Auxiliary steel lattice structures were prepared to allow performing the panel tests, such that, as shown in fig. 7, with the application of vertical loads on the lattice, the panel could be horizontally loaded in the transverse direction near to its top end. Under oscillation, the load produces forced movement that amplifies the horizontal action on the wall and induces vibration on it. The auxiliary structure consists of HEB100 steel bars and allows an eccentricity of 1.0m for the vertical load.

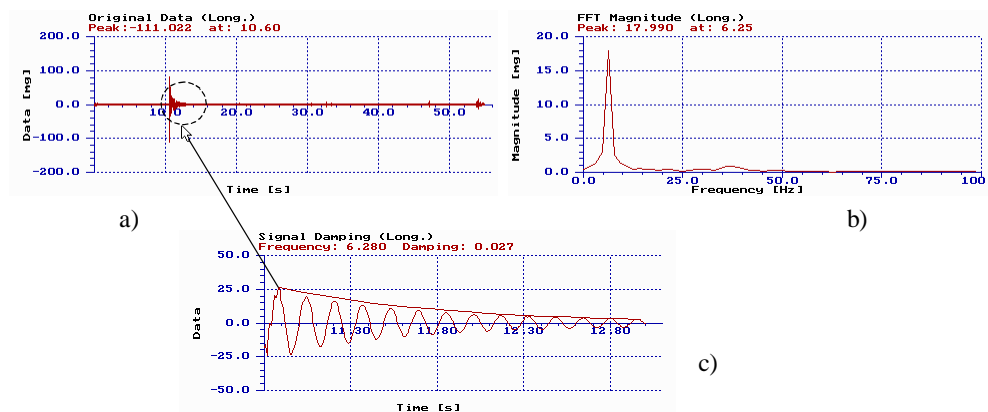
Fig. 8 – Response records due to impacts in the normal direction to the wall. a) acceleration; b) estimated frequency through the FFT and c) estimated damping

The vibration recordings and the respective analyses are an indirect technique of estimating the mechanical elasticity properties of a given structure. Therefore, several acceleration plots were obtained for each panel and for different load stages upon the application of an impact on the panel. Fig. 8-a shows one of these records for wall A1, without horizontal load and subject to an impact in the transversal direction (normal to the wall). That signal was processed to estimate the predominant frequencies and damping, respectively, by selecting amplitude peaks of the signal FFT (Fast Fourier Transform), fig. 8-b, and by adjusting an exponential curve to the fading response, fig. 8-c.

This procedure was used for the three directions, transversal, longitudinal and vertical, thus providing graphs of the same type for the other walls [4] that were used to obtain frequencies and damping values of each tested panel. These test results are summarised in Table I.

The effectiveness of the strengthening technique used in the panel A2 (steel mesh in both wall sides) is quite apparent from the increased frequency values shown in Table I. By contrast, the technique adopted in panel A3 did not lead to a clear improvement of wall performance, although the longitudinal frequency tends to suggest some stiffness increase. This might be related with difficulties in ensuring that internal voids were effectively filled with the poured mortar.

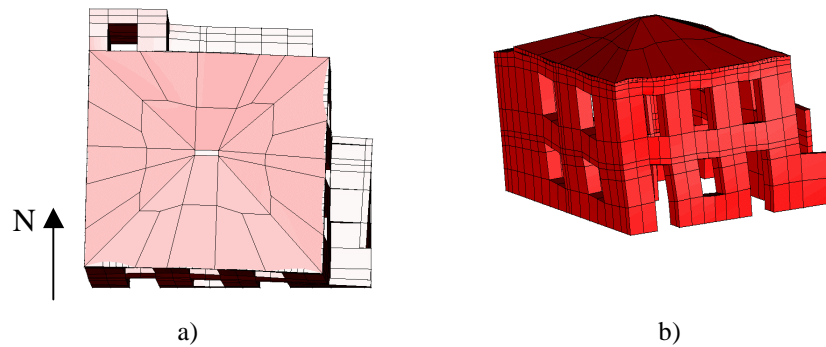
Fig. 10 – Plan view (a) and perspective (b) of the 1st vibration mode (5.7 Hz)

Figures 10 and 11 show the two first vibration modal configurations obtained by numeric calculation, where the north-south component is dominant in the 1st mode, whilst the east-west direction is preponderant in the 2nd mode. Note, however, that these are not pure translations due to the presence of substantially stiff and local elements (stairs and chimney) responsible for some rotation. The third vibration mode (not illustrated) is essentially a rotational mode with 8.05 Hz frequency.

The similarity of measured and numeric simulation frequencies for the two vibration modes, with an adjusted elasticity modulus of 0.23 GPa, shows that the achieved stiffness calibration is realistic. This calibration is even more sustained because that value is well within the value range resulting from the experimental panel testing campaign [3].

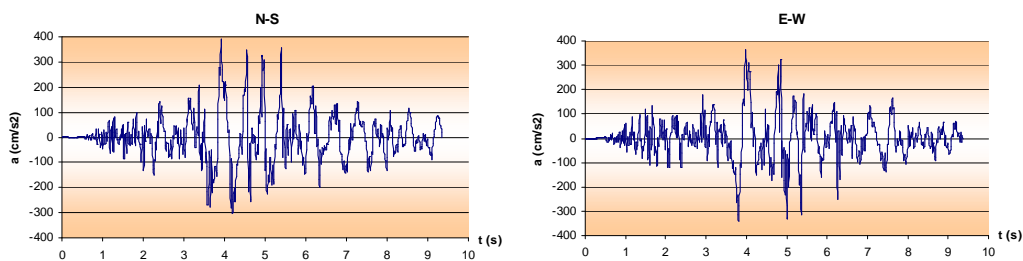
Figure 12 – Accelerograms for the 9 July 1998 earthquake (N-S and E-W directions)

As already referred, the structural seismic response was numerically obtained by means of a linear dynamic analysis using the three components (N-S, E-W and vertical) of the 9 July 1998 earthquake in Faial [7]. Fig. 12 shows the two horizontal components of the records obtained at the foundations of the Prince of Monaco Observatory (located on the top of a hill at 60 m altitude), for an epicentral distance of about 10-15 km.

These records of horizontal components correspond to a very characteristic earthquake in Azores (the so-called near-field earthquake) and have dominant frequencies in the interval from 1Hz to 2.5Hz. The vertical component has considerable peak amplitudes (0.32g) with frequency components between 6Hz and 7Hz.
