# Journal of Applied Geophysics

# A case study of the use of GPR for rehabilitation of a classified Art Deco building: The InovaDomus house

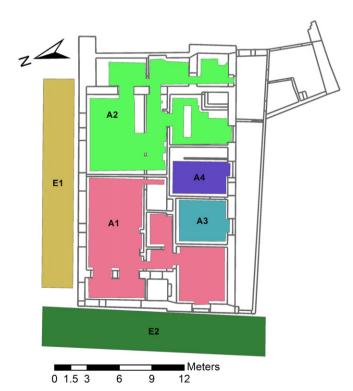
The 500 MHz antenna was used to carry out these studies outside the building in areas E1 and E2 (Fig. 5).

Fig. 5. Surveyed areas on the exterior ("E" areas) and on the interior ground floor ("A" areas) of the InovaDomus building.

Thus the ground floor of the building (Fig. 5, areas A1 and A2) was surveyed with a 800 MHz antenna, using a 0.1 m spacing between lines in orthogonal directions.

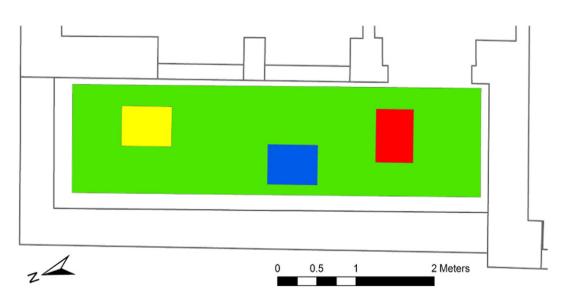
The survey on the balcony was repeated using a 1.6 GHz antenna in three smaller areas in each of the previous zones (Fig. 14). The bottom of Fig. 13 shows the amplitude isosurface data that reveals the different rebar structure of the three areas surveyed with the 1.6 GHz antenna:

Fig. 14. Location of the surveyed areas on the balcony. In green 800 MHz survey, in yellow, blue and red, 1.6 GHz surveys (color correspond to Fig. 13).
