<b>Geologia Croatica</b>	55/1	93 - 100	8 Figs.		ZAGREB 2002
--------------------------	------	----------	---------	--	-------------

## Water Reservoir Within the Karst Field Overburden: Gusić Polje, Croatia

**Key words:** Surface water reservoir, Karst, Water losses, Geophysical investigation, Gusić polje, Croatia.

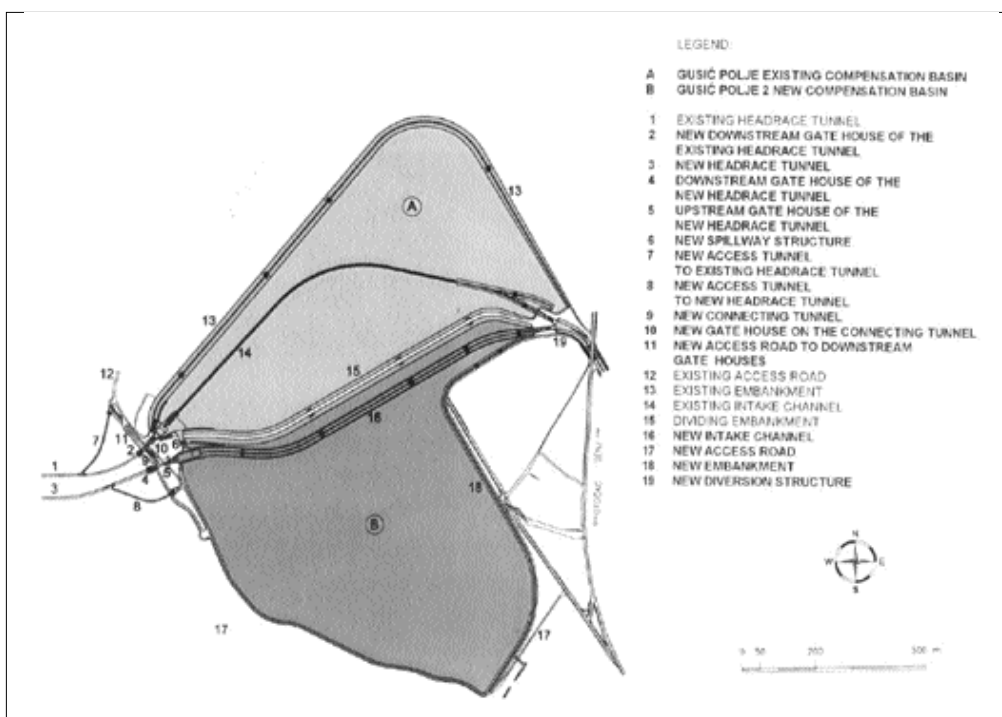
Fig. 7 Gusić polje basins layout.

Due to the increase of installed flow of HP Senj, the building of a new compensation basin, 2.0 mil. m<sup>3</sup> in volume, is planned, next to the existing basin (Fig. 7).

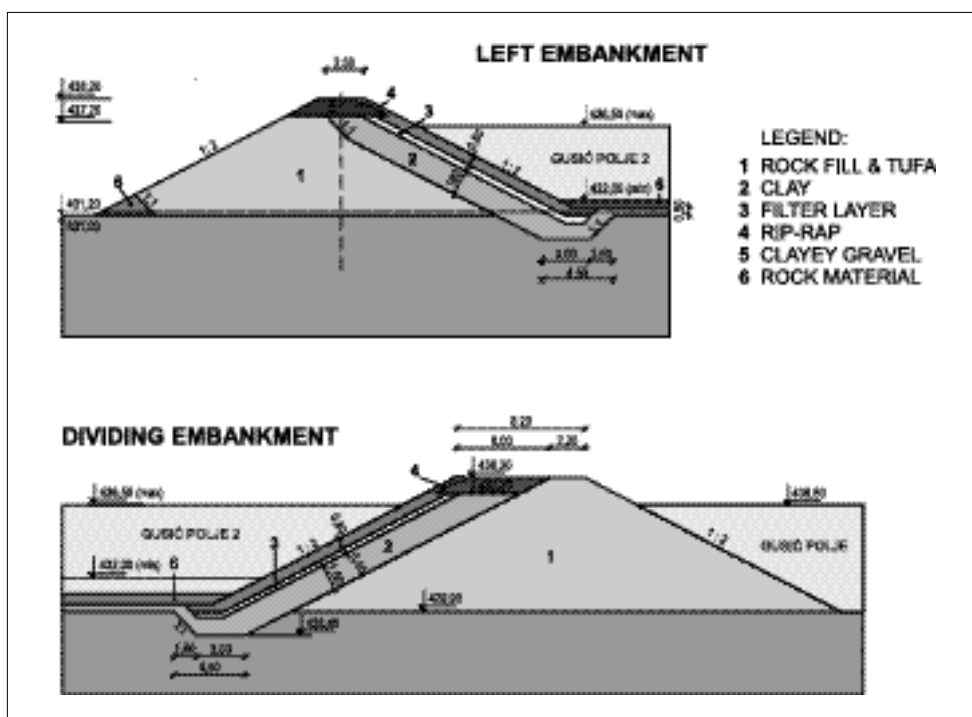
Fig. 8 Gusić polje basin embankments.

This basin is planned to be built on similar geological foundations. Assurance of the water holding capacity of the basin bottom and embankment slopes was taken into consideration in the variant of using artificial materials and clay (Fig. 8). In the vicinity of the basin there is a source with sufficient quantities of quality clay, the economic-technical comparison of variants showed the worthiness of constructing the clay carpet with a thickness of 50 cm. The clay carpet is laid on the geotextile layer with the density of 500 g/m<sup>2</sup>, which is laid on the neat and compacted bottom of the basin. It is also foreseen that the layer of geotextile with density of 500 g/m<sup>2</sup> will be laid on the surface layer of clay and then covered with layer of crushed rock 30 cm thick. The geological investigations determined several faults in the basin area, which in case of sudden changes in the groundwater level, could alter the pressure on the bottom of the basin. Therefore the possibility for draining the air below the clay carpet is foreseen, using the system of drainage tubes which are laid along the faults with exits on air slopes of embankment.
