An Evaluation into the Cause of Corrosive Failure in Autophoretic Coated Material

ABSTRACT

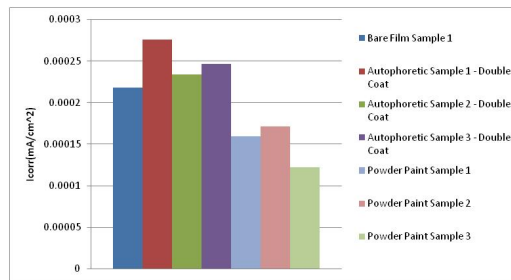
Figure 18: Corrosion Rate Study

The results obtained from the Tafel plots indicate AP coatings have a higher corrosion current density than powder paint coatings, which insinuates a higher corrosion rate. Consistent Tafel plots for each sample were obtained, and anodic/cathodic currents could be extrapolated to find the corrosion current. Figures 17 and 18 below show a comparison of bare, AP and powder paint coated sample Tafel plots and corrosion current, respectively. It should be noted that Figure 18 shows a distinctive difference in current density between powder paint and AP. However, it was also determined that the AP samples had a higher corrosion density than that of the bare metal control sample which was used. This phenomenon may have been caused due to breaches in the coating which expedite corrosion.
