R. TALAR, A. STOIĆ

ISSN 0543-5846
METABK 52(3) 383-386 (2013)
UDC – UDK 539.377:621.833:661.55=111

LOAD CAPACITY OF HARDENED GEAR WHEELS MACHINED WITH CUBIC BORON NITRIDE (CBN) WEDGES

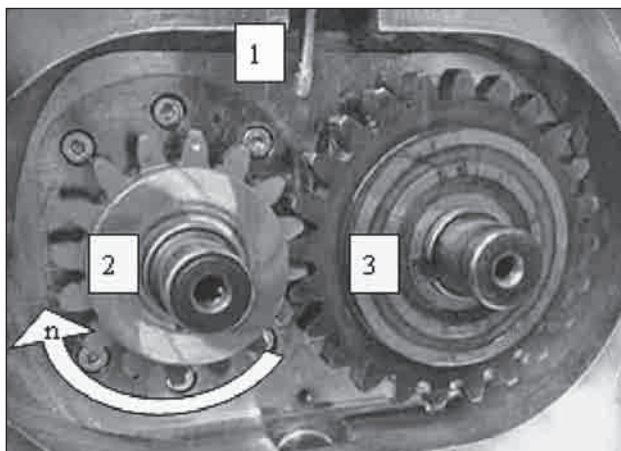
Figure 1 The transmission under investigation on the rig with power loop: 1 – oil nozzle, 2 – pinion, 3 – gear wheel

Due to the geometry of the transmission, where the values of sliding between the teeth are moderate even when the pinion was running at 6 000 rpm, no seizure has been found. No large symptoms of fatigue wear have been found, either. The area of the occurrence of shallow fatigue pinholes has not exceeded 6% of tooth area for the pinion. The area was located in the region of the base diameter where the radius of the involute curvature is smallest. In the case of gears, uniform area with fatigue pinholes did not appear, only single pinholes could be observed. In addition to the moderate, admissible fatigue wear, activity of the process of abrasion has been observed, particularly in the region of tooth vertex. The investigation has proved the ability of the examined gears to bear high loads. The maximum calculated pressure load for the pinion, under the imposed working conditions was nominally up to 1 300 MPa. As a result

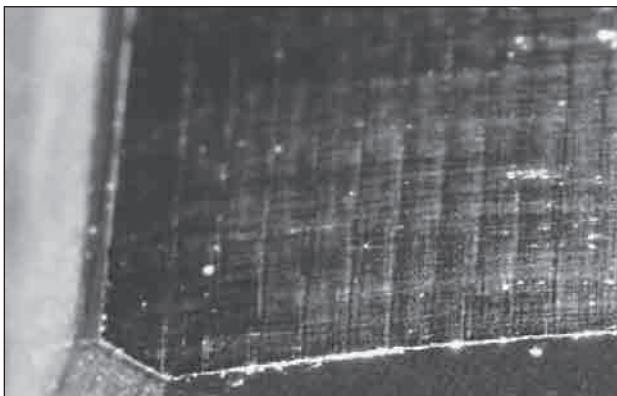
pinion tooth vertex without symptoms of wear. In the photograph, one can see a periodical structure consisting of bands parallel to the tooth line. The bands are reflections of the kinematics of machining and they correspond to the subsequent orbital passes of the tool. The source of the transmission seizure can also be traced back to the high temperature of the wheels and oil. Further testing, exceeding 7 hours would result in seizure of the gear wheels. The tooth surfaces near the roots have been completely deformed by the adhesion processes.

Figure 4 The surface of a pinion tooth vertex without traces of wear
