The 2015 Nepal Gorkha Earthquake: An overview of the damage, lessons learned and challenges

H. Hazarika¹, N.P. Bhandary², Y. Kajita³, K. Kasama⁴, K. Tsukahara⁵ and R.K. Pokharel⁶

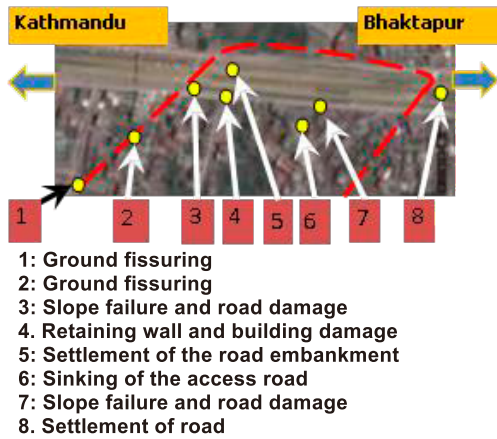
Fig. 5. Locations of the damaged area in the main road and the access road (Source map URL: <http://www.maps.google.com>).

The various locations of the surveyed area were are shown in Fig. 5. In the Kathmandu side, heaving and subsidence of the road, slope failures in the main road and in the access road, ground fissuring, retaining wall damage and damage to the residential buildings close to the access road were observed. Similarly, in the Bhaktapur side, heaving and subsidence of the main road, slope failures in the access road and ground fissuring were observed.

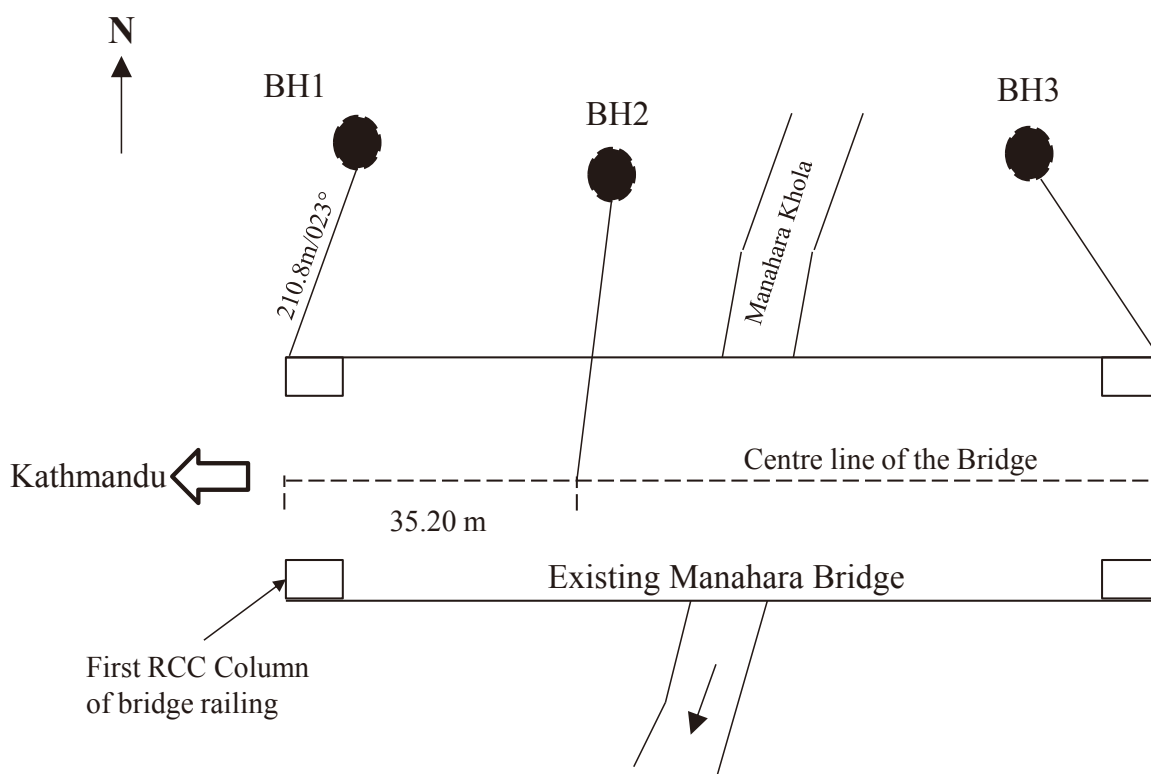
Fig. 12. Borehole locations around Manahara bridge (JICA, 2007).

No detailed geotechnical information about the soil characteristics in the Lokanthali area is available. The closest information available is from the three borehole locations near 84m long Manahara bridge (**Fig. 12**) which is located less than 1 km from Lokanthali (JICA, 2007). **Figure 13** shows the geological profile of the borehole no. 3 (location close to Lokanthali).

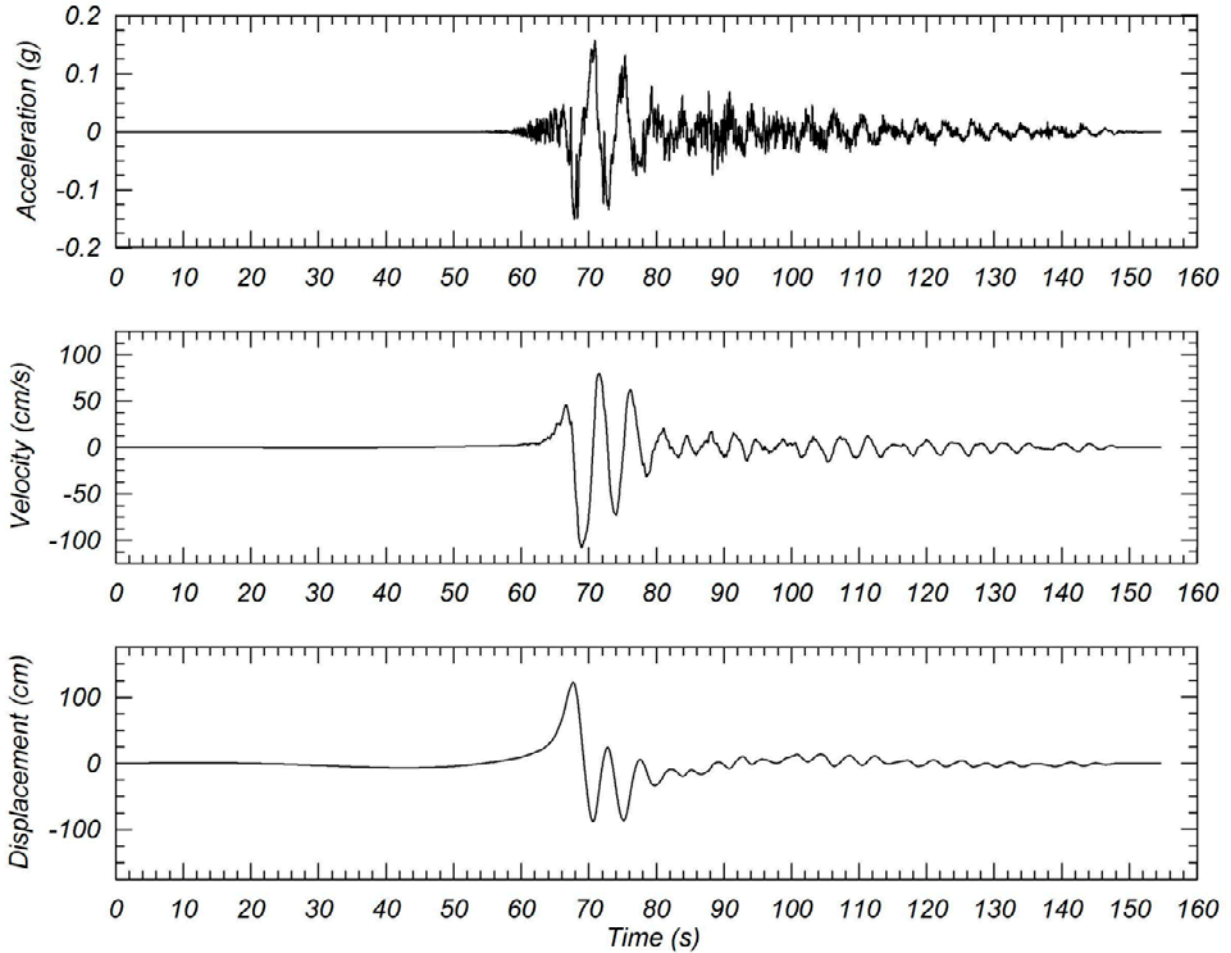
Fig. 37. Acceleration, velocity and displacement profiles of the earthquake (Source: USGS).

The acceleration, velocity, displacement profiles (**Fig. 37**) and spectral distribution (**Fig. 38**) of the earthquake reveal that the maximum acceleration (about 182 Gal) is not that high. However, the velocity, which is a barometer for generated earthquake energy, is rather high. Also, the spectral distribution of acceleration reveals that it was a long-period motion.

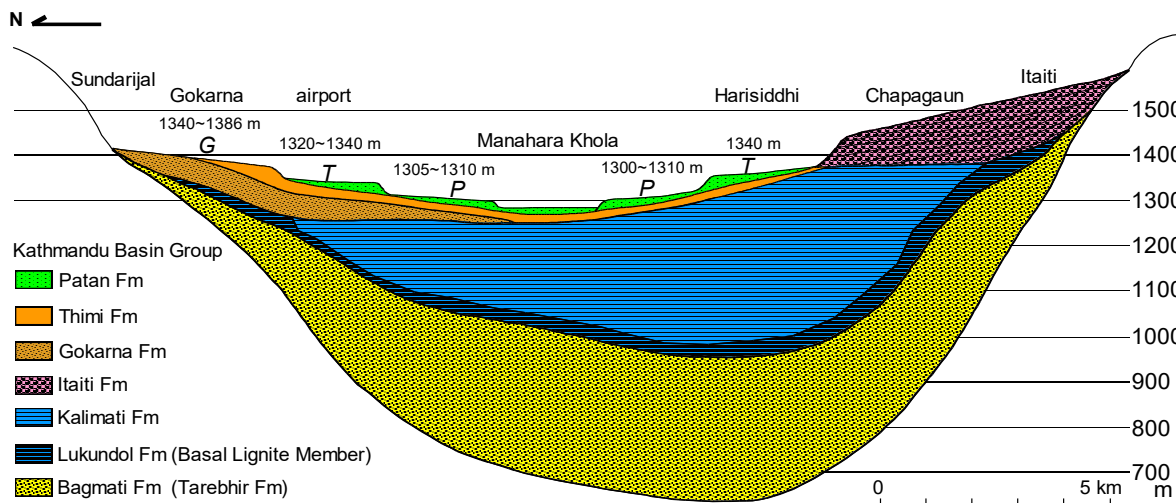
Fig. 39. Schematic geological cross section of Kathmandu valley along N-S (Sakai, 2001).

Most of the damage can be contributed to the non-engineered structures (combination of sunburnt brick and clay mortar), which have negligible resistance to earthquake type loading. Also, damage were mostly localized, which indicate the possibilities of resonance due to ground motion amplification in Kathmandu valley, which basically compose of soft alluvial deposits in old rivers and lakes (**Fig. 39**). The Kathmandu valley comprises of thick semi-consolidated fluvio-lacustrine Quaternary sediments on the top of basement rocks. Piya (2004) reports that the maximum thickness of the valley sediments reaches up to 550 m at the central part of the valley. The shear wave velocity of the soft sedimentary deposits ranges between 167 m/s and 297 m/s, and ground amplification may be ranging between 1.9 and 7.9 according to Chamlagain and Gautam (2015). Due to complicated geology of the Kathmandu valley two levels of resonance are expected (Paudyal et al., 2012).

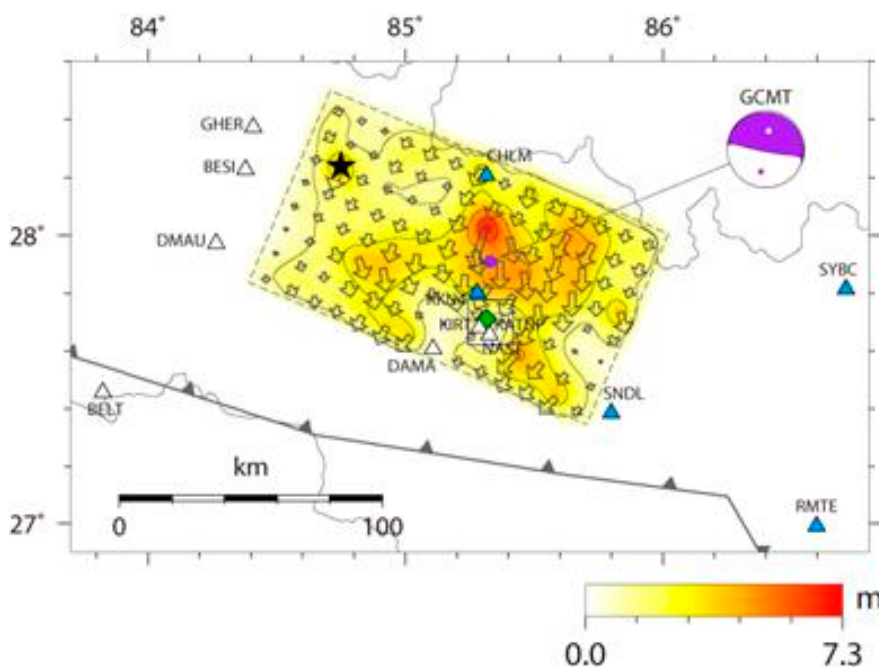
Fig. 40. Map projection of the final-slip distribution (Kubo et al., 2016).

The attenuation of acceleration distribution is shown in **Fig. 40**. It was observed that the damage in most of Kathmandu City, closest to the epicenter, was minor, however, the eastern part of Kathmandu was extensively damaged even though it was further from the epicenter. The extensively damaged areas were located in the north-east of the Kathmandu valley. **Figure 40** is a map projection of the final-slip distribution, using fully Bayesian multiple-time-window source inversion (Kubo et
