Habitat assessment and ecological restoration design for an unnamed tributary of Stone Dam Creek, Conway, Arkansas

Undergraduate Research Articles

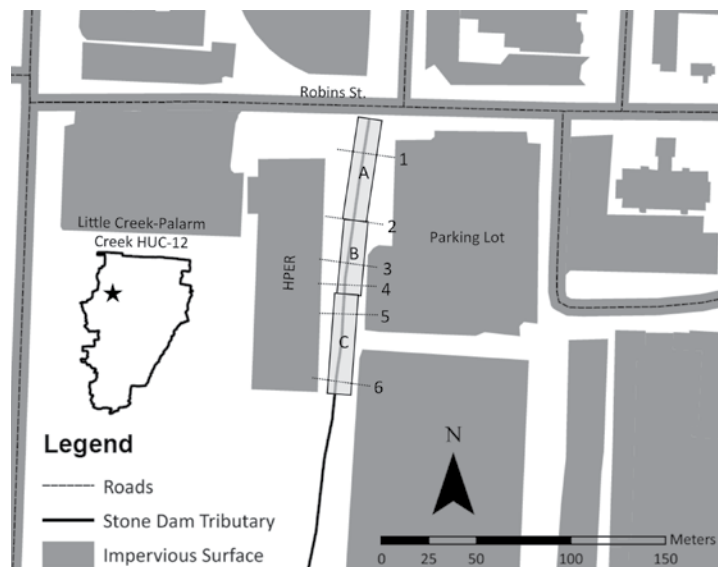
Fig. 2. Map of the study area within the Little Creek-Palarm Creek HUC-12 watershed. Study sections where Rapid Bioassessment Protocol assessment was performed are labeled A, B, and C. Surveyed cross sections are labeled 1-6.

which is currently undergoing construction. The area under study begins where the tributary exits the culvert south of Robins Street and ends at the far end of the HPER building, a total length of 138 m. The area was further broken up into three sections, with breaks between sections 1 and 2 at the dam and between sections 2 and 3 at the point of change in canopy cover (Fig. 2).

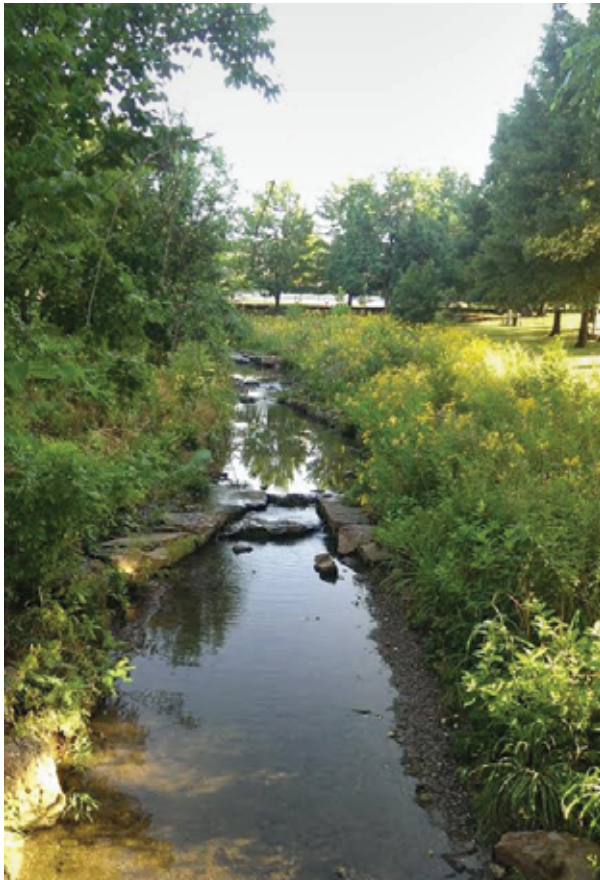
The Mullins Creek restoration utilized in-stream features to divert flow away from the banks, as well as revegetation efforts with native flora (Fig. 3) to increase habitat diversity and stabilize stream banks (pers. comm., Matthew A. Van Eps, Watershed Conservation Resource Center). Based on their similarities, a habitat assessment RBP was conducted on a 50-m reach of Mullins Creek to determine an estimate of what the unnamed Conway tributary habitat assessment goal could be after restoration. An average of four assessors' scores was taken.

Fig. 3. Upstream view of Mullins Creek on the University of Arkansas campus, Fayetteville, Ark.
