BIODETERIORATION OF THE WOODEN ROOF OF THE PHNOM PENH NATIONAL MUSEUM

Bartolomeo Megna*, **Giovanni Liotta**

Laboratory of Materials for Restoration and Conservation, Dipartimento di Ingegneria Civile, Ambientale, Aerospaziale, dei Materiali, Università di Palermo, Italy

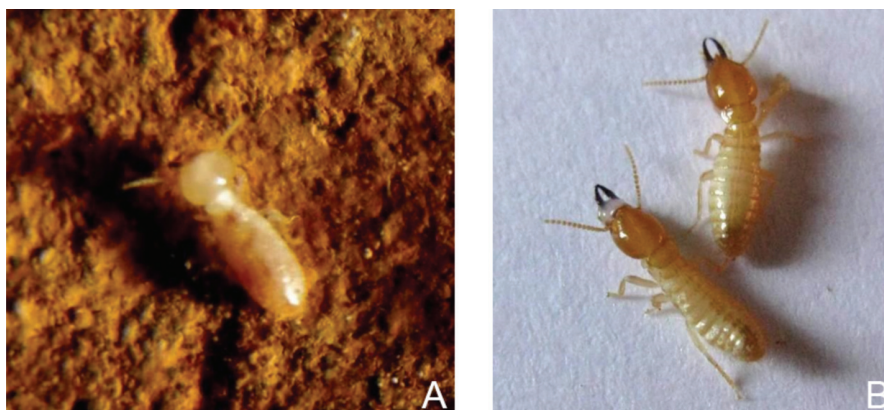
for wood. *Coptotermes gestroi*, as all other species belonging to the Rhinotermitidae family, are subterranean termites, i.e. they build their nest in the soil and the workers spread all around to find wet wood to feed on, reaching places that are quite far from the nest (dozens of meters) [15]. The *Coptotermes gestroi* species attack only wooden structures with a high moisture content. Once they start infestation, they can spread to nearby dry wooden elements because these termites are able to create by themselves a proper environment for their activity, potentially leading to very serious damage. In the roof environment, the main cause of high humidity is probably the occurrence of condensation phenomena. One way to prevent humidity from condensation is to ensure good air circulation [16-18].

Figure 8. *Coptotermes gestroi*: A) worker; B) soldiers.
