ASIA TURBOMACHINERY & PUMP SYMPOSIUM
SINGAPORE | 22 - 25 FEBRUARY 2016
M A R I N A B A Y S A N D S

Dry gas seal failure and trouble shooting

Manikandan, A

Moorthy Subramanian

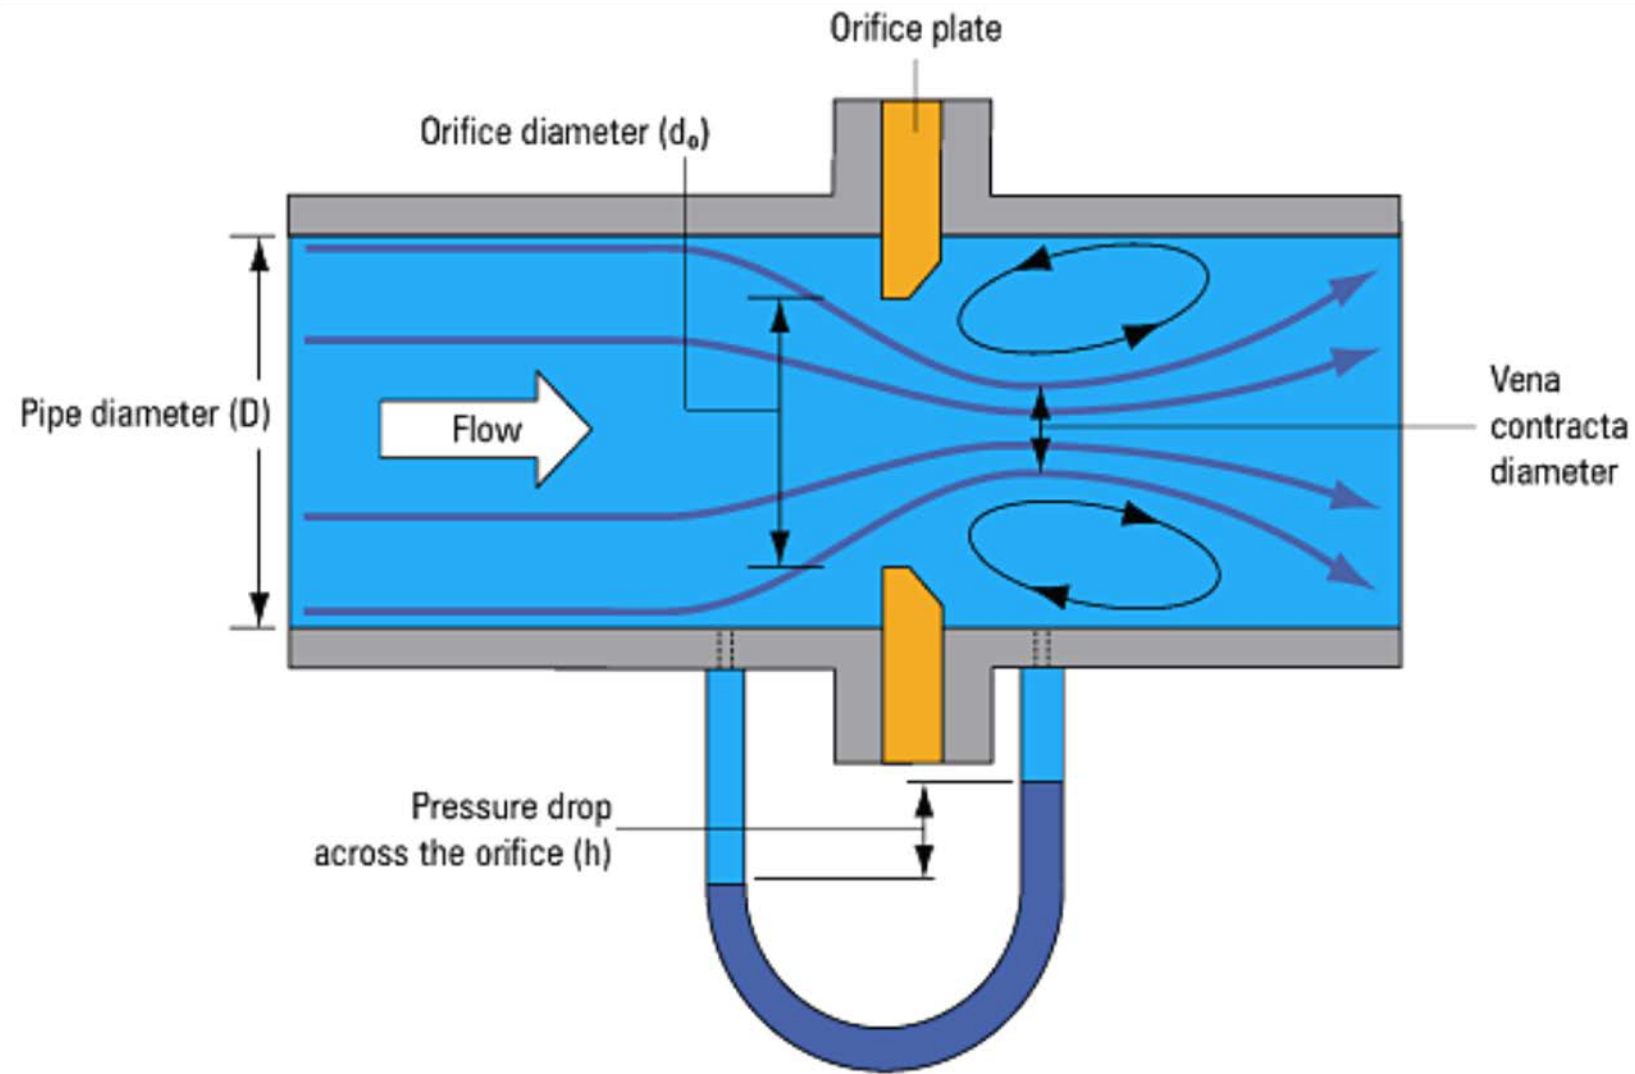
Horizontal Position

The orifice plate installed at the NDE primary vent line was lower than the center line of the compressor. It makes the primary vent gases turn to liquid at the orifice plate due to pressure drop. The condensates started accumulating over the period of time in the loop and blocked the orifice plate hole for further escape of the gases which leads to back pressure in the line. But the DE primary vent orifice was found already at the height of 1.5m as per the design from ground level.

The orifice was removed from the original location and moved at the height of 1.5meter from the ground level. This eliminated the possibility of condensate formation and proper exit for primary vent leakage. The unit was started and the primary vent leakage pressure was found as 0.036barg at NDE and 0.04barG and DE which was just above the minimum leakage requirement.
