Piping Load Effect on Shaft Vibration in a Multi-Stage Barrel Type Boiler Feed Pump

American Electric Power (AEP) – Welsh 1 Power Plant in Pittsburg, TX
Base load: 1500 MW Coal Fired Power Plant (Welsh 1, 2, and 3 combined)

Type: 4 stage Double Case with Twin Suction and 2nd stage bleed-off
Rotation: CCW Viewed from the Driver
Speed: 4,000 rpm to 4,860 rpm (66.7 Hz to 81 Hz)
Capacity: 9126 GPM
Suction Pressure: 216 psig
Discharge P.: 3016 psig
Total Dynamic H: 7,370 ft
Temperature: 375 °F
Specific Gravity: 0.877
BHP: 17,530 HP (steam turbine)

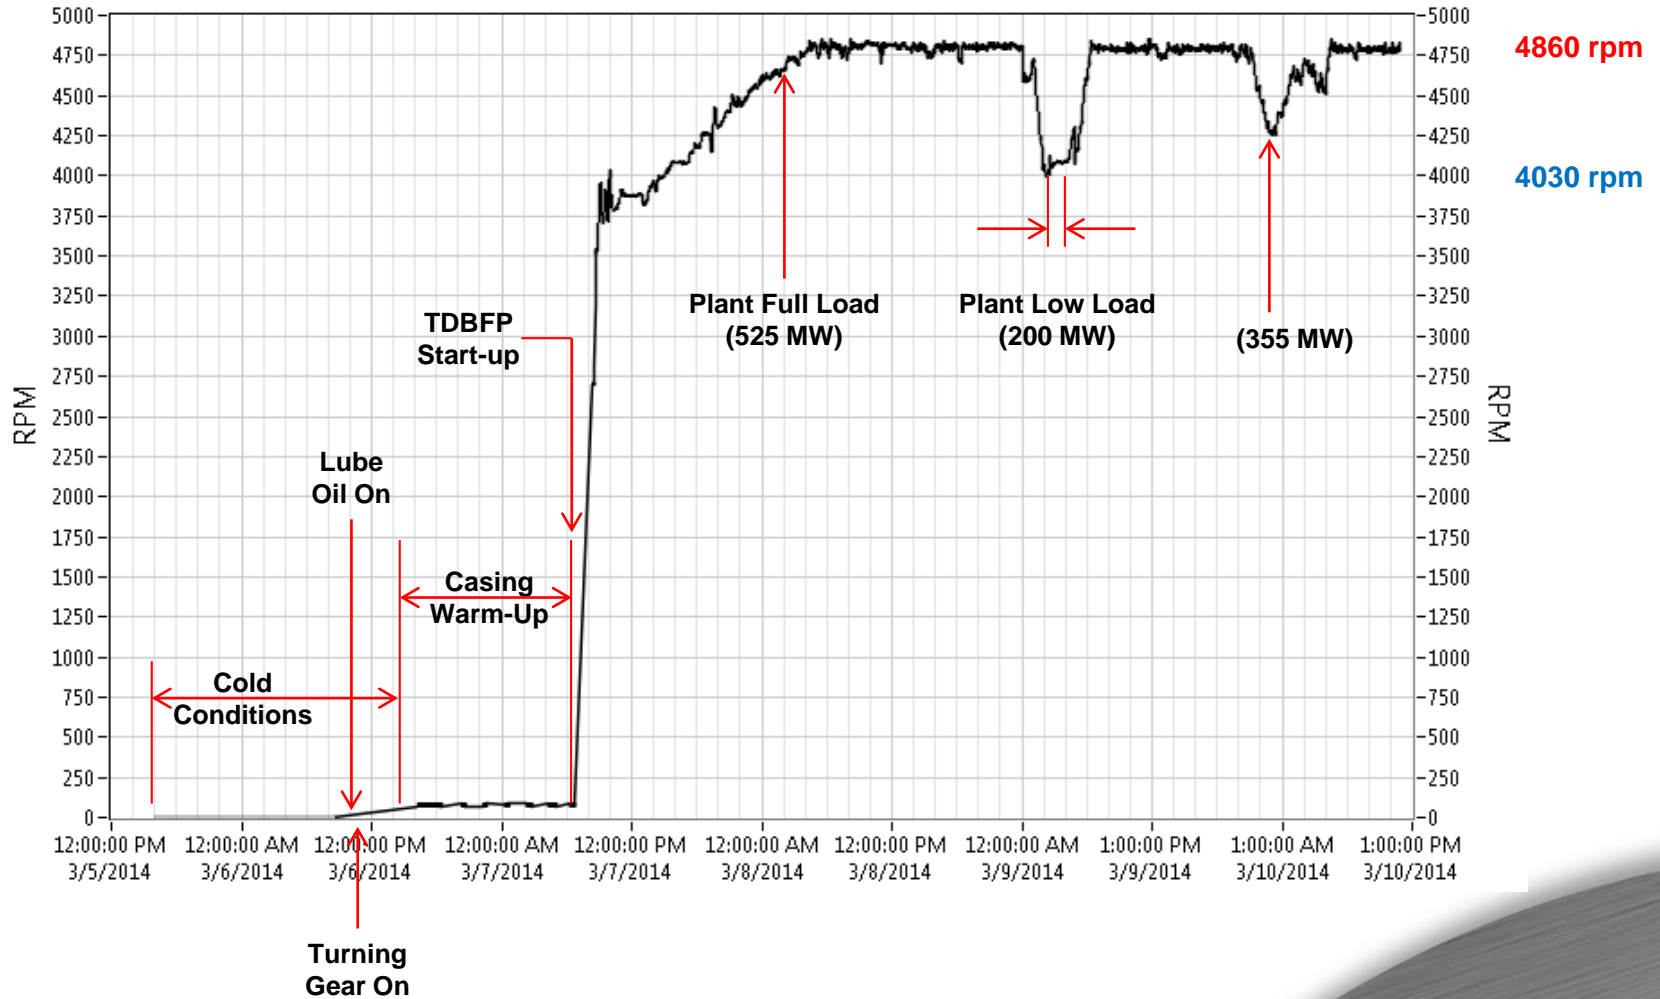
Speed Trend Plot From 3/5/14 to 3/10/14

Pump rotor overall vibration at the IBB was measured to be elevated (~5.0 mil pk-pk) at full load operation (525 MW). Strong vibration change versus speed effect is observed in this trend plot. ~830 rpm reduction, the vibration at IBB-X was reduced from 4.6 to 1.6 mils pk-pk.

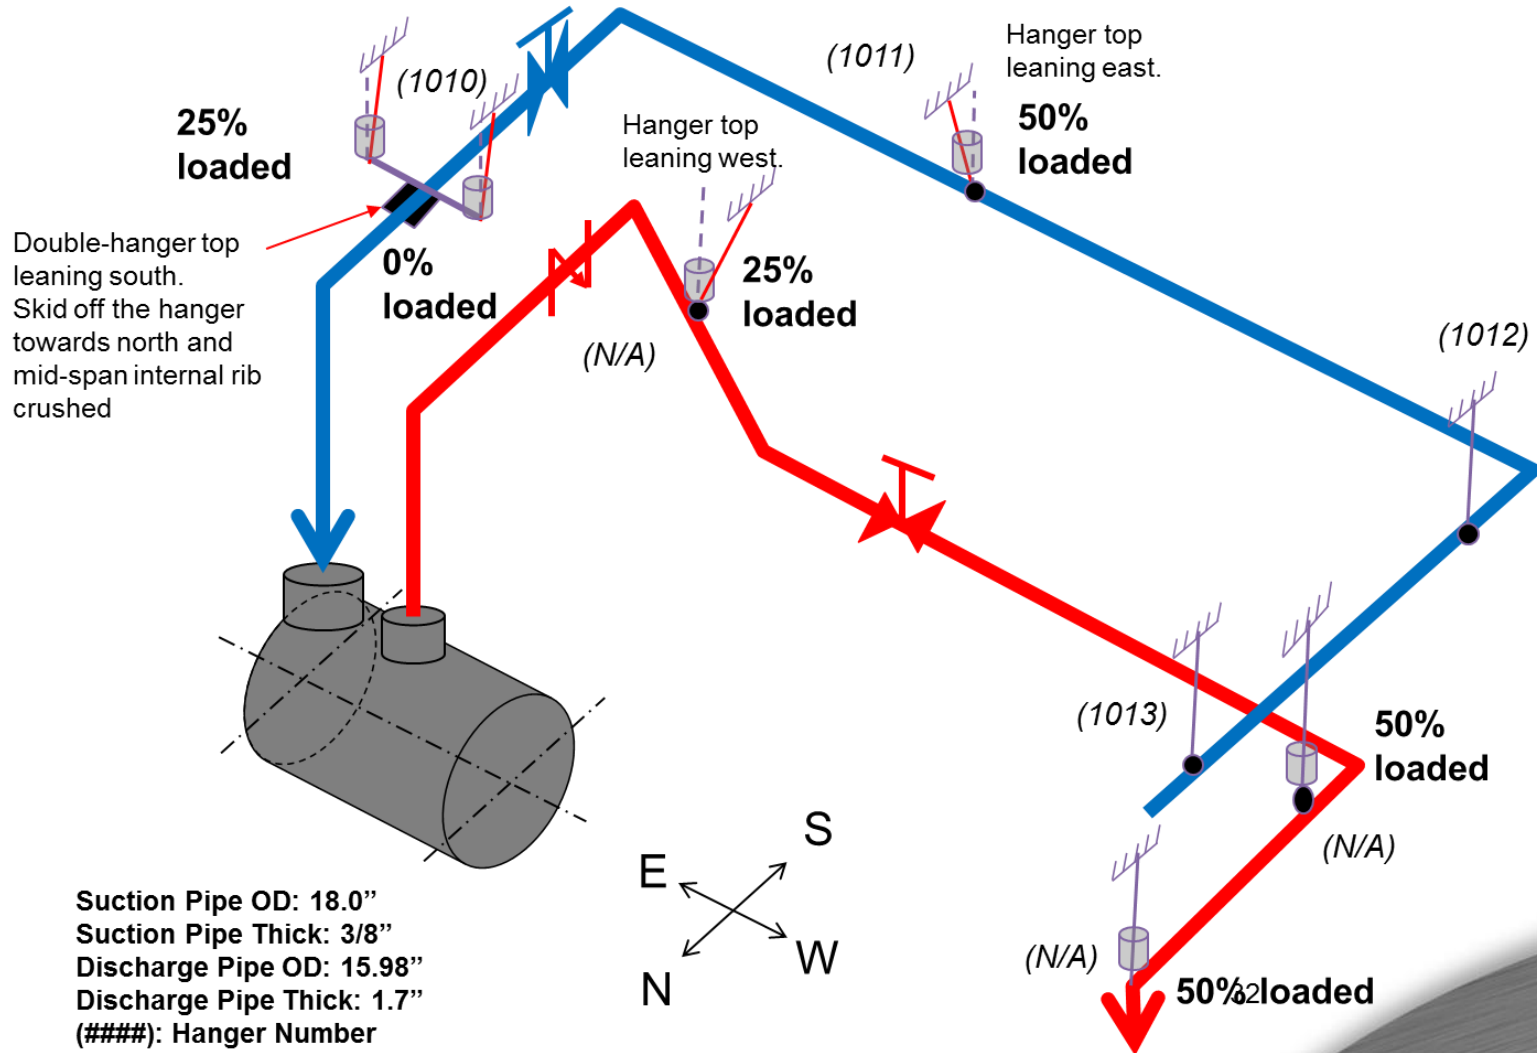
Welsh 1 TDBFP Pipe Diagram

1. The root cause of the high vibration amplitude at the IBB of the pump is due to excessive preload acting on the bearing. Excessive piping strain was measured from the suction and discharge loading. The pump casing was acting as a pipe anchor or support.

1. The loads of the hangers for the suction and discharge piping must be corrected. The hangers must be set in their straight vertical condition. The excessive vertical load was considered the main contributor for the casing deformation and therefore, pre-loading of the IB bearing of the pump.
2. The loads for each hanger should be corrected at cold conditions, taking into account the longitudinal thermal growth of the piping. Once these issues are corrected, the new baseline alignment approach should be conducted.
3. Conduct a hot alignment for verification purposes.

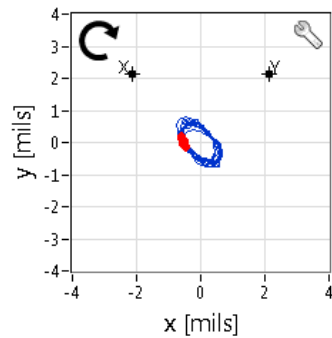
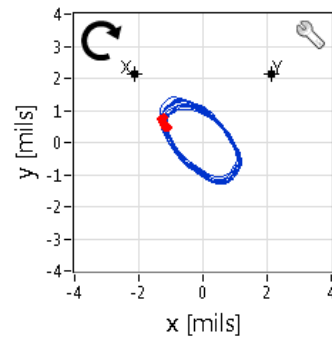
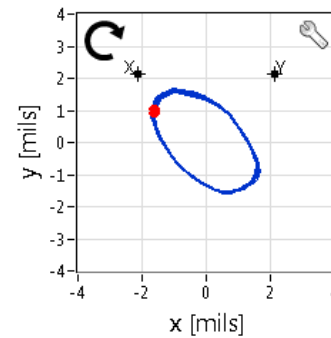
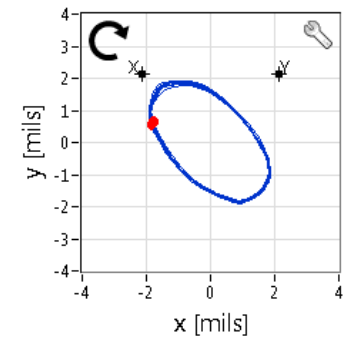
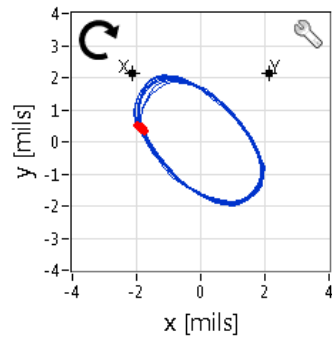
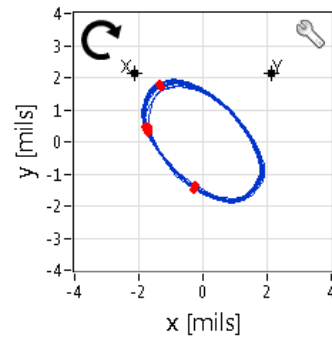
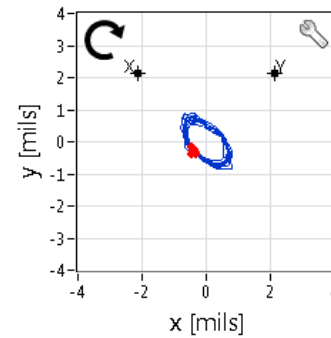
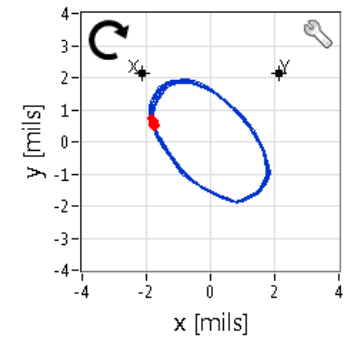
Pump Inboard Bearing Orbits

Sequence of the IBB orbit plots at different load conditions.
