TURBINE ROTORS WHIRL AFTER DYNAMICALLY STABLE DESIGNS ARE UPRATED

Fred L. VanLaningham

Union Carbide Corporation

ABSTRACT

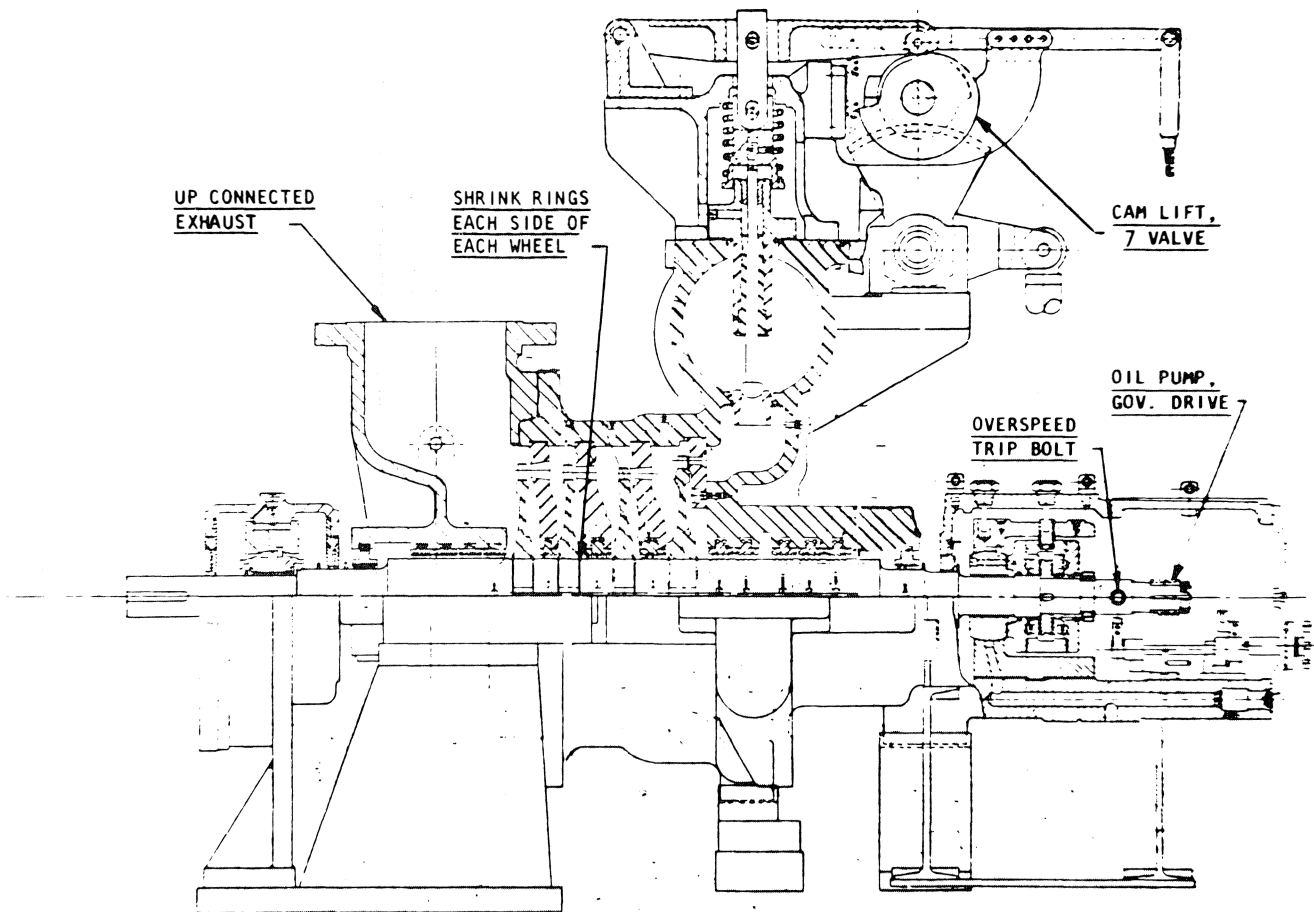
Severe rotor vibration at subsynchronous speeds began to plague the nearly identical steam turbine drivers of process compressors installed at different chemical process plants following several months of satisfactory operation (Figure 1). Internal rubs, oil whirl, distortion of the casing due to excessive pipe strain and hysteresis whirl were each considered as a possible contributor or cause of the vibration. Bearing design and aerodynamic excitations were also considered and investigated before a solution to the problem was found.

Figure 1. Cross-Section of Four-Stage Multi-Valve Steam Turbine with Built-Up Rotor.
