# Failure Analysis of Power Devices Based on Real-Time Monitoring

著者	Watanabe A., Tsukuda M., Omura I.
journal or publication title	Microelectronics reliability
volume	55
number	9-10
page range	2032-2035
year	2015-07-17
URL	<a href="http://hdl.handle.net/10228/00006262">http://hdl.handle.net/10228/00006262</a>

A. Watanabe<sup>a, c\*</sup>, M. Tsukuda<sup>b, c</sup>, I. Omura<sup>a, c</sup>

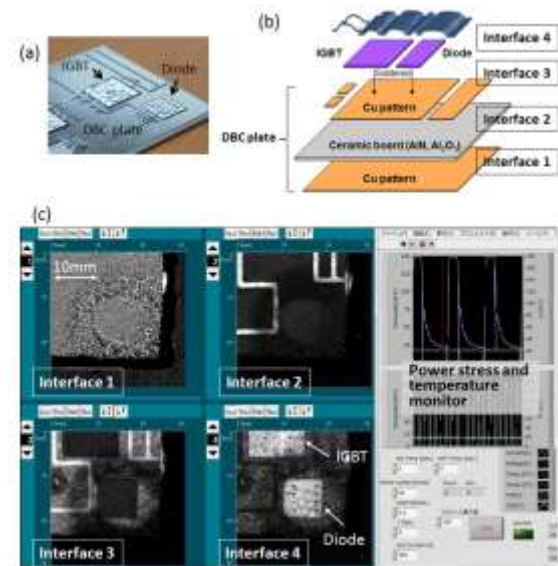
A GUI for the real-time monitoring is shown in Fig. 2. The observed area was 30 mm x 30 mm with 0.2 mm scanning pitch. Under this condition, the frame rate was 3 frames/min.; therefore, complete 1 frame imaging within 1 cycle (7 sec) was impossible in this experiment. Image noise appeared around the

Fig. 2. Specimen DBC module (a), (b) and GUI of real-time monitoring system (c). (b) indicates corresponding interface observed in the GUI.
