Article

Failure Analysis of High Strength Galvanized Bolts Used in Steel Towers

Abstract: This paper analyses the failure of three bolts used in the structural connections of a number of steel towers located in northern Europe. The analysis comprises optical and scanning electron microscopy, microstructural and hardness analysis, mechanical testing and structural integrity assessments. The three bolts present very similar failure processes, with a circumferential external crack that led to the final failure. The morphology of the crack propagation is typical of Hydrogen-Induced Stress Corrosion Cracking (HISCC), with mixed intergranular-transgranular micromechanisms, tearing processes and secondary cracking. The cracks then grew subcritically until they reached their critical size. Quench cracking or fatigue processes have been ruled out.

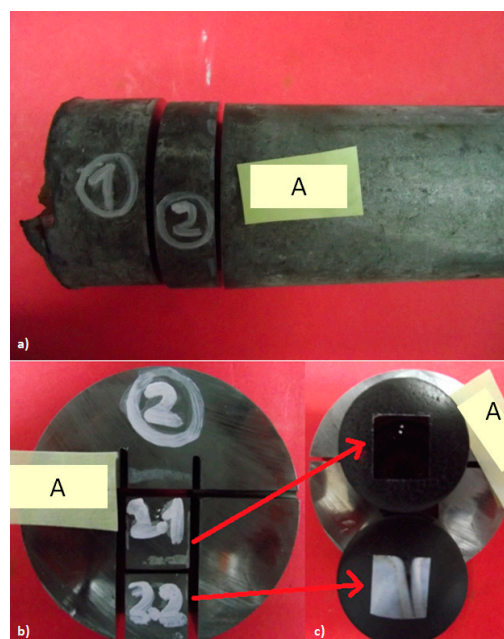
The bolts were sectioned as shown in Figure 3. Two sections (identified as 1 and 2) were obtained from each shank: the first piece contained the fracture section, while the second section was used to analyse the material microstructure in two different locations (samples 2.1 and 2.2, as shown in Figure 3).

Figure 3. Sectioning of the shaft (bolt A). (a) Sections 1 and 2; (b) samples 2.1 and 2.2 taken from Section 2; (c) samples 2.1 and 2.2 mounted.

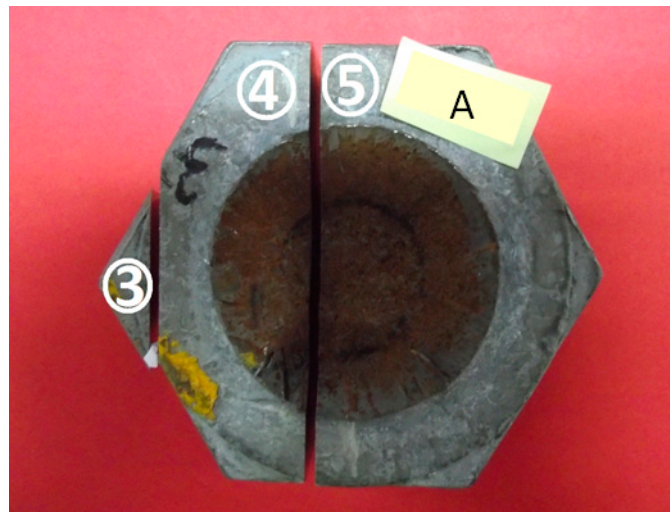
The heads of the three bolts were also cut (see Figure 5) into three sections (named 3, 4 and 5). Different samples were obtained from Section 4 in order to analyse the corresponding microstructure. This was analysed at different points (A to D, as shown in Figure 6). In all cases, tempered martensite was found to be the dominant microstructure, with bainite in the centre of the section (point D, see Figure 7).

Figure 5. Quartering of the head (bolt A).

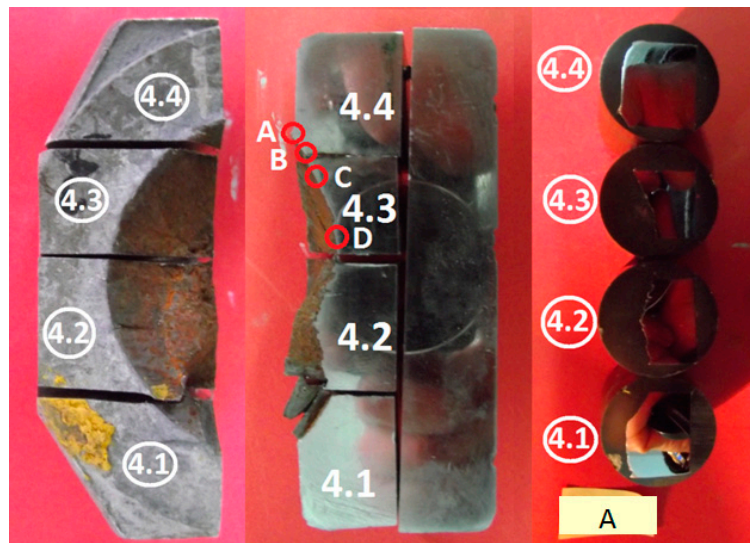
Figure 6. Quartering of Section 4 (bolt A) with the identification of the different samples and the location of the points where the microstructure was analysed.

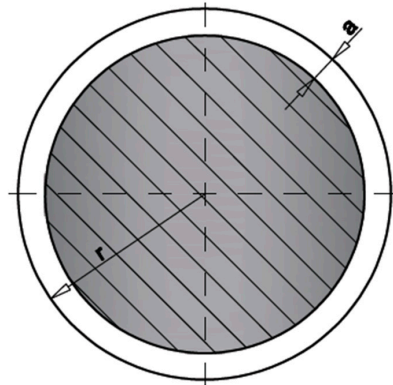
- Circumferential flaw in the round bar (Figure 15), the crack size (a) being 11.5 mm (as a lower value of the size of the external smooth area). The corresponding critical load is determined.

Figure 15. Idealisation of the bolt section and the crack geometry.
