White Paper Report

Implementing Sustainability Strategies for the Abbe Museum's Collections Environment

Grantee Institution: Abbe Museum

## **BUILDING AIR-BARRIER EVALUATION REPORT—ABBE MUSEUM**

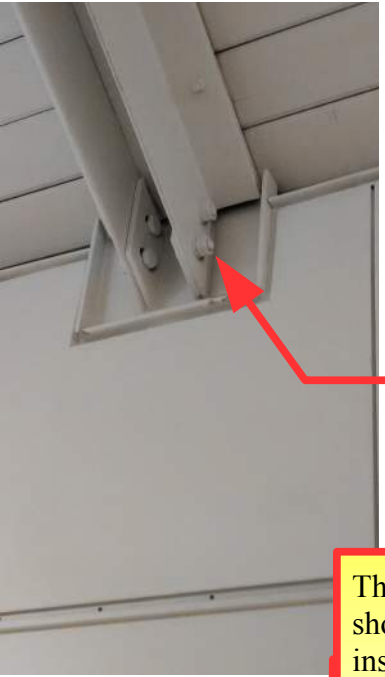
Julia Clark pointed out the 2 areas where ceiling leaks have occurred—at the HVAC supply duct penetrating the upper east sloped-ceiling, and along the east-eave at a steel roof-framing bracket, above the common wall with the adjacent hallway. These leaks occur during the heating season only.

The overall effect is warm moist air forcing into a poorly ventilated attic, condensation occurring at specific air-leaks adjacent to metal (ductwork, steel-framing bracket) and at the roof-deck and framing, then either water leaking into the space where condensation occurs (ductwork/bracket), or water collecting, beading and draining down the surface of the exhibit hall ceiling insulation (foamboard), to leak at the eave above the common wall with the adjacent hallway.

This is one of the identified leak areas. Note metal adjacent to leak.

Priority	Retrofit/Air-sealing recommendations
<b>High</b>	<p><b>EAVE</b>—In the attic, remove the lower 6-foot section of foamboard insulation (2 layers) to expose the membrane over the ceiling. Remove all debris and insulation at building assembly transition to opposing slope and wall of computer room. Seal all penetrations in the membrane with flexible adhesive sealant. Install new 6” polyisocyanurate foamboard (in 2 or 3” alternating layers) from pitch change to within 1-foot of transition above common-wall with hallway below. Install 4” SPF (in 2 applications of 2”) to exposed ceiling membrane and building-assembly transition (to either wall or sloped-ceiling).</p> <p><b>SUPPLY DUCT</b>—cut back existing insulation roughly 1-foot from edge of duct/duct-insulation. Air-seal duct penetration in the ceiling with flexible adhesive caulking. Be sure to remove insulation at the bottoms of the adjacent valley rafters, and air-seal all cracks/holes/seams with canfoam. Install 4” SPF (in 2 applications of 2”) to exposed ceiling encasing rafter-bottoms/plate.</p>

The eave-leak issue is both an air-barrier and thermal barrier breach. Therefore complete removal of foamboard to pitch change (at red-line left) and removal of fiberglass along reverse slopes (to the right red-line) followed by comprehensive membrane-sealing, air-sealing, and re-insulation should fix the water leaking in, and air leaking out.
