Stability and consolidation of an ashlar barrel vault with great deformations: the church of Guimarei

S. Huerta, G. López

Departamento de Estructuras de Edificación, Escuela Técnica Superior de Arquitectura, Universidad Politécnica de Madrid, Spain

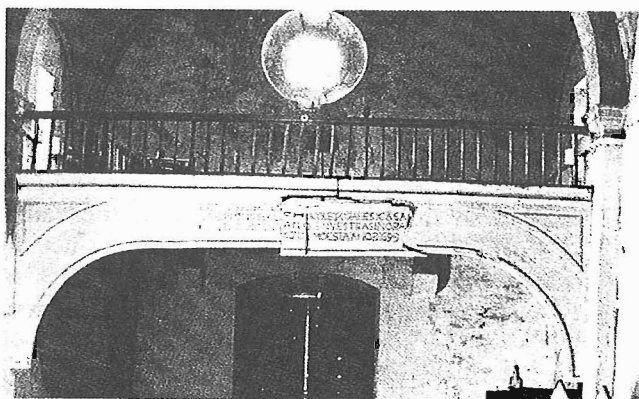
Figure 6

In Guimarei the cracking was due to a leaning outwards of the abutment system (walls plus counterforts) of the nave. The vault adapted itself with a "classical" pattern: a crack in the crown, directed inward, and two cracks in the haunches, directed outwards (see Figs. 2 and 6).

It should be noted that the inclination of the walls is different inside and outside (greater). This difference of inclination have produced a separation of both faces (internal and external) of the wall, which afterwards moved independently.

When the new counterforts were added, the deformation remained. The inside inclination governs the vault deformation. This has been verified calculating the crack width in the crown (57 mm) and comparing this value with the actual width (55 mm).

The different leaning of internal and external facing of the wall suggests a crack in the wall's core; it was also recommended to make some stitching and grouting to consolidate the walls of the nave.
