# Monitoring of “Zarzuela Racecourse” structure by means of non-destructive techniques for durability assessment

**ABSTRACT:** Present paper describes some aspects of the restoration project recently undertaken in La Zarzuela Racecourse, designed by E. Torroja and Domínguez in 1934. Despite the good mechanical work of steel, it has started a deterioration process which has caused the corrosion of reinforcement by carbonation. It has been detected corrosion attack in some places due to the breaking of the upper waterproofing membrane of the shell which enabled the water to remain long periods in the roof and therefore promoted corrosion of reinforcement. For the repair first an assessment of the degree of corrosion was made. The restoration project finally consisted in the injection of all the cracks in order to assure the joint work of the shell and the patching of the deteriorated zones. Profiting these works it was installed a monitoring system of corrosion sensors. Results of the recording are given in the paper.

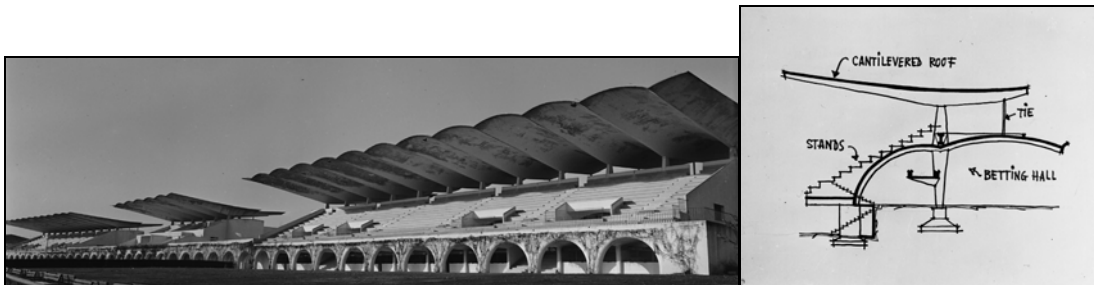
The three decks of the structure are considered an art in terms of engineering. It is formed by thin concrete sheets of a hyperboloid shape with variable thickness between 65 cm in the area of pillars and 6 cm at the edges, supported up by a single pillar as cantilever to 13 m high; Zarzuela Racecourse-Construction Reports, (1962). That is possible thanks to intelligent intertwined armed design and installation of steel bracing liabilities (Figure 1).

Figure 1. Panoramic photograph of the decks and construction scheme.

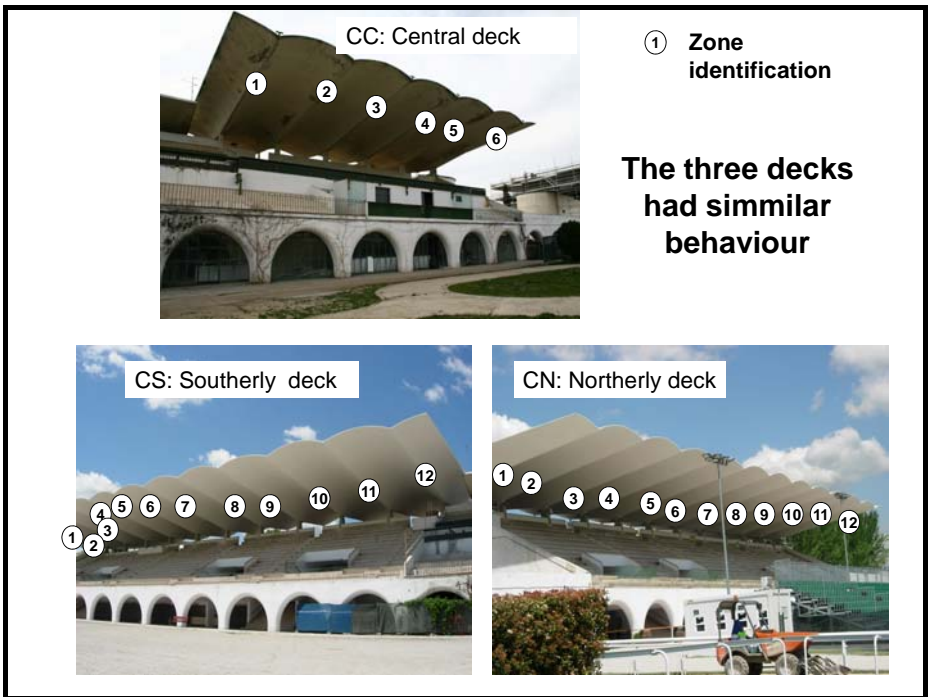
The corrosion rate (evaluated by the modulated confinement method by means of the corrosion rate meter Gecor 08) was quantified in different areas of the three decks (Figure 5). The results indicate that almost all the structure is corroding due to the concrete carbonation. The majority of the values registered are in the range of moderate corrosion rates (between 0.5 and 1  $\mu\text{A}/\text{cm}^2$ ), as is shown in the example of 04b (Feliú et al. 1990).

Figure 5. Different zones evaluated in the three decks.

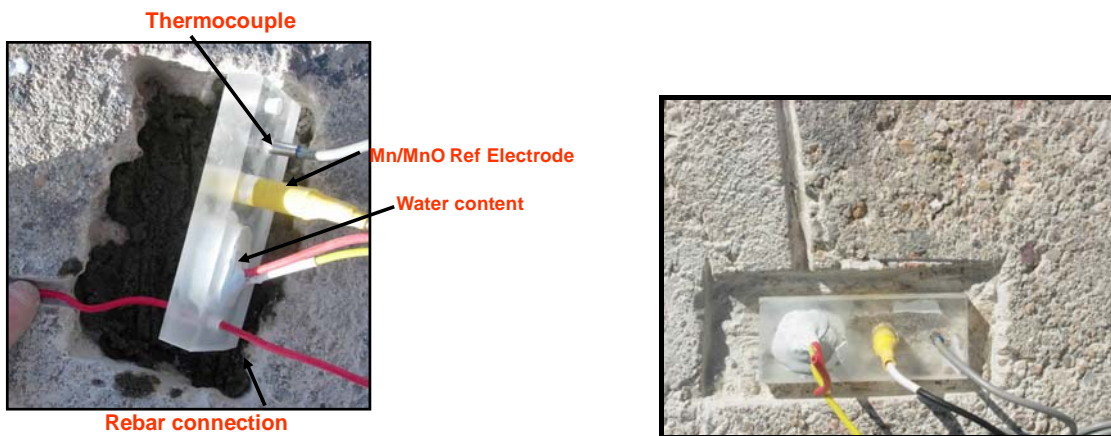
Electrochemical sensors able to indicate the risk of corrosion of reinforcement were installed in the decks and in the ties. These sensors enable the monitoring of the water content and the corrosion potential, in order to predict the need of maintenance interventions, Martínez & Andrade (2009). As an example a photograph of the sensors installed and some of the first results obtained are presented in Figure 9 and Figure 10.

The  $E_{\text{corr}}$  tend to less negative values with time what means that the steel is being passivated. In the case of water content sensors, the response is measured in mV (difference of potential between two metals embedded in the sensor). Values around 0mV means no liquid water, so, the new waterproofing system is working properly

Figure 9. Permanent sensors installed
