# Performance analysis of a 7-kW crystalline silicon generator after 17 years of operation in Madrid

Eduardo Lorenzo , Roberto Zilles , Rodrigo Moretón , Trinidad Gómez and Ainhoa Martínez de Olcoz

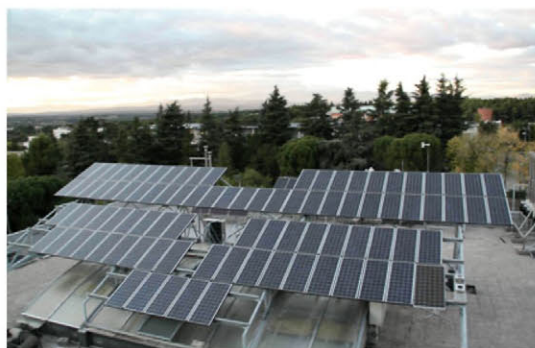
(a)

In fact, despite significant backsheet delamination and silicon joint degradation, the PV modules have successfully passed the two electrical insulation tests (dielectric withstanding test and wet leakage test) established by the IEC 61215 [11]. As far as we know, the wet leakage insulation test results for aged PV modules have not been published before. Hence, the good insulation performance of our modules can be understood as the good news of this paper. This is particularly interesting because thermal cycles and damp heat following the IEC 61215 do not normally give rise to delamination [16], so that the associated electrical

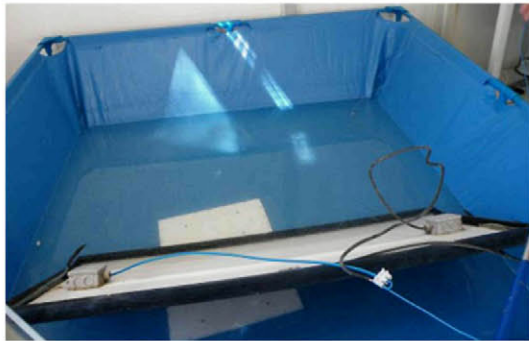
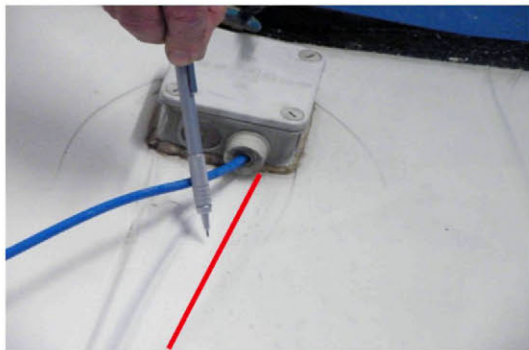
high-grade backsheet delamination to the dielectric withstanding test and to the wet leakage test described in the IEC 61215. Applied voltages have been 1216 and 500 V, respectively. For both tests, the acceptance criterion [11] is that the product of the resulting insulation resistance,  $R_{ISO}$ , and the PV module surface,  $S$ , must be equal to or larger than  $40 \text{ M}\Omega \cdot \text{m}^2$  or  $\text{M}\Omega \cdot \text{m}^2$ . Because  $S = 0.7965 \text{ m}^2$ , it means  $R_{ISO}$  must be larger than  $50.2 \text{ M}\Omega$ . Figure 10 shows the details of the leakage wet test. Table III shows the tests results. All the modules widely succeeded in passing the tests.

**Figure 10.** Wet leakage test. (a) Positive and negative poles are short-circuited. The photovoltaic module is then submerged up to the terminal boxes in a water solution with  $656\ \Omega\text{-cm}$  or  $\Omega\text{cm}$  resistivity, and voltage is applied between the poles and the frame. (b) Detail of the partial submersion: the line indicates the liquid level. The non-submersed part of the module is sprayed with the same water solution.
