# Observed degradation in photovoltaic plants affected by hot-spots

Miguel García , Luis Marroyo , Eduardo Lorenzo , Javier Marcos and Miguel Pérez

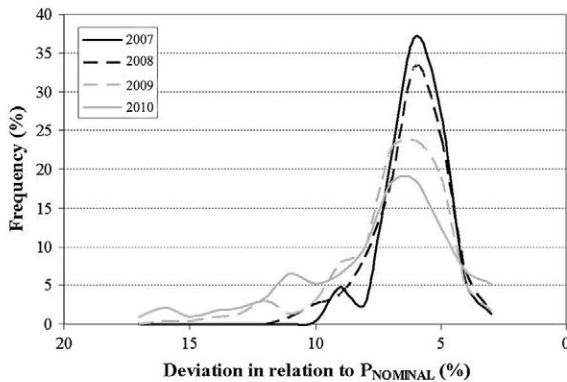
**Figure 1.** PV generator STC power histograms for the plant from 2007 to 2010. The STC power is expressed as a deviation from its nominal value.

In 2010, the problem grew to become more serious, with more than 17% of the generators with STC power outputs of below 90% of their nominal value. However, the module manufacturer, aware of the problem, replaced the affected modules. This explains the increase in the number of generators with an STC power output of over 95% of the nominal value in 2010, as shown in Figure 1.

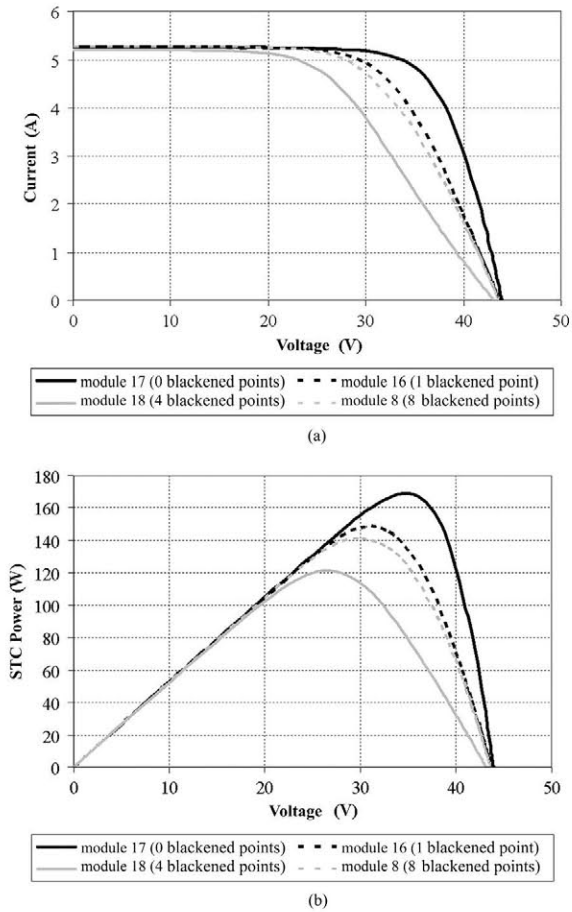
**Figure 6.** (a) I-V curve and (b) P-V curves, in STC for four modules of a generator severely affected by localized heatings.

conditions (STC). There was no sign of localized heatings in one of the modules, whereas it was possible to observe 1, 4 and 8 blackened points in the TEDLAR respectively, in the other three.

Figure 6 illustrates how the presence of those localized heatings has the same effect on the I-V curve as a resistor connected in series with the module. Furthermore, the impact of the localized heating is not only dependent on quantity but also on the state of degradation and on whether the localized heatings are on the same block or on different blocks. For instance, although module 18 shows fewer blackend points in the TEDLAR than module 8, it actually has a greater effect on the pressure-volume curve.

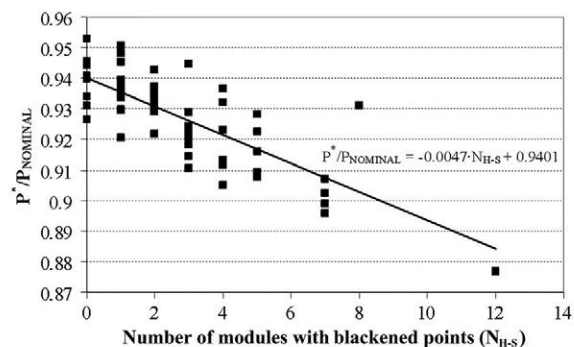
At the end of 2009, a thorough inspection was made of all the PV generators in the most affected areas of the plant, quantifying the number of modules with blackened points in the TEDLAR. Figure 8 shows the STC power output for those generators in relation to the number of modules with blackened points in the TEDLAR.

**Figure 8.** STC power output of the generators from the most severely affected areas of the plant, in relation to the number of modules with blackened points in the TEDLAR.

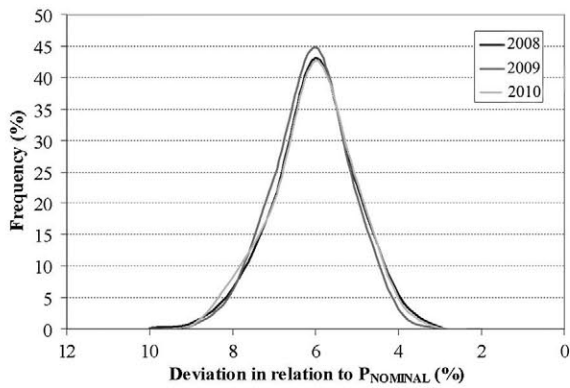
**Figure 10.** Histogram of the STC power for the PV generators from 2008 to 2010. The STC power is expressed at a deviation in relation to the nominal value (as a %).

histogram of the generator STC power from 2008 to 2010. The power was calculated in the same way as for the PV plant described earlier [12]. As the power outputs approximately fitted a normal distribution, there did not appear to be any trackers with an unusually low power output

The power histogram in Figure 10 shows that there is little variation in the generator STC power over the 3 years studied. This appears to indicate that the hot cell phenomenon stabilized during the first year of plant operation. Based on the thermal imaging inspection carried out in 2010, amongst other things, it was possible to determine that the total number of modules affected was 1259; 5.7% of the total number of modules installed. No new hot cells were detected over the following year, confirming the fact that there was no discernible degradation over time. However, as in the case of the other plant, it was not possible to continue the degradation study once the manufacturer had replaced the defective modules.

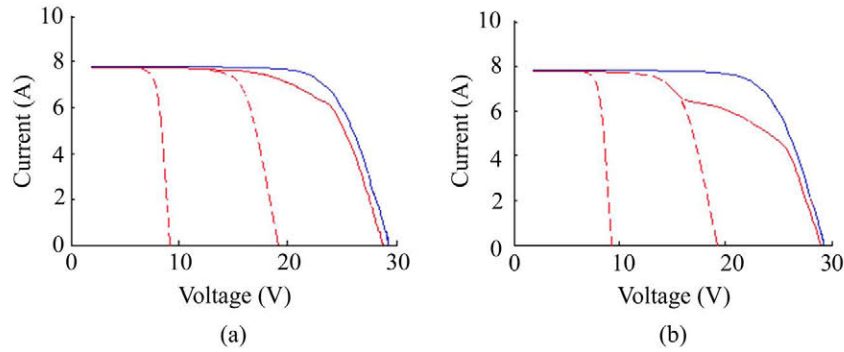
The effects of the cracked cells on the PV module electrical performance are only evident when the cracks lead to isolated cell areas [18]. Figure 12a and b show the I–V curves for two of the defective modules (red). In this case, the modules comprise three blocks. The dashed lines in Figure 12 correspond to the imaginary lines obtained by dividing the modules into blocks. Both modules had two sound blocks and one block with hot cells. Alongside these curves, the I–V curve (blue) of a sound module has also been plotted.

**Figure 12.** I-V curves of two modules with hot cells (red) and the curve of a sound module (blue).

Modules with hot cells, as plotted in Figure 12, show I-V curves similar to those of partially shaded modules. Several of the thermal images showed many hot cells to have some areas that were noticeably colder, corresponding to areas that were completely isolated from the rest of the cell. Depending on the size of the isolated area, the curve step (i.e. the severity of the defect) would be either larger or smaller, explaining the differences between Figure 12a and b.

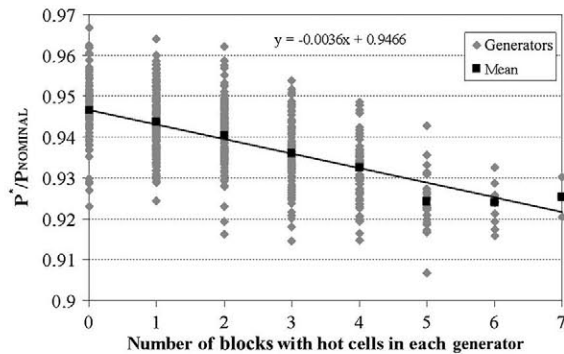
**Figure 13.** Generator STC power (related to the nominal value) versus number of blocks with hot cells. The black dots mark the mean power of generators with the same number of blocks with hot cells. The black line shows their linear fitting.

There is an evident correlation between the generator STC power and the number of blocks with hot cells. Each block with hot cells represents a mean decrease in generator power of 0.36%.

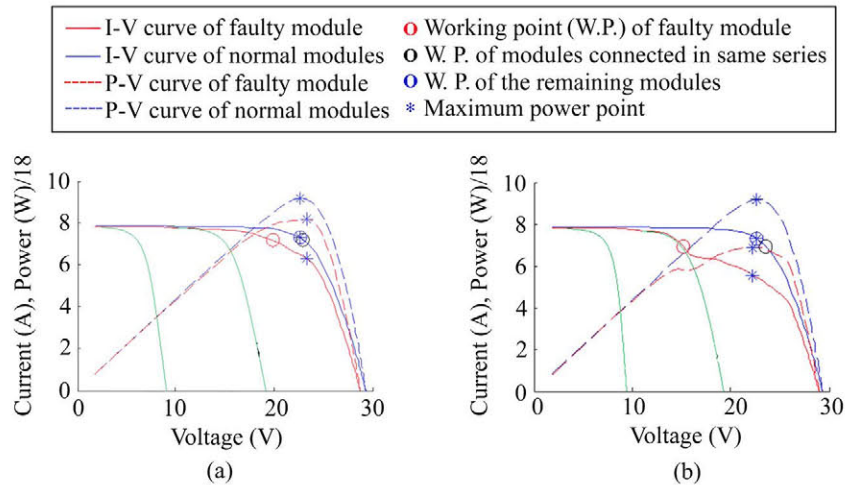
**Figure 14.** V-I curves, maximum power point and operating point for the PV modules making up the simulated generator: (a) Module with a slight defect and (b) Module with a major defect.

the case shown in Figure 14b, the defect in the faulty module forces the corresponding bypass diode to conduct, whereas the defect in the faulty module of Figure 14a is not severe enough to force the bypass diode to do so. Such behavior was experimentally verified, as shown in Figure 15. It is easy to understand that the maximum power loss caused by a cracked cell corresponds to the power of a whole block (when the diode is forced to conduct) plus the mismatch losses caused to the rest of the blocks. It is thus of interest to determine how often a cracked cell causes the corresponding bypass diode to conduct.

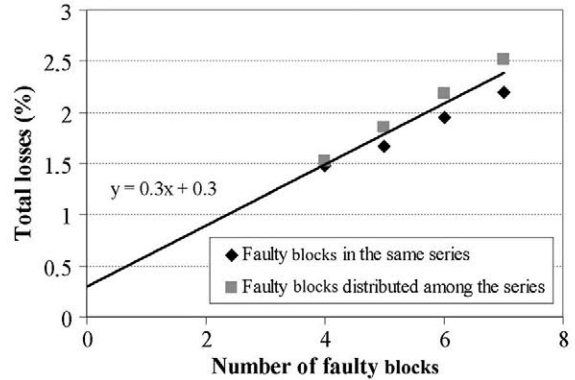
The energy loss of an entire block, as the diode starts to conduct, is 0.83% (1/120 total number of blocks in a PV generator). Adding approximately 0.3% for mismatch losses in the remaining blocks, the total power loss is 1.2% per block with cracked cells. On the other hand, simulation results (Figure 16) revealed that a defective block, with a slight defect (similar to that shown in Figure 12a) approximately involves a mean energy loss of 0.3%. However, the field measurements shown in Figure 14 suggest that each defective block has an average effect on the power loss of 0.36%. This value is much closer to the loss

**Figure 16.** Total energy losses in a PV generator in relation to the number and position of the faulty blocks.

caused by a slight defect (0.3%) than the power loss produced when a bypass diode conducts (1.2%). Therefore, it seems likely that in most cases, the bypass diodes do not conduct.

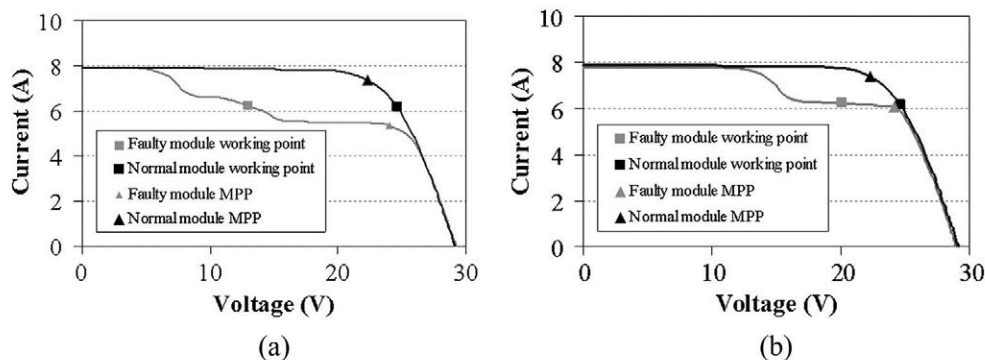
**Figure 15.** I-V curves and operating points measured in the field: (a) sound module and module with two blocks affected by hot cells and (b) sound module and module with one block affected by hot cells. The maximum power points are also indicated for each curve.
