Construction of a high anchored wall at highway EX-A1 (Spain)

A. Gómez¹, A. Soriano², E. Carrera³ and A. Soriano-Martínez⁴

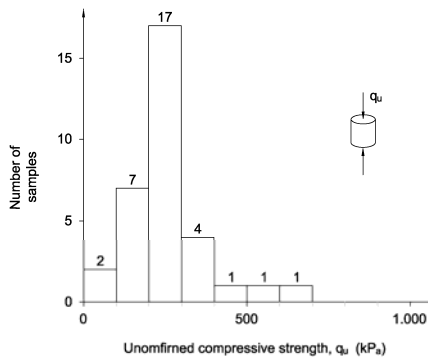
Figure 1.- Compressive strength of the soft marls

Examination of the relation between the depth of the sample and the q_u value indicates no a clear correlation.
