RAPID RESERVOIR SEDIMENTATION OF FOUR HISTORIC THIN ARCH DAMS IN AUSTRALIA

by H. CHANSON¹ and P. JAMES²

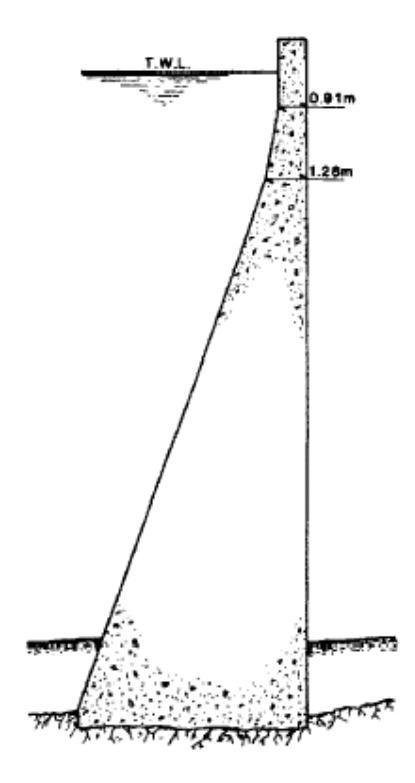
Figure 2 - Moore Creek dam (1898)

The Moore Creek dam was completed in 1898 to supply water to the town of Tamworth, NSW. The 18.6-m high dam was designed with advanced structural features : i.e. thin single-arch wall (7.7-m thick at base, 0.89-m thick at spillway crest, 0.87-m thick at dam crest), made of Portland cement concrete (Table 2). The arch wall has a vertical downstream face and a battered upstream face (Fig. 2). The thin arch extends with a left-bank gravity cross-section with downstream inclined face. The dam was equipped with an overfall spillway and two bottom outlets (a scour valve⁴ and a pipe outlet).

(A) Sketch of the dam arch cross-section

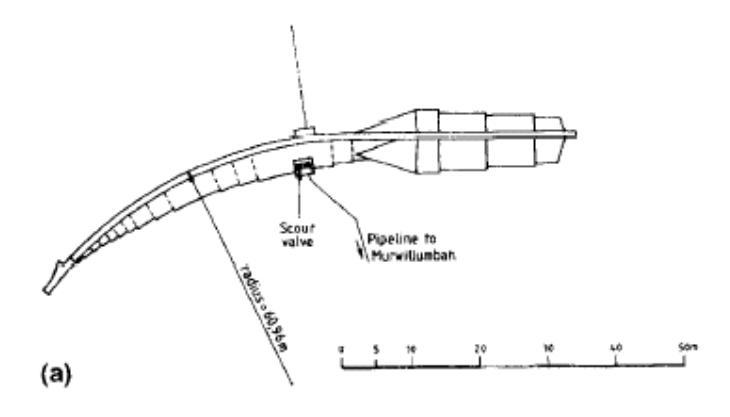
Figure 4 - Korrumbyn Creek dam (1918)

The Korrumbyn Creek dam is located on the Korrumbyn Creek, a tributary of the Tweed river. The dam was completed late 1918 to supply water to the town of Murwillumbah, NSW. The 14.1-m high⁶ dam is a single arch wall (61-m radius in plan) with a left-bank tangent of gravity cross-section (Fig. 4). It was equipped with two bottom outlets (a pipe outlet and a scour valve) and an overfall spillway. The catchment area is only about 3 km² for an original volume of 27,280 m³.

The dam was rapidly abandoned because a log jammed the scour pipe entrance during a flood. It could not be removed and the reservoir silted up very quickly by bed-load. Further, during dry periods, the water level used to drop, the water would turn green and foul as it warmed up, making it unfit for use. The dam still stands today, the reservoir being occupied by an overgrown tropical forest (Fig. 4).

(A) View in plan (from original drawing after construction)

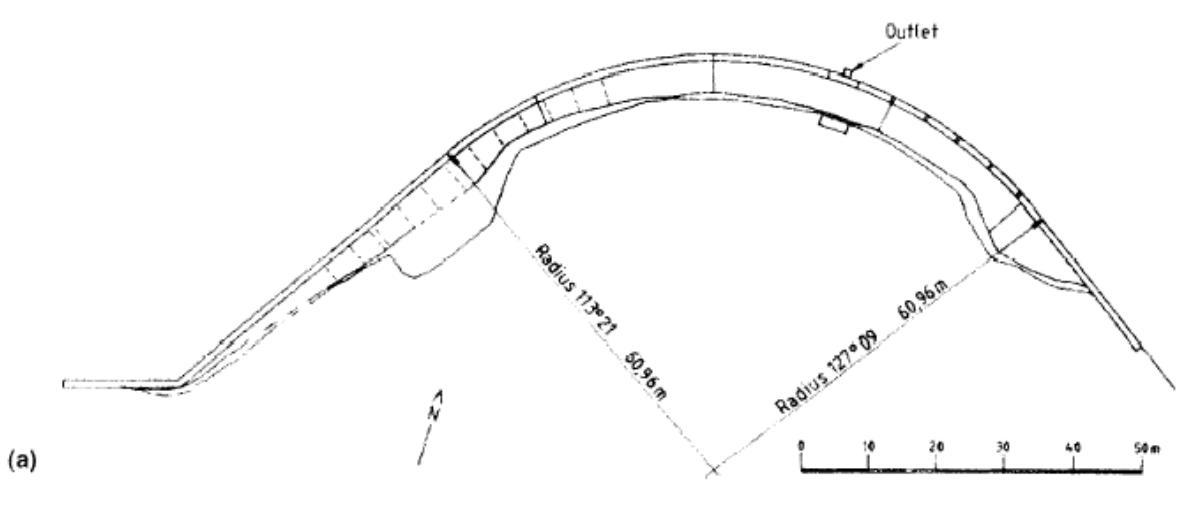
Figure 5 - Quipolly dam (1932)

The Quipolly dam⁷ was completed in 1932 to supply water to the town of Werris Creek, NSW : drinking water, irrigation, water for railway steam engines. The dam wall is a concrete single-arch (1.08-m thickness at crest) (Fig. 5). The design of the dam arch is elegant in comparison with Moore Creek dam and Korrumbyn Creek weir, both designed with a (thicker) gravity section. The reservoir was equipped with two bottom outlets and an overfall spillway.

(A) Elevation in plan (after original drawing)
