CHANSON, H. (2000). "A Review of Accidents and Failures of Stepped Spillways and Weirs." *Proc. Instn Civ. Engrs Water and Maritime Engrg*, UK, Vol. 142, Dec., pp. 177-188 (ISSN 0965-0946).

## A REVIEW OF ACCIDENTS AND FAILURES OF STEPPED SPILLWAYS AND WEIRS

by Hubert CHANSON

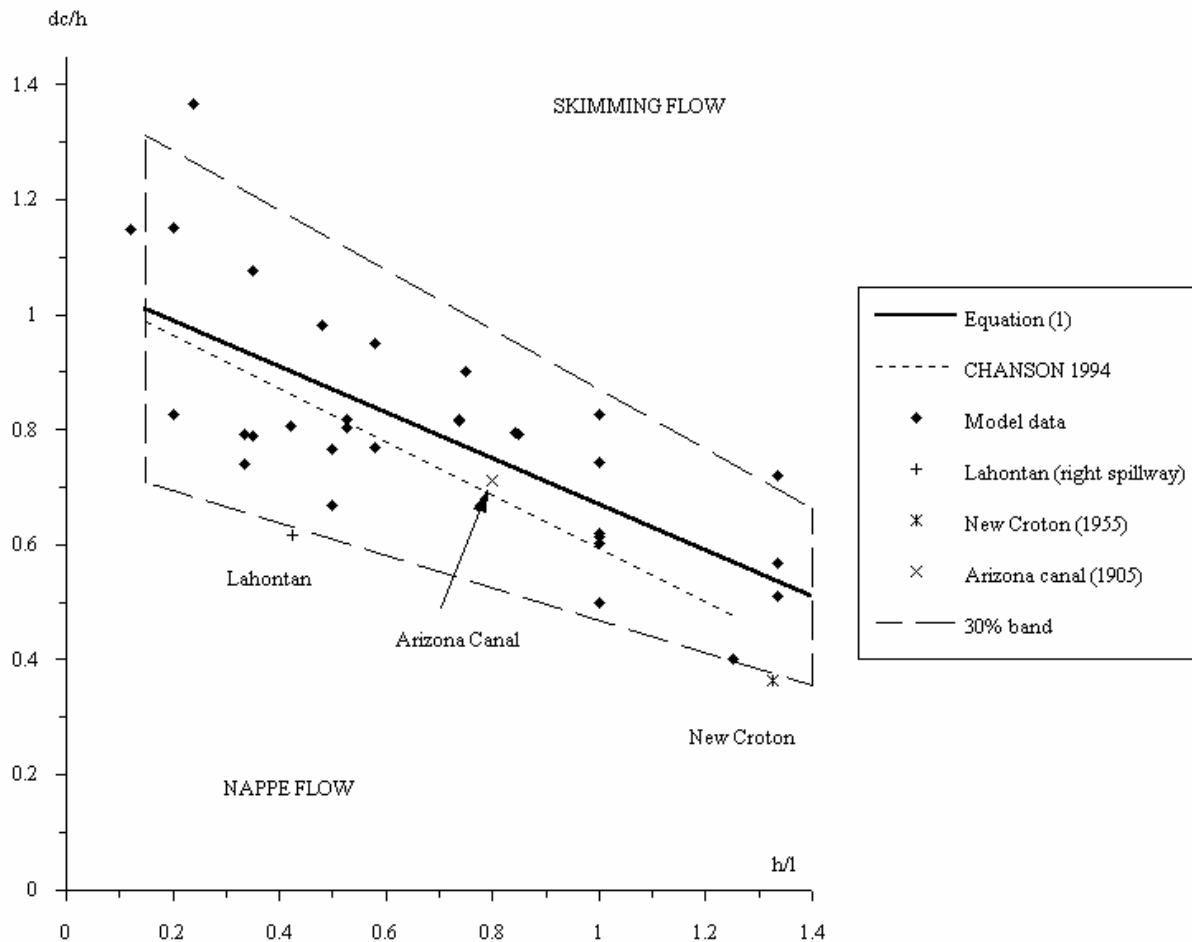
the structure. In two well-documented cases (Arizona canal and New Croton), failures occurred during overflow conditions very close to the onset of skimming flow (Fig. 2). In another case (Lahontan), the design flow of the right spillway corresponded to a transition flow. Extensive damage to that chute was experienced to the point that it was considered to pass "*flood flows over the left side only*" to reduce "*the cost of repairs*" (DOUMA and GOODPASTURE 1940). Basically designers must avoid such transition conditions and consider additional hydraulic and structural tests if they cannot avoid a flow regime transition. If the design flow regime is nappe flow, all the flow conditions up to design flow conditions will be nappe flow. If the design flow is a skimming flow, the transition flow regime is unavoidable for some flow rate below design discharge. For gated spillways, suitable gate operation must be selected to avoid the transitory flow conditions (Fig. 2). For ungated spillways, it is recommended to select a spillway geometry (step height, width) such that the transition occurs at very-low flow rates.

Transition between nappe and skimming flow must be avoided. It is characterised by hydrodynamic instabilities causing additional fluctuating loads on the structures, and the resulting fatigue might increase the rate of failure. Figure 2 illustrates that the transition regime is related to the flow rate (or critical depth), step height and chute slope. It further provides some indication of the range of flow conditions for which transitory flows might occur.

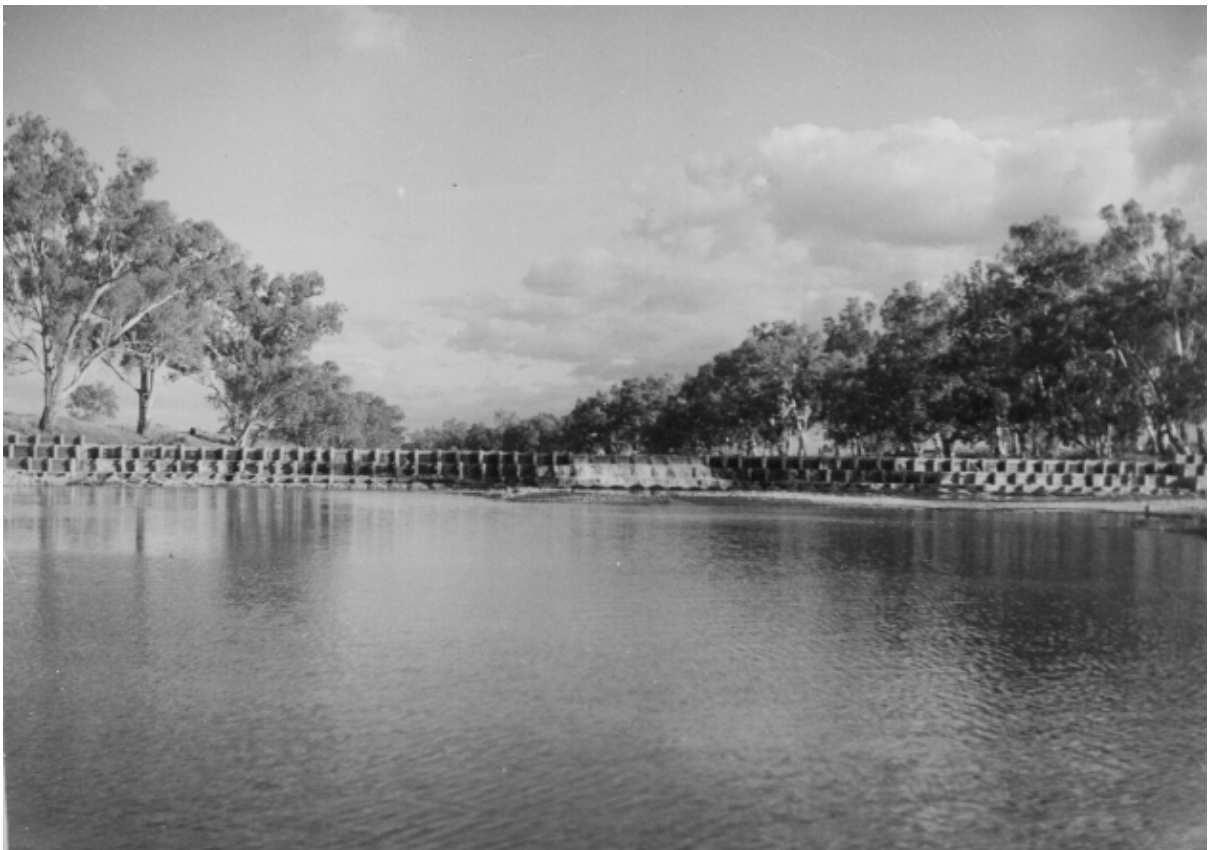
Fig. 4 - Bonshaw weir

(A) First Bonshaw weir around 1953, view from downstream (Courtesy of the Department of Natural Resources)

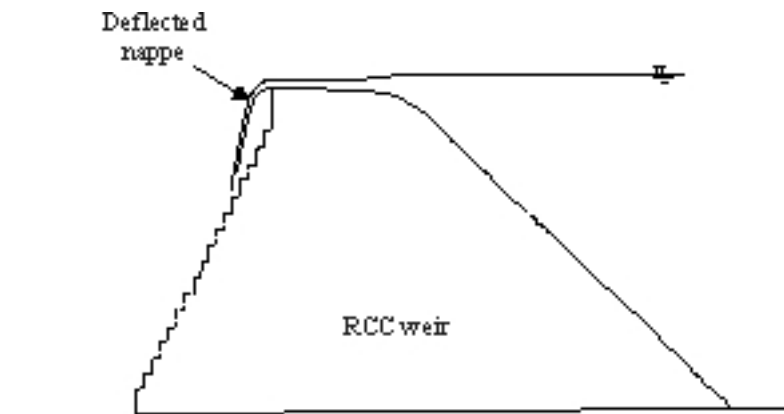
Fig. 5 - Bucca weir spillway : low overflow (cross-section)

Completed in 1987, the Bucca weir is a 12-m high RCC weir equipped with an overflow stepped spillway (Fig. 5). The design is an inclined-upward broad-crest followed by a 1.6-m drop and seventeen 0.6-m high steps ( $h/l = 2$ ). The maximum design discharge is  $7,250 \text{ m}^3/\text{s}$ .

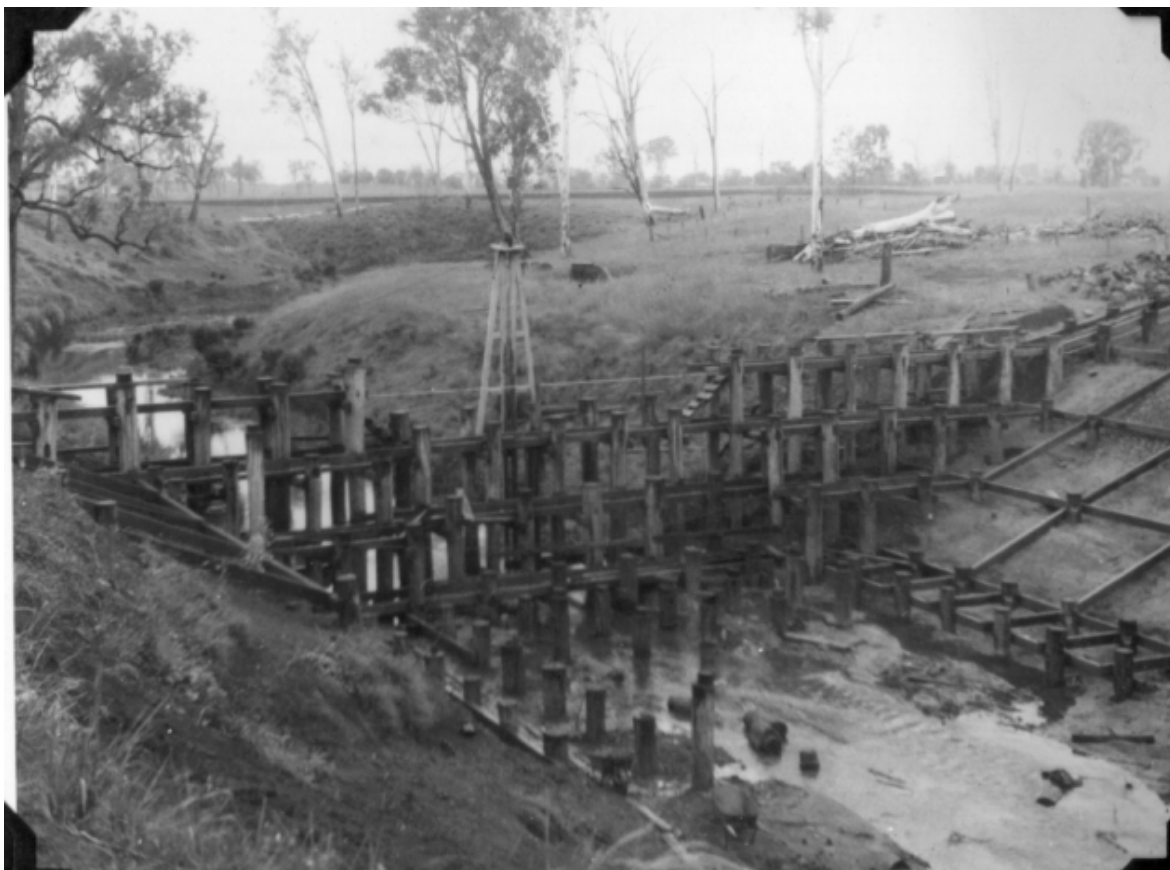
Fig. 7 - Silverleaf weir

The Silverleaf weir was built between 1951 and 1953 for stock water. The 5.1-m high weir was designed as a timber crib piled weir with concrete protection of the four steps (Fig. 7). The upstream wall was sealed with a clay embankment held by boulders set in mortar. The weir was refurbished in 1995 with the installation of a new outlet, construction of an upstream vertical concrete wall to replace the clay fill and to heighten the weir crest by an additional concrete step, and construction of a counterweir downstream.

(A) During construction in April 1952 (Courtesy of QLD Department of Natural Resources)

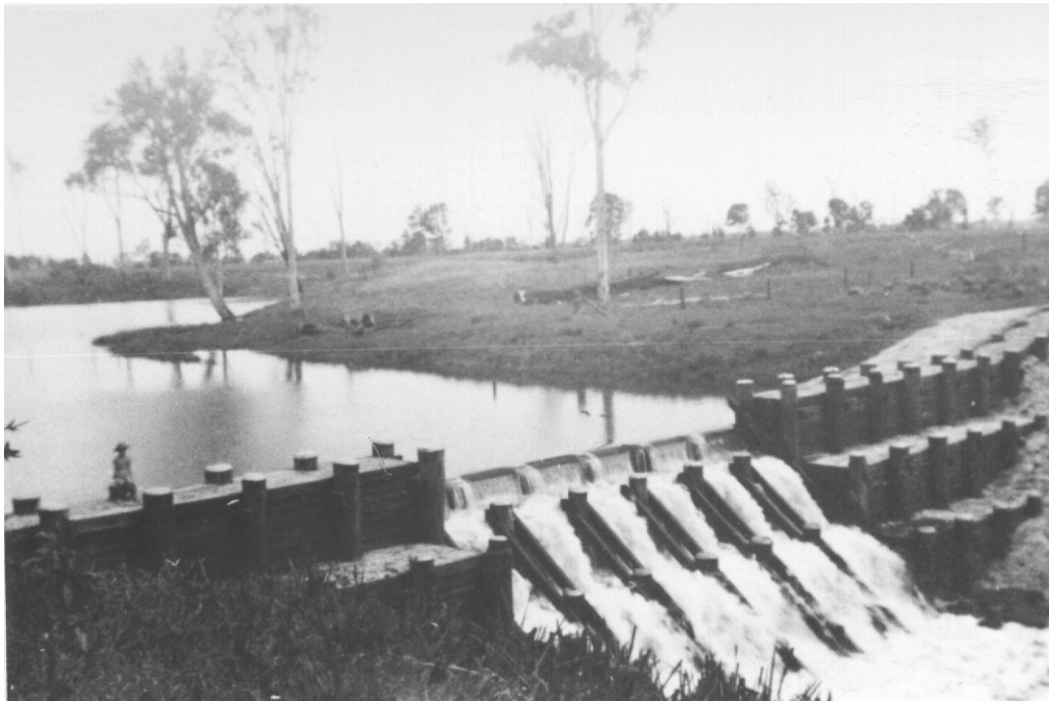
Fig. 7 - Silverleaf weir

The Silverleaf weir refurbishment was completed as planned and the weir is still in use (Fig. 7). Overall, the experience suggests that the timber weir design was sound and the structure is very stable despite its age.

(B) view from downstream right bank during a low overflow, shortly after completion (Courtesy of Mr J. MITCHELL)
